# Geotechnical Seismic Retrofit of Mission Bridge, British Columbia, Canada

Thuraisamy Thavaraj, Alex Sy and Bruce Hamersley  
*Klohn Crippen Berger Ltd., Vancouver, BC, Canada*

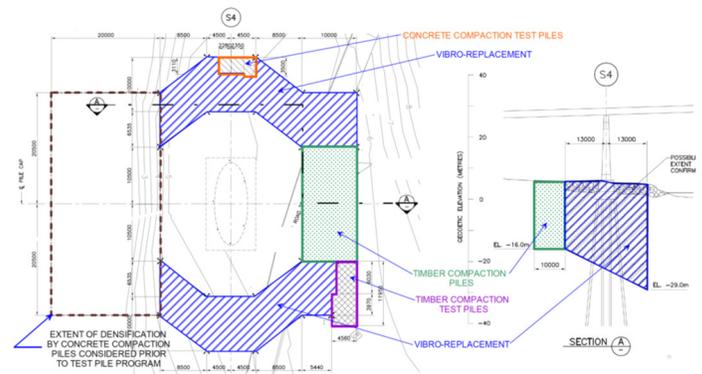
Figure 2: Vibro-replacement and timber compaction piling densification zones at Pier S4, including test pile areas

- River Piers (N4-S3): Structural retrofit of concrete columns to accommodate potential lateral displacements of the piers of the order of 0.3 m, and preferably up to 0.4 to 0.5 m was proposed;
- South River Bank (S3-S4): At the south riverbank, the required depth of ground improvement varies from about 35 m on the river or north side of the pier to 22 m on the south side. Concrete compaction piles were originally proposed for the deep areas as a potential technique to densify deep soils. However, the test pile program showed that the concrete piles would not be a viable or economical technique and was rejected. Following the test pile program, a combined structural retrofit of the pier columns at S4 plus ground densifications were proposed (See Figure 2).

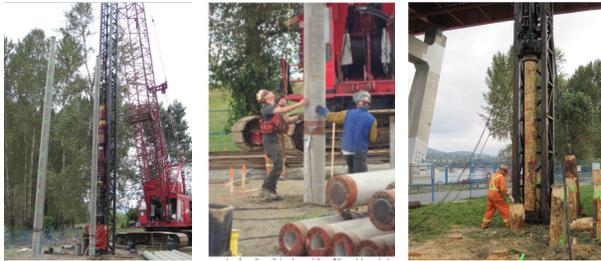
Figure 3: Concrete and timber compaction test piling at the south riverbank

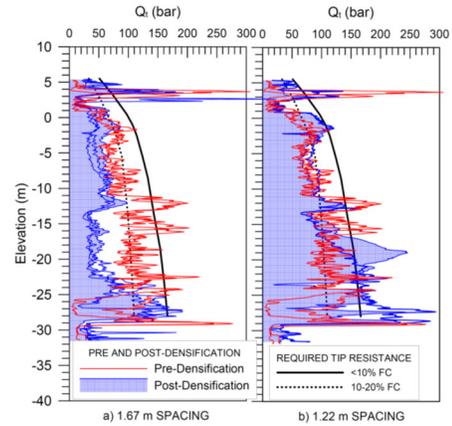
Figure 4 shows comparison of pre- and post-densification cone tip resistances and the required minimum tip resistances corresponding to soils with less than 10% fines and 10% to 20% fines from test areas where piles were installed at 1.67 m and 1.22 m spacings. Significant reduction in tip resistances was evident at 1.67 m spacing or greater. When the spacing was reduced to 1.22 m, no reduction in resistance was observed with some slight increase in resistance. During piling, the surface settlement was monitored at several locations in and round the test area and no noticeable heave was observed. The concrete test pile program showed that, although the piles could be driven to 36 m depth with relative ease and without any damage at close spacing, they would not provide the required densification unless the spacing is reduced to less than 1.22 m. Driving long concrete piles at smaller than 1.22 m will not be economical and may not be practical.

Figure 4: Effectiveness of concrete compaction test piles

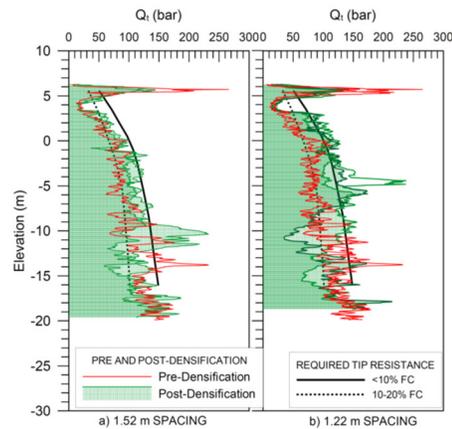
shows the comparison of pre- and post-densification CPTs, suggesting that the piles were effective in densifying the soils and piles at 1.22 m spacing generally provide the required densification.

Figure 5: Effectiveness of timber compaction test piles

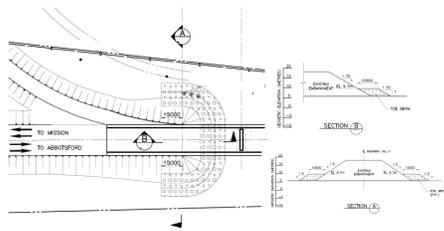
Figure 6: Toe berm at the north abutment

- North Abutment (N11): A horseshoe-shaped toe berm as shown in Figure 6, comprising compacted sand and gravel placed against the existing abutment slopes. The toe berm is 10 m wide and approximately 4 m high;
- North Approach Piers (N5 to N10): A ring of seismic drains around the perimeter of the existing timber pile group. Seismic drains consisting of fine gravel columns 230 mm in diameter installed through the Unit 1 silt and into the Unit 2 sand at 3 m centres to about 3 m below the timber pile toes were proposed;

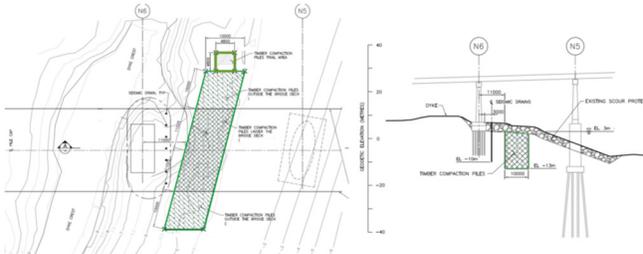
Figure 7: Timber compaction piles at the north riverbank

- North River Bank (N5-N6): As shown in Figure 7, a 10 m wide, about 15 m deep and 42 m long densified zone, or a “seismic dyke”, located between Piers N5 and N6. Due to limited head room, timber compaction piles were proposed to densify soils both under and outside the bridge deck;

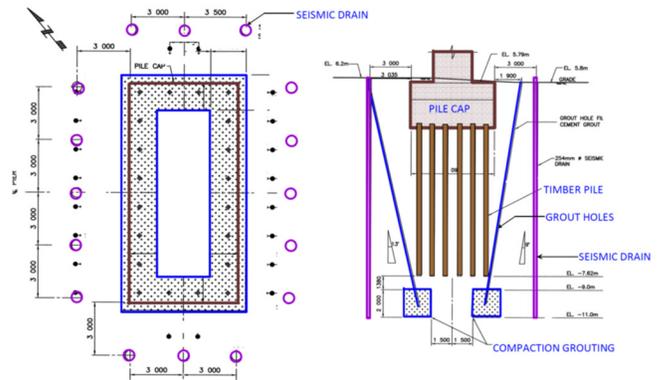
Figure 8: Compaction grouting and seismic drains at south approach Pier S5

- South Approach Piers (S5 through S9): As shown in Figure 8, a 2 m wide by 2 m deep annulus ground improvement zone beneath the edges of the existing timber pile group. Ground improvement by compaction grouting through inclined drill holes was proposed as viable technique. In addition, a ring of seismic drains around the perimeter, similar to those at north approach piers, was also proposed.

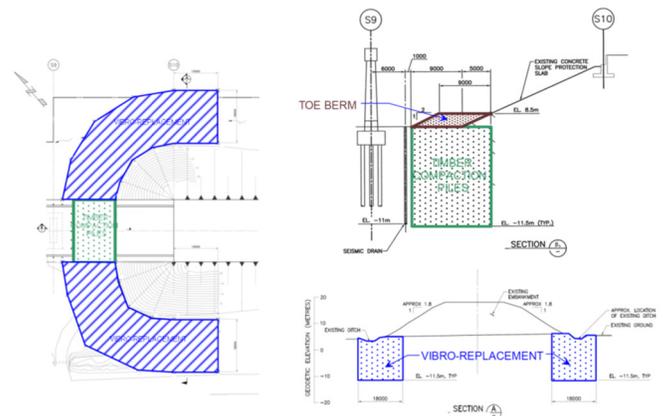
Figure 9: Vibro-replacement, timber compaction piles and toe berm at the south abutment, S10

- South Abutment: As shown in Figure 9, a horseshoe-shaped zone of ground improvement and a toe berm. Outside the bridge deck, the densified zone is 20 m wide by 17.5 m deep; under the deck, the densified zone is 15 m wide by 17.5 m deep. The toe berm is 10 m wide and 3 m high beneath the bridge deck and 5 m high outside the deck. Timber compaction piles and vibro-replacement were proposed to densify soils beneath and outside the bridge deck, respectively.

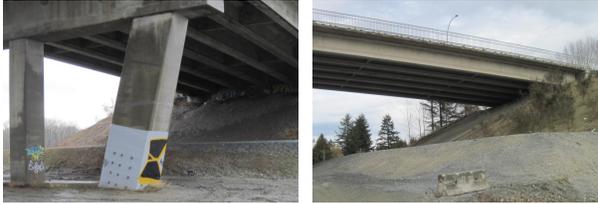
Figure 10: Toe berms at the north and south abutments

A horseshoe-shaped toe berm comprising compacted sand and gravel was constructed at both the north and south berms (see Figure 10).

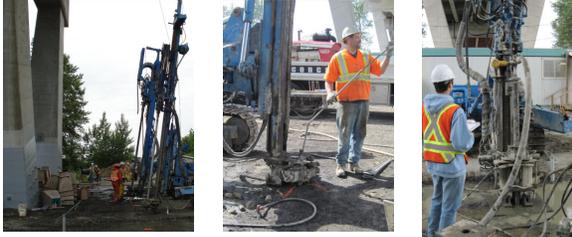
Figure 11: Compaction grouting at south approach piers-casing installation, inclination check and grouting

At the south approach Piers S5 to S9, compaction grouting was performed to create a ring-shaped annulus densification zone beneath the original timber pile group foundation. Grouting was conducted by drilling grout holes at 9° to reach the loose zones beneath the pile toes, and grouting was conducted with target volume and limiting pressure established through trials (see Figure 11). Two trials were performed prior to production grouting and the performance was verified using CPTs. Details of grouting trials, performance verification and production grouting are described in Thavaraj and Sy (2017).

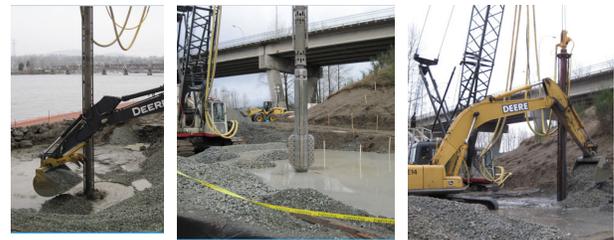
Figure 12: Vibro-densification at the south riverbank and south abutment

Vibro-replacement using stone columns was carried out at S4 and S10 locations to densify the soils outside the bridge deck (see Figure 12). Trials were conducted both at S4 and at S10 prior to the production to establish pattern, spacing, means and methods for the stone columns and to verify performance.

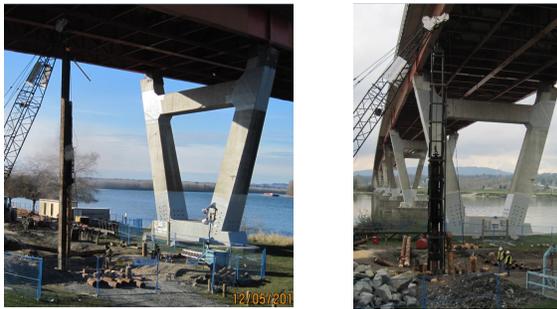
Figure 14: Compaction pile driving at south riverbank

At S4, timber (Douglas Fir) piles with a minimum tip diameter of 225 mm were driven in three sections using two splices (See Figure 14). The approximate first length of the pile was 6 m, and the second and third sections were approximately 7.6 m. 900 mm long steel tube with a 150 mm wide centre plate were used as splices. The diameter of the splices used varied between 254 mm and 356 mm depending upon the pile sizes. The piles directly above and below the splice, and pile tops were banded to minimize or eliminate pile damage during driving. The piles were installed at 1.22 m spacing in an equilateral triangular pattern. The initial lengths were driven using a 2500 kg drop hammer and the subsequent lengths were driven using three single acting diesel hammers mostly between 45 kJ and 63 kJ energies. A total of 179 piles were installed at S4 which included only 9 remedial piles. The required densification was generally achieved with the chosen pattern, spacing and installation procedure. Notably, the use of two splices to drive piles in three segments under the deck to depth of as deep as 21 m was successful.

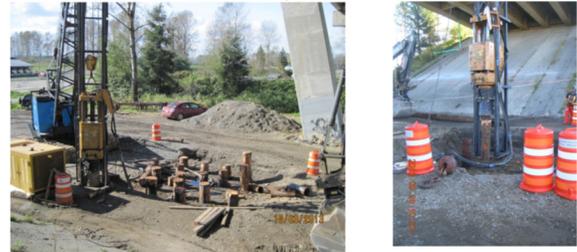
Figure 15: Compaction pile driving at south abutment using low headroom hydraulic hammer

At S10, timber (Douglas Fir) piles with a minimum tip diameter of 225 mm were driven in three sections using two splices (see Figure 15). The approximate length of each section was 6 m. Same splices as in S4 were used. The piles were installed at slightly greater 1.25 m spacing in an equilateral triangular pattern. Initial driving was conducted using a 2500 kg drop hammer, and near the end of driving most of the piles were driven with APE 7.5a low-headroom hydraulic hammer at the maximum rated energy of 34 kJ. A total of 219 piles were installed and only 4 remedial piles were required at S10. At S10 also, driving piles in three sections using two splices to depth as deep as was 17 m was successful. Figure 16 shows comparison of CPTs for piles at S10.

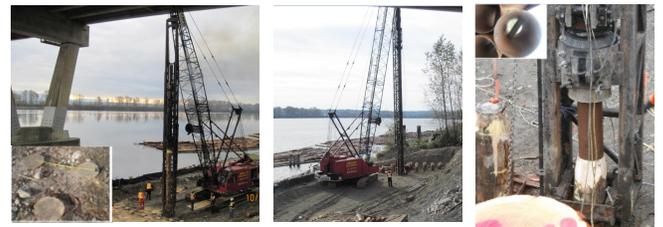
Figure 17: Compaction pile driving at north riverbank using an open-ended diesel hammer and splicing of pile

At N6, timber (Douglas fir) piles with a minimum tip diameter of 225 m were driven at 1.22 m spacing in an equilateral triangular pattern to a depth of approximately 15 m (see Figure 17). The piles outside the deck were driven in single section, and the piles under the deck were driven in two sections with a splice. The length of each section driven under the deck was approximately 7.5 m. 914 mm long by 279 mm outer diameter steel tubes with a center plate were used as splice. All piles were driven using an APE D19-42 diesel hammer with maximum rated energy

of 64 kJ. No drop hammer was used during pile driving even for initial driving. Driving the entire length of pile in two sections with a splice using a diesel hammer under the deck was successful. A total of 362 piles were installed, which included 12 remedial piles.

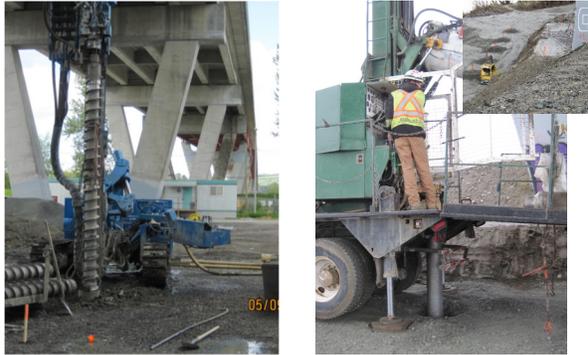
Figure 18: Seismic drain installation using auger and sonic rig

Seismic drains with 255 mm diameter were installed at the approach piers in a ring shape, approximately 3 m from the edge of the pile cap, at a spacing of 3 m and to approximately 3 m below the toe of original timber piles. The drains had a 38 mm slotted Schedule 80 PVC at the center and the annulus space between the PVC and the drill hole was filled with pea gravel. The top of 1 m of the drain was widened to approximately 1 m diameter and filled with sand and gravel. All the drains, except those at N6, were installed using a hollow stem auger. At N6, a sonic rig was used for the installation of seismic drains (see Figure 18).

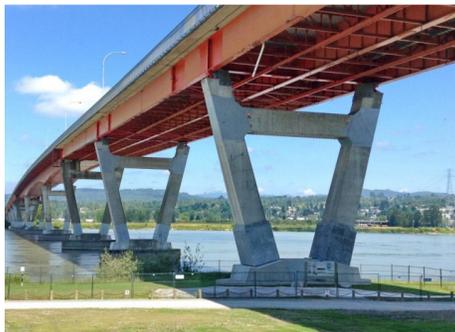
Figure 19: Retrofitted pier S4 columns with ultra-high performance fibre-reinforced concrete jackets (Kennedy et al., 2015)

For the structural retrofit of the pier columns, an innovative column jacket made up of ultra-high performance fibre-reinforced concrete was proposed to enhance their ductility and increase their deformation capacity. Details of the design and

The retrofit strategy included both structural and geotechnical retrofit measures. Ground improvements were conducted where feasible and economical to either minimize or mitigate the effect of ground displacements on the structures. At the river piers where ground improvement was not feasible or economical, and at south river bank pier S4 where fully mitigating the effect of displacement by ground densification was not feasible, structural retrofit measures were adopted. At S4, a column jacket was added to improve its ductility and deformation capacity (see Figure 19).
