Highway Embankment Failure on Weak Ground – Case History

Z. S. Ozden
SNC-Lavalin, Vaughan, Ontario, Canada
D. Staseff
Ministry of Transportation, Toronto, Ontario, Canada

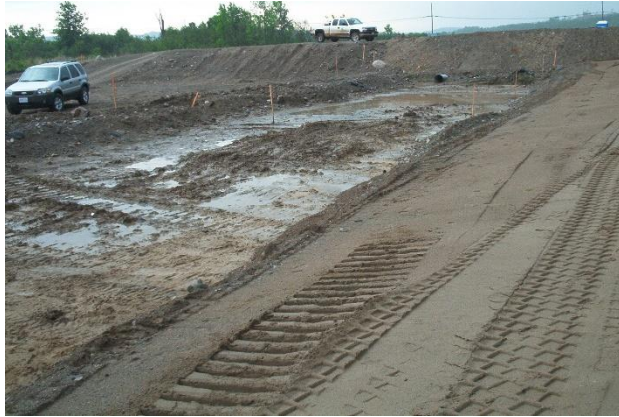
Figure 6 – Highway 17 construction (2005) – culvert embankment in background

The presence of the higher embankment built for the construction of the twin concrete culverts, as shown in the background in the photographs in Figures 6 and 7, also contributed to high pore pressures. When the loaded trucks, especially the unarticulated rock haul trucks, moved down from the top of the culvert embankment to the failure area at a significant speed and frequency, they caused considerable impact on the ground and tended to generate excessive pore pressures in the underlying soils, thus causing a failure condition. According to the contractor, they were under intense pressure to keep the opening schedule for the highway and thus the rate of the construction truck traffic was about one loaded truck per minute.

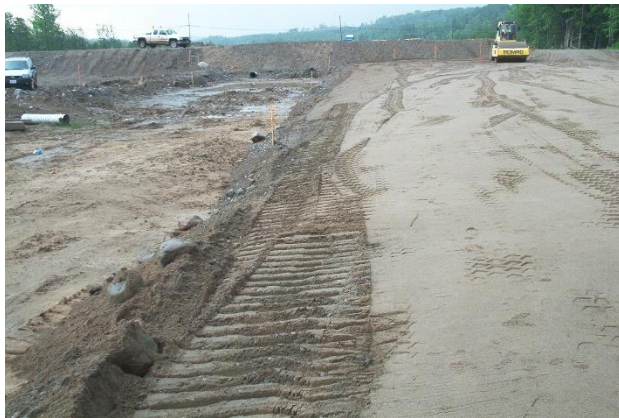
Figure 7 – Highway 17 construction (2005)

At the background of the photograph in Figure 7 is the surcharged embankment for the twin concrete culverts and the heavy vibratory compactor in operation in front of it. At one point during this site visit, the primary author was trying to convince the contractor to stop applying vibration for compaction of the embankment fill or to at least reduce it to a minimum so as to minimize generating excess pore pressures in the silty granular fill being used to construct the embankment and in the underlying wet native silty fine sand foundation soils with the groundwater table being at the o.g. level. By coincidence, the ground surface in the median area started to visibly rise towards the left side of the photograph. This phenomenon convinced the contractor to heed the advice from the geotechnical engineer (primary author) and to not only cease applying

vibration during the compaction process but also to immediately provide a culvert pipe along the median for drainage and then immediately backfill the median area to form a quick mid-height stabilizing berm. They were also advised to place a mid-height stabilizing berm on the north side. The width of the berm was limited to 5 to 6 m, as the property beyond this point had not been acquired by the government. The mid-height stabilizing berms were placed uncompacted, except for several passes of a dozer. These measures were taken on the same day, immediately after noticing the rising ground surface and there were no further visible movements along the WBL.

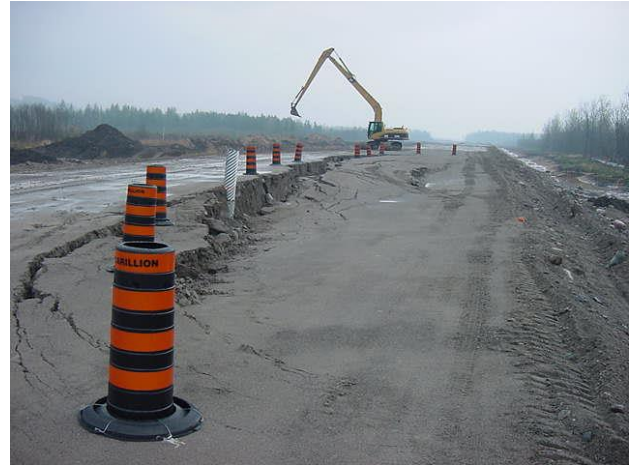
In early May 2005, an approximately 80 m long embankment section of the highway under construction failed between Stations 13+080 and 13+160 along the east bound lanes (Figures 8 to 10). The failure occurred shortly after the embankment reached 2.4 m above o.g. level (full height of embankment, including surcharge fill). Upon failure, some ground heave was noted towards the south side, but not within the median area to the north of the east bound lanes.

Figure 8 – May 10, 2005 – Embankment Failure

In summary, the main causes of the embankment failure were rapid construction and heavy truck traffic, particularly the unarticulated rock haul trucks.

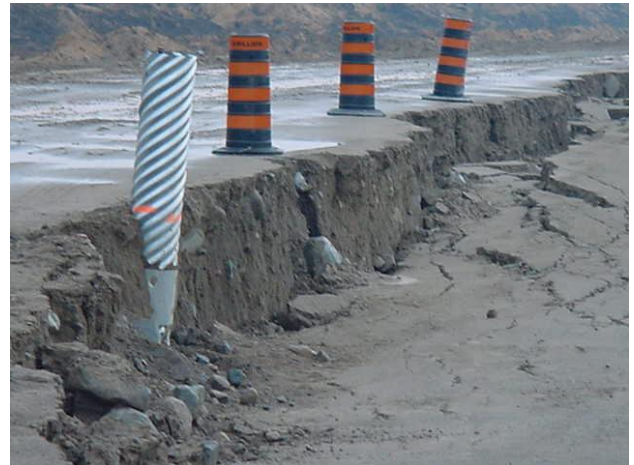
Figure 9 – May 10, 2005 – Embankment Failure

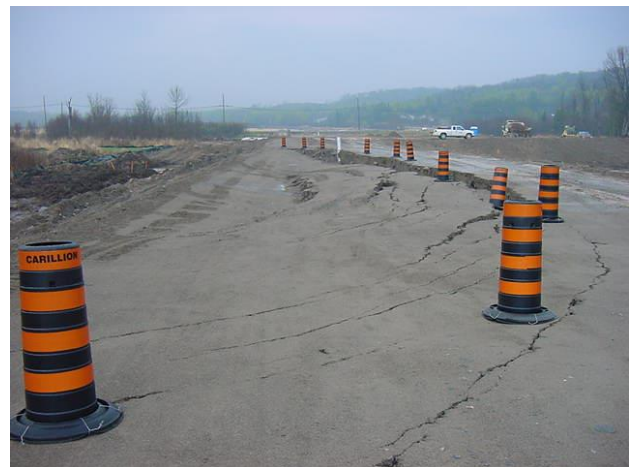
Figure 10 – May 10, 2005 – Embankment Failure

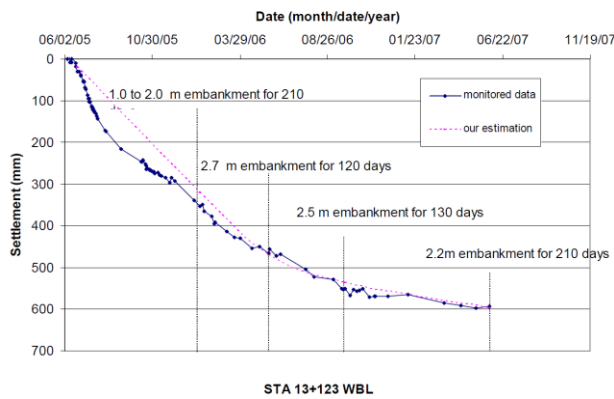
Figure 16 shows the predicted and the measured settlements under the weight of the embankment built after the failure. In spite of the fact that some of the settlements had already occurred under the weight of the embankment prior to failure (in addition to lateral yield), another 0.6 m of settlement materialized in addition to the originally predicted 0.7 m for a total of 1.3 m, some of which can be attributed to the rebound when the failed embankment weight was removed for reconstruction and some to further lateral yield.

Figure 16 – Predicted and measured settlements under the weight of the embankment built after the failure

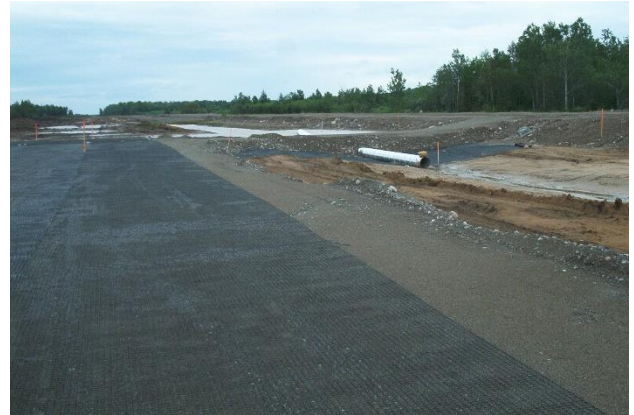
Figure 17 – June 14, 2005 – Embankment Reconstruction

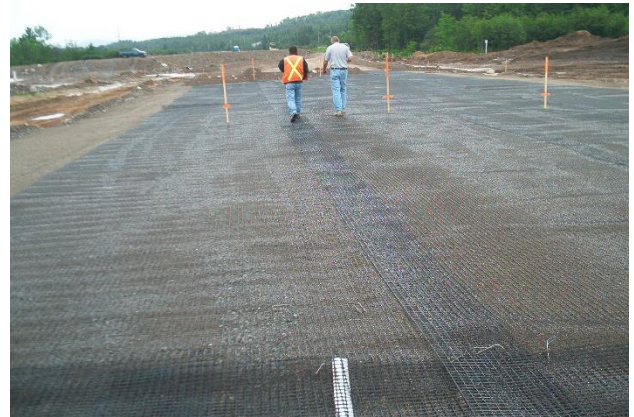
Figure 18 – June 14, 2005 – Embankment Reconstruction

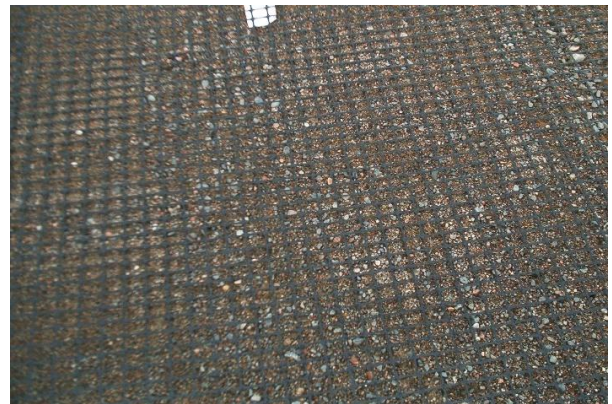
Figure 19 – June 14, 2005 – Biaxial (BX) Geogrid

The sketches of the recommended reconstruction are given in Figures 13 to 15. As shown, the failed section of the east bound lanes was reconstructed using two layers of biaxial geogrid with some granular fill in between. These extended across the 4 m wide stabilizing berm, i.e. all the available property, which was recommended as part of the remediation measures. It was also recommended that several vibrating wire piezometers and two settlement monitoring plates with rods be installed between Stations 13+120 and 13+126, with tip elevations of the piezometers ranging from El. 178.2 to 171.4 m.
