Remediation of a Settlement and Heave Anomaly on a Pipeline in the Northern Region of Canada – an Update

Entzu Hsieh, Blake Brodland, Alexandre Tchekhovski, Stephanie Wegrzynowski
Wood Environment & Infrastructure Solutions, Calgary, Alberta, Canada
Lyndon Lamborn
Enbridge Pipelines Inc., Edmonton, Alberta, Canada

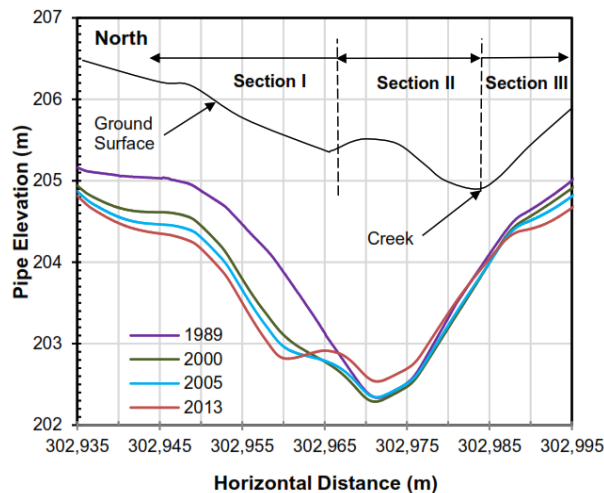
Figure 1. Measured Pipe Elevation – ILI Data

Between 1989 and 2000, varying degrees of settlement were detected in all sections. From 2000 to 2013, upward movements were detected in the pipe in Section II while settlement continued in Sections I and III at varying rates.

Comparison of pipe strains in 1989 and 2013 revealed that there were no significant increases in pipe strain for most of Sections I through III. An exception to this was approximately 24 m north of the creek where the vertical strain changed from negative to positive within the above noted time. A negative pipe strain indicates the pipe is subjected to settling (convex bending) whereas a positive pipe strain indicates heaving (concave bending).

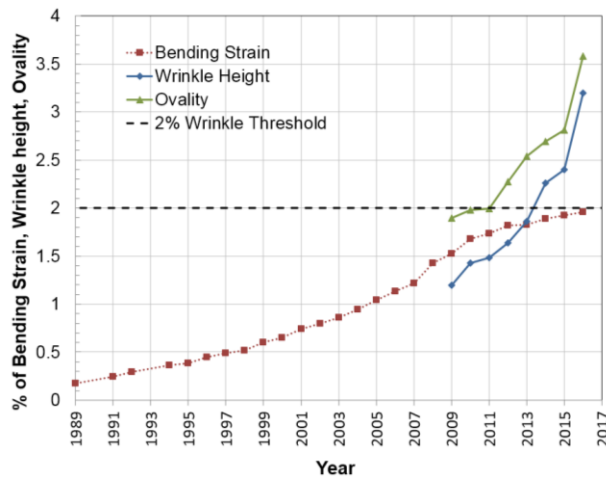
Figure 2. ILI Data Trends Near the Creek

Percent of bending strain accumulation from 1989 to 2016 and wrinkle height as well as ovality after 2009 are plotted in Figure 2. An in-line inspection (ILI) caliper tool with bending strain measurement capability has been used annually since 1994 on this pipeline segment, usually in the summer or early fall months. The ovality and onset of a wrinkle became significant in 2009, and is plotted thereafter in terms of percentage of OD. The 2% wrinkle formation at approximately 1.9% bending strain is consistent with other >2% wrinkles in NPS 12 pipe in this wall thickness range. The pipeline was required to be replaced because the 2% wrinkle criteria was exceeded.

Ovality and wrinkle formation appear to correlate with bending strain, with an acceleration in 2011 when bending strain exceeded 1.7%. Typical pipeline internal pressure at this location is 2,450 kPa with very little pressure variation.

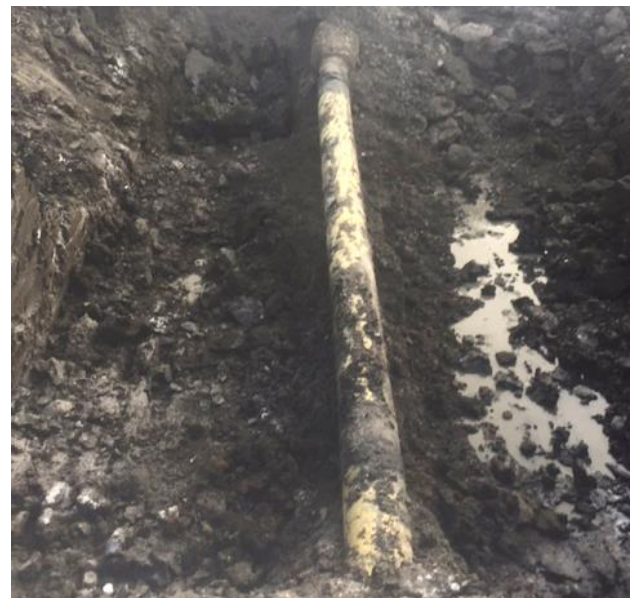
Figure 3. Horizontal Displacement of the Pipe

Within the middle zone, the pipeline was observed to sag, with the lowest point located approximately 15 m north of the creek. Approximately 0.5 to 1 m of horizontal displacement was also noted across the extent of the excavation. Figure 3 illustrates the horizontal displacement & field bend in proximity to the wrinkle.

Five excavations were completed in February 2017 to expose and replace approximately 60 m of pipeline on the north side of the creek and 30 m of pipeline on the south side of the creek. During preparations for replacement work, all instruments installed in 2014 were destroyed.

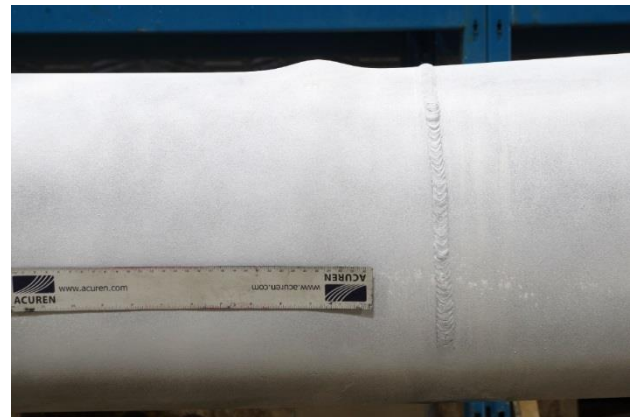
Figure 4. Pipe with wrinkle (top of photograph)

A laboratory photograph of the wrinkle and girth weld after removal of the polyethylene coating and shrink sleeve is shown in Figure 4. The wrinkle height was found to be about 13.7 cm. The pipe has been rotated approximately 180 degrees in Figure 4 showing the wrinkle at the top for photographic convenience. The field-discovered wrinkle orientation was actually at the six o'clock position. The wrinkle formed close to the center of a field bend of radius 93.5D, 1.3 degrees right and 1.9 degrees down, just upstream of a transition weld to heavier walled pipe.

Measurement of the minimum radius of curvature associated with the buckle using the procedures outlined in ASME B31.8R gave a minimum radius of curvature of 29.8 mm and a calculated local strain value of 16.8%. The laser strain mapping of the wrinkle is shown in Figures 5 and 6.

The pipe was found to be free of corrosion, cracking, or mechanical damage features in proximity to the wrinkle. Basic mechanical properties and chemistry of the X52 pipe material met all CSA Z245.1 requirements with an average longitudinal elongation of 39%.

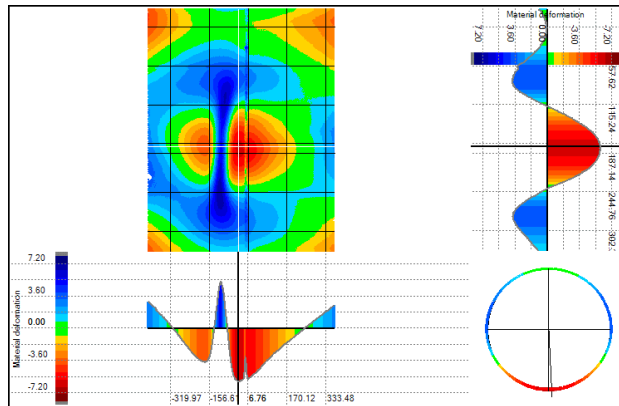
Figure 6. Laser Measurement of the Wrinkle Feature

top-bottom diameter of 327.1 mm, and a 3 to 9 o'clock diameter of 322.9 mm. The downstream heavy wall pipe adjacent to the feature had a top-bottom diameter of 326.4 mm and a 3 to 9 o'clock diameter of 321.2 mm. The calculated ovality after formation of the wrinkle is 1.3% upstream and 1.6% downstream of the wrinkle feature. The upstream peak ovality, $(D_{max} - D_{min}) / D_{nominal}$, reported by ILI in 2013, just before the wrinkle formed, was 2.54%.
