Near Collapse of the St. Adolphe Bridge - An Exercise in Emergency Geotechnical Engineering

R.M. Kenyon, Ph.D., P.Eng, FEIC, B. P. Arpin, P.Eng.
KGS Group, Winnipeg, Manitoba, Canada

Manitoba Infrastructure and Transportation, Winnipeg, Manitoba, Canada

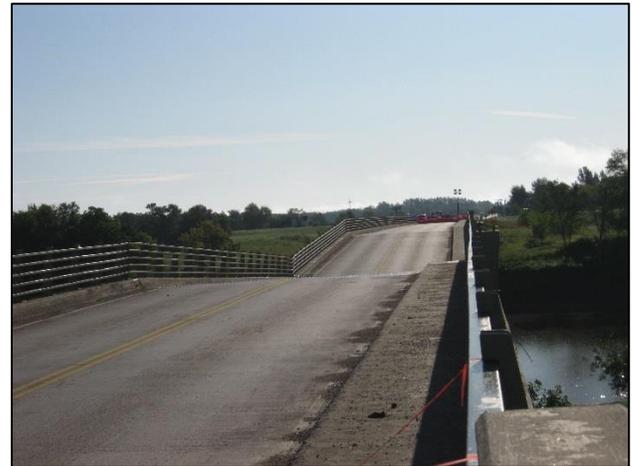
Figure 4. Bridge deck profile upon first inspection.

On August 20, 2009, following drawdown of the summer flood event, Manitoba Infrastructure (MI) noted that severe displacements and rotation of Pier SU 3 had begun. Pier SU 3 is located on the lower west bank of the river. Figure 4 is a profile view of the bridge deck upon first site inspection by the authors. Figure 5 shows the rotation and settlement of the affected pier SU 3. Figure 6 presents the surveyed movement of that pier during the early stages of the emergency.

The first emergency geotechnical inspection and meeting between bridge engineers, geotechnical engineers, and MI occurred late on August 21, 2009. During that meeting, the bridge and bank stability conditions were as shown on Figures 4, 5, and 7. The only geotechnical information available at the inspection was the stratigraphic profile of the bridge shown in Figure 3.

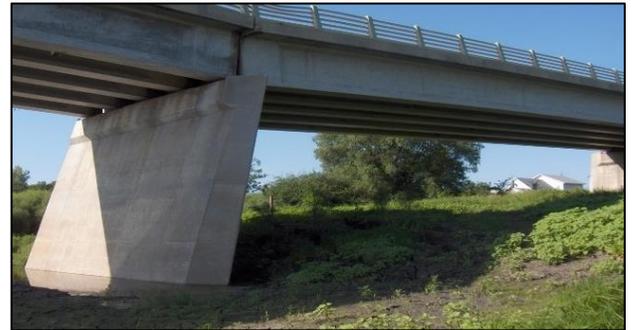
Figure 5. Pier SU 3 upon first inspection.

First of all, Pier SU 3 was failing by settling and rotating actively and visibly at the time. Movements were ongoing and active, and you could hear the bridge structure responding audibly. A well-defined and localized head-scarp, approximately 1 m high, was noted immediately upstream of Pier SU 3. This accounted for the pier failure. Figure 8 illustrates the lower bank failure as it was assumed to be that first night. It was concluded immediately that the precast pre-stressed concrete piles had been sheared off by the movements and that the pier was probably resting and settling on its pile cap.

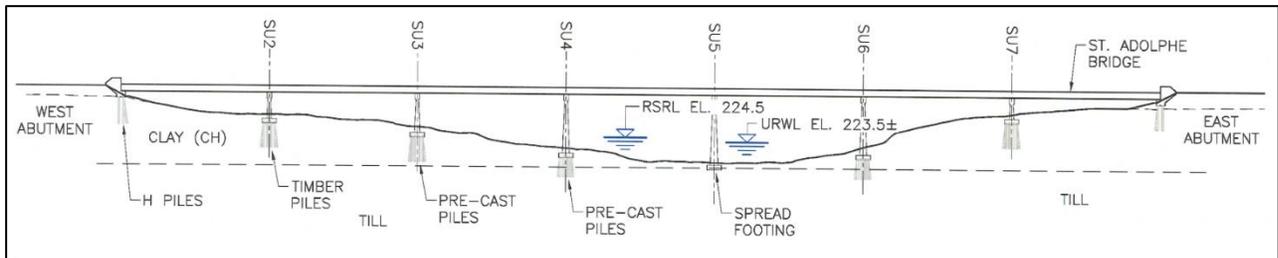
Figure 3. Stratigraphic Section with Pier Foundations.

Figure 3 presents a 1974 stratigraphic section of the bridge. Overburden stratigraphy consists of some 15 to 17 m of soft and compressible high plasticity clay on the west or outside bend with the same depth of alluvial flood plain deposits of intermediate plasticity on the east or inside bend of the river. The clay is underlain typically by a thin soft layer of ablation till followed by competent dense basal tills and limestone bedrock.

As shown on Figure 3 the bridge abutments and piers are supported on a variety of foundation types including driven steel H piles, driven timber piles, driven precast pre-stressed hexagonal concrete piles, and shallow footings.

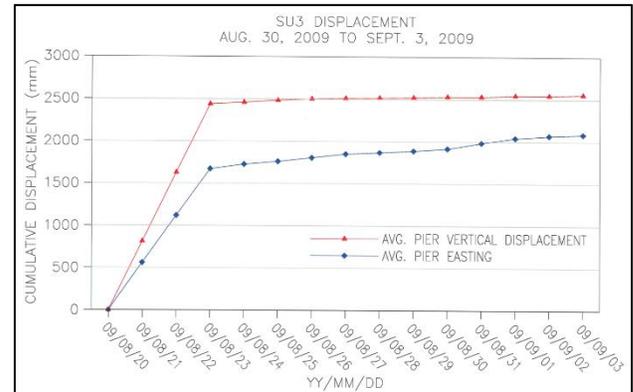
Figure 6. Survey movements of Pier SU 3.

MI immediately initiated a survey monitoring program of all piers and concluded that Pier SU 3 was settling and translating at a rate of 0.8 to 1.0 m per day.

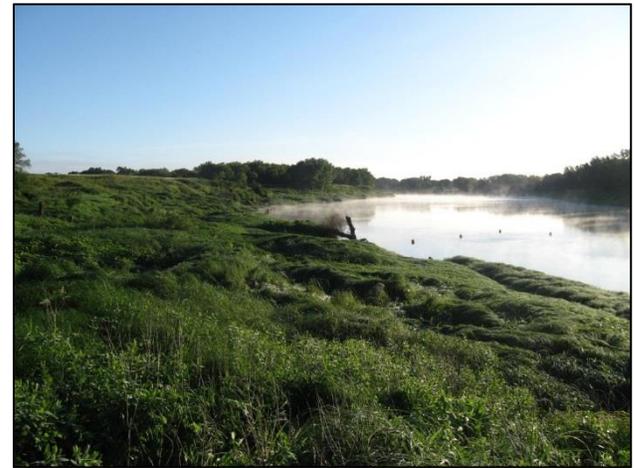
Secondly, the entire riverbank, from river's edge to top of bank presented multiple headscarps and a hummocky appearance. It was concluded that any attempt to access the bridge from the riverbank on either side would very likely initiate further bank movements and this might initiate catastrophic loss of more elements of the bridge structure. Therefore the geotechnical objective was to develop an emergency stabilization plan that would improve stability to the point where equipment could safely access the bridge structure to complete demolition.

Figure 7. Typical pervasive and retrogressive bank failure conditions.

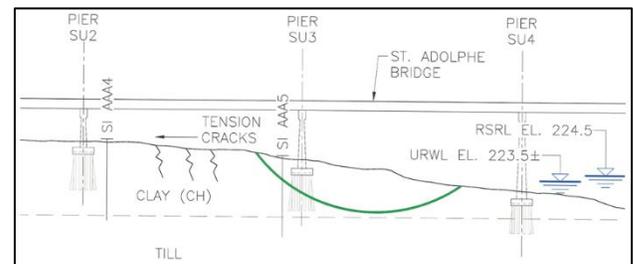
Figure 8. Failure conditions as assumed upon first review.
