Variations in river level and their impact on slope stability at the Borden Bridge landslide

Jenae Nixon¹, David Elwood², Harpreet Panesar³ & Allen Kelly¹

¹*Clifton Associates Ltd., Regina, SK, Canada*

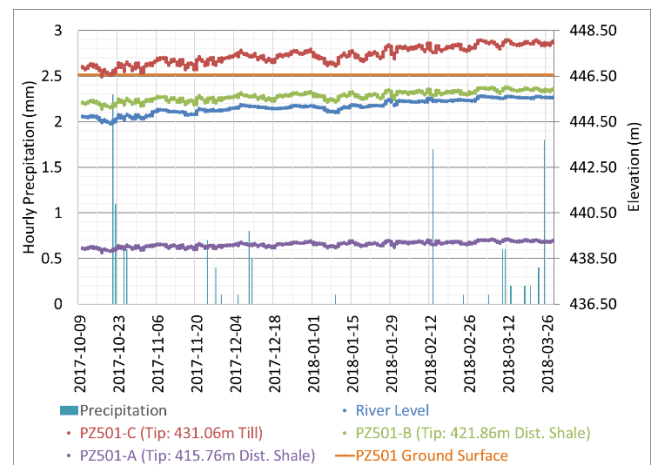
Figure 6. Piezometric readings near toe of slope with hourly precipitation and river levels read from PZRiver from fall 2017 to spring 2018

Piezometric readings from PZ501, precipitation record, and the PZRiver readings between fall 2017 and spring 2018 are combined in Figure 6 below. There is no visible indication that river level is impacting groundwater levels. However, the period of data available is through the winter months. During the majority of this period the ground surface and river level would have likely been frozen.

Observed river levels and pore-water pressure conditions along the slip surface were compared. One comparison is shown above in Figure 6. Currently there is no clear pattern between river level increases and pore-water pressures

measured along the slip surface. This may be due to the river level records consisting almost exclusively of winter flow levels and the associated freezing effects of the season.

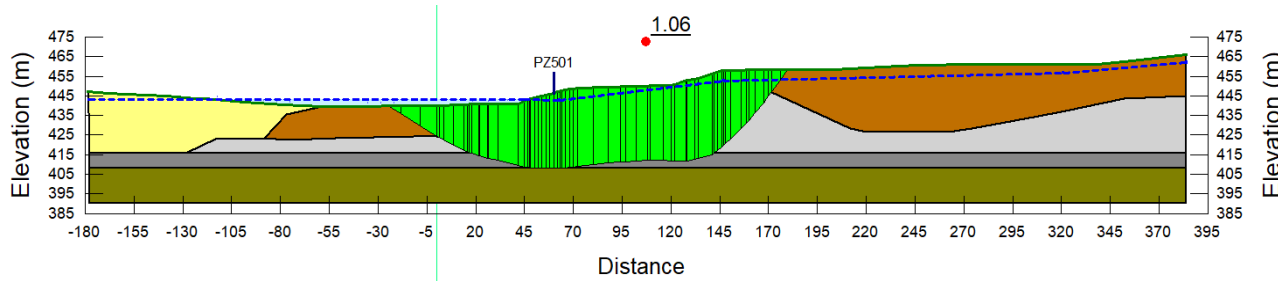
Figure 8. Optimized slip surface with a factor of safety of 1.06

The results of the stability analysis indicated that the landslide at the Borden Bridges had a low factor of safety equal to approximately 1.06. This agrees with the observed movements in the slope inclinometers. The optimized slip surface of the landslide is shown in Figure 8. This model used a river level elevation of 443.05 m, from September 2011.

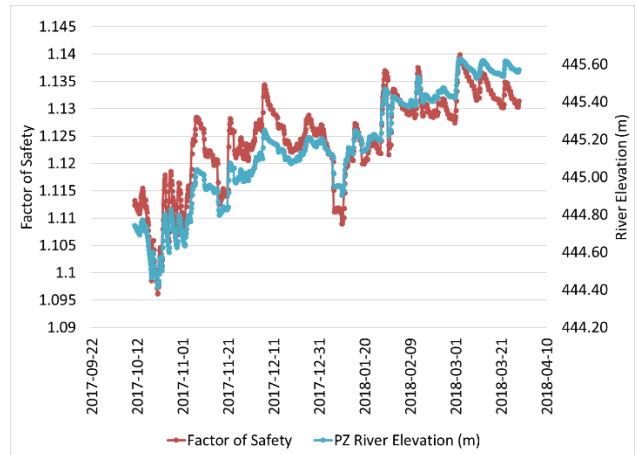
Figure 9. River level variations and associated critical slip surface factor of safety.

The river level data from PZRiver was utilized in a stepped seepage analysis with the resulting pore-water pressures used in a stability analysis. The results from this analysis are shown in Figure 9. It is indicated that the factor of safety of the slope is significantly influenced by river level variations. The pore-water pressure response to variations in river level indicated that the till unit responded rapidly to changes, while all underlying shales responded only to large variations and not immediately.

The results of this analysis are preliminary, as the available data was during freezing periods and do not illustrate extreme flows that may be experienced during runoff and extreme precipitation events.

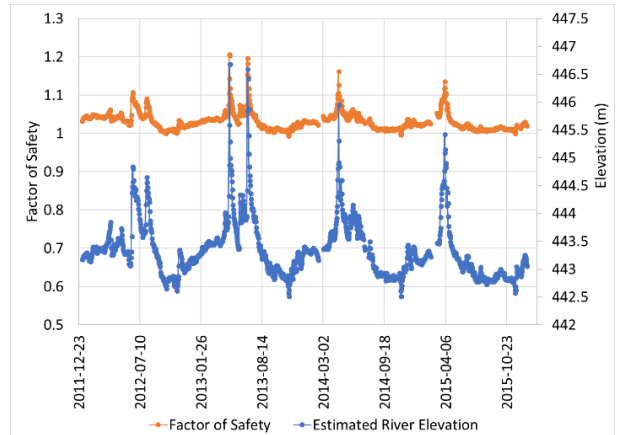
Figure 10. Estimated river level variations and associated critical slip surface factor of safety (null readings omitted)

To illustrate potential extreme river level fluctuations, a second analysis was carried out. This analysis utilized river level data from the Prince Albert hydrometric station. It was assumed that Borden would experience the flows two days prior to that of Prince Albert. River elevations for this analysis were calculated based on the river elevation at Prince Albert on September 3, 2011. On September 1, 2011 a survey was carried out at the Borden Bridges where river elevation is known. A change in the Prince Albert levels between that date and the following dates was applied to the known elevation at the study site to provide river level estimates. Utilizing this estimation, river levels between 2012 and 2015 had a minimum and maximum elevations of 441.212 m and 446.696 m. The results of this estimated analysis is provided in Figure 10. Once the river level falls below an elevation of 443.0 masl, the factor of safety drops to 1.
