Design and Construction of Rockfill Columns in Deep Clay Deposits for Riverbank Stabilization in St. Jean Baptiste, Manitoba

The integrity of flood protection dikes for the town of St. Jean Baptiste in southern Manitoba were at risk due to slope failures along the Red River through Lake Agassiz clay deposits. Manitoba Infrastructure completed stabilization works to protect the dikes adjacent to over 100 m of riverbank with the construction of rockfill columns. This is a common landslide stabilization technique in the region, however the depth of the clay deposit and artesian groundwater conditions in the underlying aquifer provided unique design and constructability challenges. This paper presents the design including deformation predictions, construction details, and a review of the performance to date.

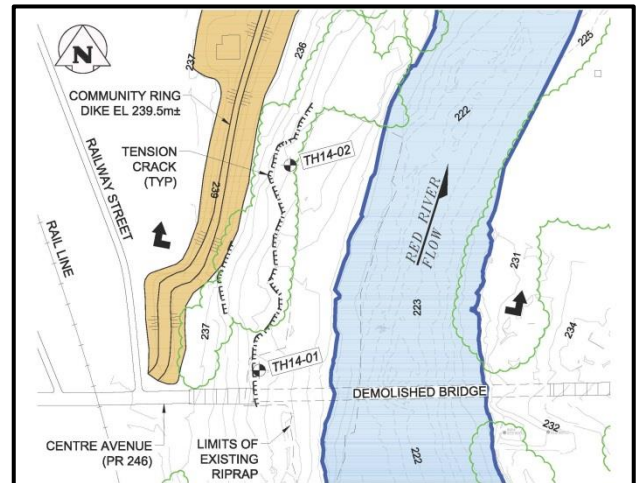
Figure 2: Topographic site plan prior to stabilization works.

The portion of riverbank that runs parallel to the dike has a history of instability (Penner, 2007). In 2009, routine inspections by M.I. revealed multiple active bank failures along a 125 m long section of riverbank with headscarps that had propagated to the toe of the dike. The slope failures had compromised the integrity of the dike and threatened the town with the risk of flooding.

Detailed investigations were conducted in stages between 2007 and 2014. This included a drilling and sampling program, laboratory testing, electric piezocone testing (CPTu), and installation of slope inclinometers (S.I.), piezometers and monitoring wells. A site plan is shown in Figure 2 and a general cross section is shown in Figure 3.

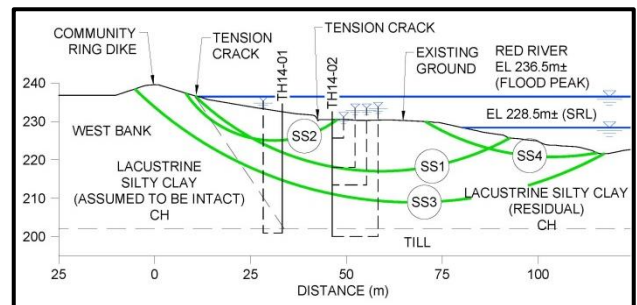
Figure 3: Section A – General cross section.

Based on the geotechnical investigations, the stratigraphy was identified as consisting of approximately 30 m of high plasticity clay of glaciolacustrine origin overlying granular till. The general stratigraphy of the site is shown in Figure 3.

Monitoring of the piezometers and groundwater monitoring wells identified that artesian groundwater conditions were present at the site. Groundwater levels measured in the till aquifer were as high as an elevation of 236 m. Groundwater levels measured in August, 2014 are shown on Figure 3.

Six (6) slope inclinometers (S.I.) were installed during the 2007/2008 drilling program. By 2012, each of the S.I. casings had deformed beyond their functional limits. The approximate slide plane is shown in Figure 3 and labelled SS1.

M.I. specified that the factor of safety (FS) of the slope be increased by a minimum of 30%. This increase was deemed acceptable because of the high level of geotechnical investigation and monitoring data that preceded final design. Several slip surfaces were analyzed including: 1) a global slip surface originating at the observed headscarp down slope of the dike and terminating at the toe of the slope, 2) an upper bank slip surface originating near the dike and terminating mid slope, 3) a potential global slip surface originating upslope of the dike and exiting at the toe of the slope and 4) a lower bank slip surface originating in the mid bank and terminating at the toe of slope. These slide planes are labelled SS1 through SS4, respectively as shown on Figure 3.

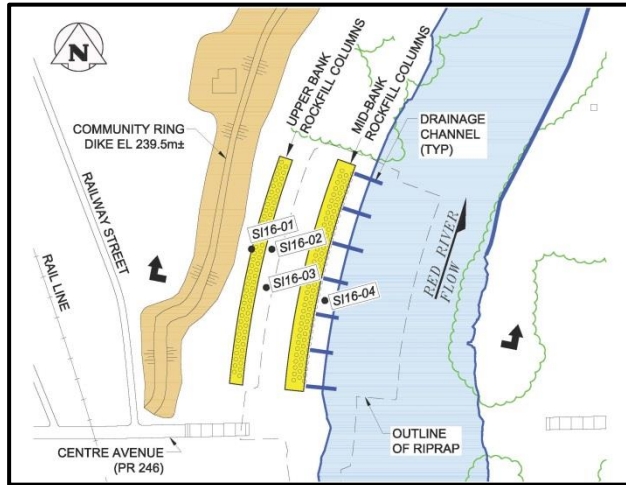
Figure 4: Plan view of Completed Stabilization Works.

The final design of riverbank stabilization works included riprap erosion protection, toe berms, rockfill columns and rockfill drainage channels. A site plan of the works is shown in Figure 4 and a general cross section of the works is shown in Figure 5.

A total of one hundred four (104) rockfill columns were installed along the mid-elevation of the bank, each 2.1 m in diameter and excavated through the lacustrine clay into the underlying till. The depths of columns varied but were generally approximately 26 m deep. These rockfill columns increased the stability of potential deep seated slide planes extending to the base of the clay and till interface.

A series of seventy (70) rockfill columns were also installed along the upper bank and downslope of the ring dike. These columns were drilled to an elevation of approximately 213.0 m, ending in the clay. These

Also included in the design was a series of passive drainage channels and blankets. A blanket of crushed rockfill was installed over the rockfill columns. Channels of rockfill connect the mid bank blanket to the riprap at the toe of the bank to allow the artesian groundwater from the till to drain up through the columns and towards the river.

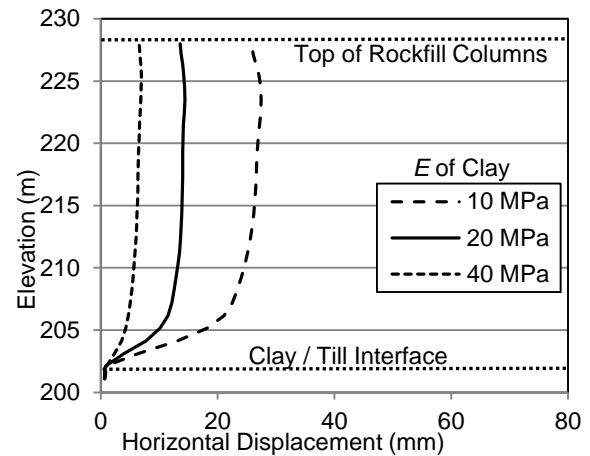
Figure 6: Estimated horizontal displacement of rockfill columns at mid-bank for river drawdown scenario 1 (from summer river level down to the winter river level) and varying Young's Modulus of clay.

A plot of the estimated displacement of a rockfill column at the mid-bank is shown in Figure 6 for drawdown Scenario 1. Figure 6 shows the deflection for varying stiffness of clay. The estimated displacement is similarly shown for drawdown Scenario 2 in Figure 7.

In both drawdown scenarios, the estimated horizontal displacements are significantly more sensitive to the stiffness of the clay than to the stiffness of the rockfill. Results from the sensitivity analysis on rockfill stiffness are not shown as the impact on horizontal displacements was minimal. This is logical when considering that the clay occupies the majority of space and only a small proportion is replaced with rockfill. For the summer to winter river level drawdown, the stress

change occurs at the toe of the slope resulting in a predominantly horizontal stress change. Therefore, most of the shear deformation occurs at the base of the column near the till. On the other hand, the magnitude of horizontal displacement near the surface is greater for the condition of flood to summer river level drawdown. The change in stress conditions is greater in the second scenario with the larger drawdown in river elevation.

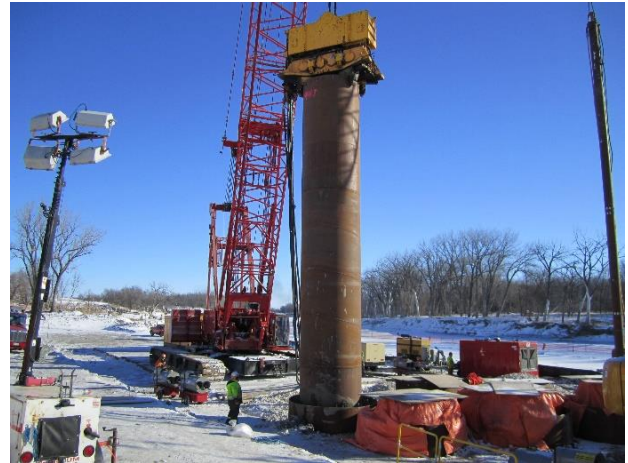
Figure 8: Advancing steel casing for rockfill columns at mid-bank.

The contractor returned to site in August, 2015 after the high river levels receded. Evidence of ongoing riverbank movements were observed following the rise and fall of the river levels. Five (5) steel casings that were left in the slope had collapsed due to continued movement of the slope after the natural drawdown of the

river levels. Three (3) sleeves were damaged beyond repair. The damaged sections of two (2) sleeves were cut and the sections that remained intact were welded together to form a new sleeve. The remaining mid bank columns were completed by August 26. An aerial view of the site from August, 2015 is shown in Figure 9.

Construction of the mid-bank rockfill columns began in February, 2015. A bench was cut along the midbank and surfaced with a rockfill travelling surface. The columns were constructed by first free drilling until sloughing occurred in the upper alluvial material at which point a 3.0 m diameter casing was advanced to approximately 10 m below surface. Drilling continued to refusal and then a 2.1 m diameter inner casing was advanced (as shown in Figure 8) into the underlying till. Any excess clay remaining in the inner casing was removed prior to backfilling with 150 mm diameter clean crushed limestone. To ensure the inner casing could be removed, approximately 3 m of limestone was placed at the bottom of the hole. The inner casing was then lifted 1.5 m and the backfilling continued until it was approximately 1.5 m above the top of the inner casing. After the inner casing was retrieved, the 3.0 m shaft was backfilled prior to retrieving the larger casing. The casings were advanced and retrieved using a vibratory hammer hoisted by crane.

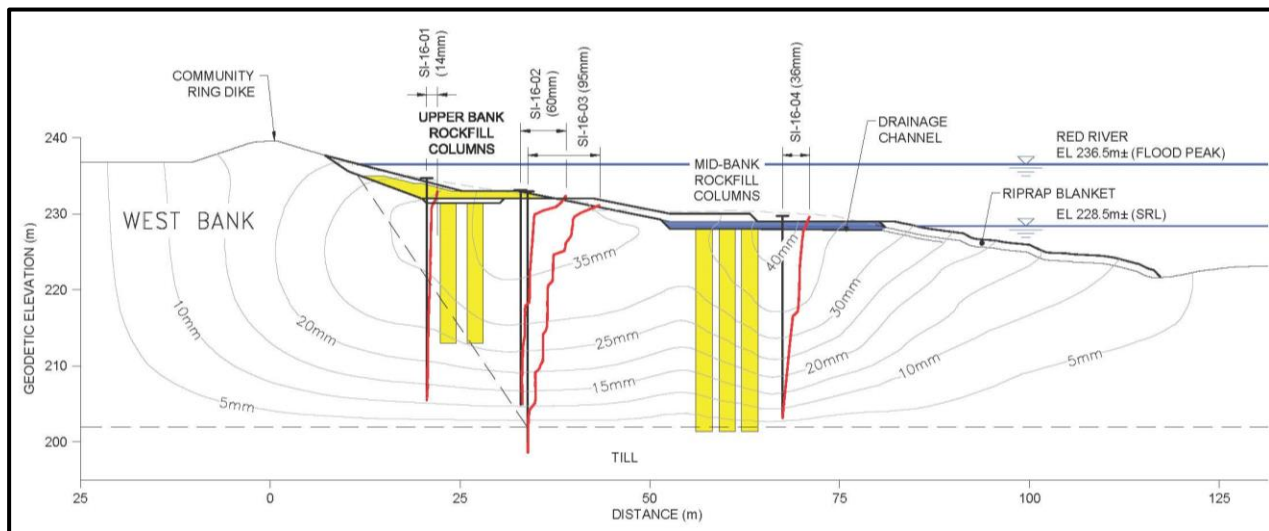
Figure 10: Slope inclinometer monitoring data and estimated horizontal displacements from finite element model.

SI16-02 is located downslope of the upper slope rockfill columns. A baseline reading was collected on February 22, 2016 and the most recent reading was collected on October 30, 2017. The same general displacement of the slope towards the river can be observed from the monitoring data. Distinct shear displacement can be observed at elevation 218 m which first occurred between April 28, 2016 and June 2, 2016. As of the most recent reading, the total cumulative shear displacement at this plane is approximately 5 mm.

SI16-03 is also located downslope of the upper slope rockfill columns. Here, the data indicates that the slope is generally straining progressively towards the river with time. Distinct shear zones are identified at elevations of 225.0 m, 221.0 m, 214.5 m, 209.5 m and 205.0 m. The cumulative shear displacement at each of these slide planes over 19 months of monitoring is approximately 13 mm, 5 mm, 3 mm, 5 mm and 7 mm, respectively. One possible explanation for the shear displacement along these five planes is that these could be pre-existing shear planes with clay at residual shear strength due to the historical movement at this site. The magnitudes of displacements post-construction have been relatively small and are not a concern at this point in time.

SI16-04 is located along the toe of the slope downslope of SI16-03. A baseline reading was collected on April 28, 2016 and the most recent reading was collected on October 30, 2017. The intention was to install another SI to till on the lower riverbank. However due to locking augers this was not possible. Consequently, the casing for SI 16-04 has been subject to interactions with

debris and ice. To date there has been no distinct shear movement observed at this location. The general trend of progressive straining towards the river was similarly observed.

Cumulative displacements from the S.I. monitoring data are shown in cross section in Figure 10. The results overlie contours of the estimated horizontal displacement contours from the finite element analysis. The displacement contours assume river drawdown from high level to summer river level and Young's modulus of 20 MPa for the clay. The quantities are not directly comparable since the S.I. monitoring data is cumulative whereas the model provides estimates for a specific drawdown event. Figure 10 does however provide an initial comparison of the observed deflection from S.I. data versus the estimated behaviour from the modelled drawdown event.
