The 2016 landslide at Saint-Luc-de-Vincennes

Tremblay-Auger, F., Locat, A. & Leroueil, S.

ABSTRACT

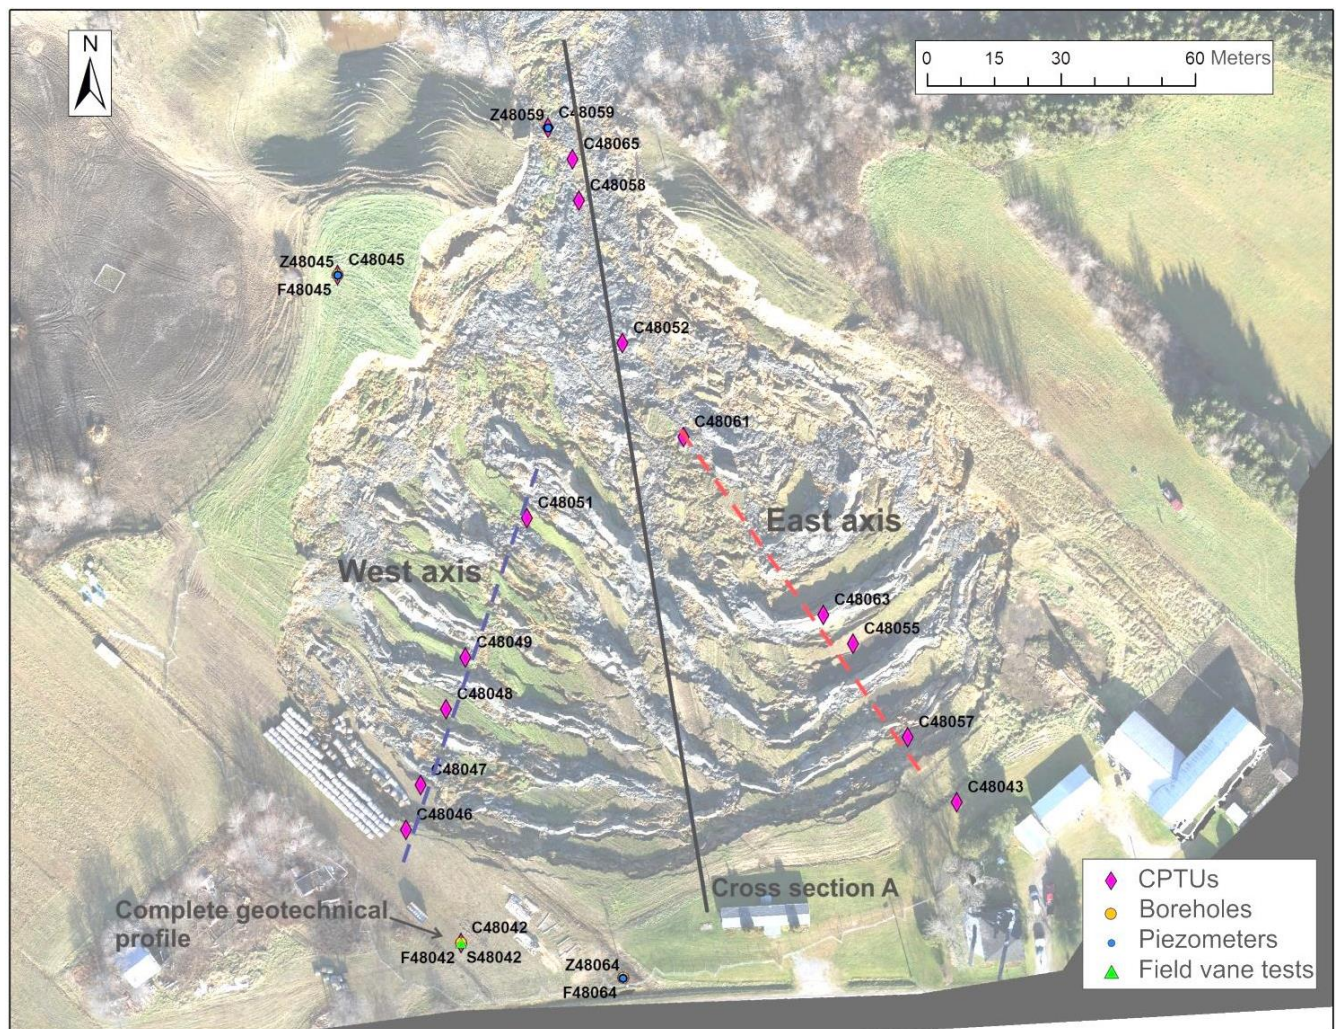
Figure 2. Localization of the geotechnical studies, the cross section A is shown in black, the west axis in blue, east axis in red and the complete geotechnical profile at location 48042 (aerial photograph taken after the event)

Horsts and grabens, beginning at the end of the landslide scar and trapped in the crater, were also identified (see figure 2). This evidence shows that a spread occurred shortly after the flowslide and was the last episode of movement, probably the one heard by the landowner. The change in the failure surface elevation on figure 5, which is explained in Section 4.2 and occurred at a distance of 110 m, could distinguish those two zones. In accordance with this hypothesis, a reconstitution of the initial slope with the grabens, coupled with some volume calculations, allows to delimit the land implicated in the flowslide and the one involved in the spread.

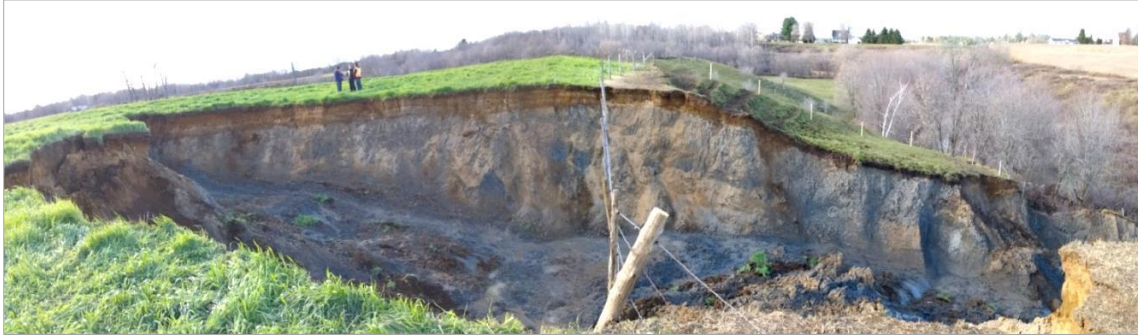
Figure 3. View of the scar of the first episode of flowslide, taken on November 9th 2016, a few hours before the major event

except for some small blocks of soil, no extension of the flow scarp was noticed (see figure 3). The latter is roughly 37 m wide and 56 m long.

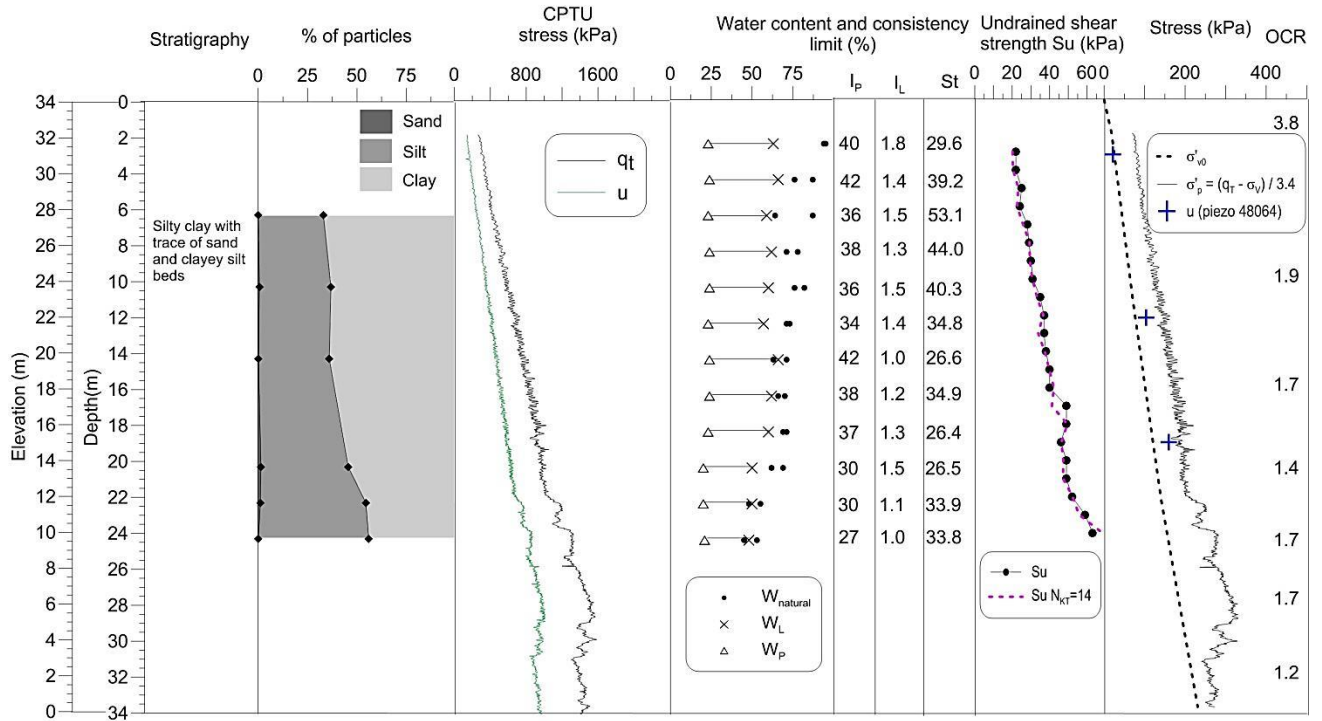
The complete geotechnical profile at the location 48042 is presented on figure 4. A homogeneous silty clay deposit with traces of sand can be identified. The percentage of clay particles varies between 44 and 67 %, silt particles between 33 and 56 % and sand particles between 0 and 1.4 %. A very thick clay deposit starts at a depth of 2 m, right under a crust layer, to depth greater than 100 m, according to previous geophysical soundings around the site. The CPTUs carried on at the site were voluntarily stopped at a depth of 50 m, so the real thickness of the clay layer is unknown. Samples were taken every 2 m up to a depth of 24 m, approximately 6 m under the river level.

The CPTU's corrected tip resistance (q_t) increases with depth from 300 to 1900 kPa between 2 and 50 m of depth. The water content decreases with values from 95% to 53% between 2 and 24 m. The liquidity index (I_L) shows values higher than unity, confirming that the clay is sensitive, and it tends to decrease throughout the layer from 1.79 to 1.02. The plasticity index (I_P) is varying between 40 and 27 and also tends to decrease with depth. The undrained shear strength obtained from the field vane tests (S_u) indicates a firm to stiff clay deposit with values from 20 kPa at a depth of 2 m to 60 kPa at a depth of 24 m. A N_{Kt} of 14 was obtained to correlate the undrained shear strength obtained from the field vane test to the corrected tip resistance (q_t), which is a normal value for eastern Canadian clay (Leroueil 1997). The clay deposit is overconsolidated with values of OCR varying between 3.9 and 1.6 up to a depth of 29 m. Under this depth, the OCR values are around 1.1, showing that the deposit is slightly overconsolidated.

The pore pressures from piezometer 48064, represented by the blue cross on figure 4, show values slightly lower than hydrostatic conditions, indicating the presence of a downward gradient at this location.

Figure 4. Complete geotechnical profile at location 48042

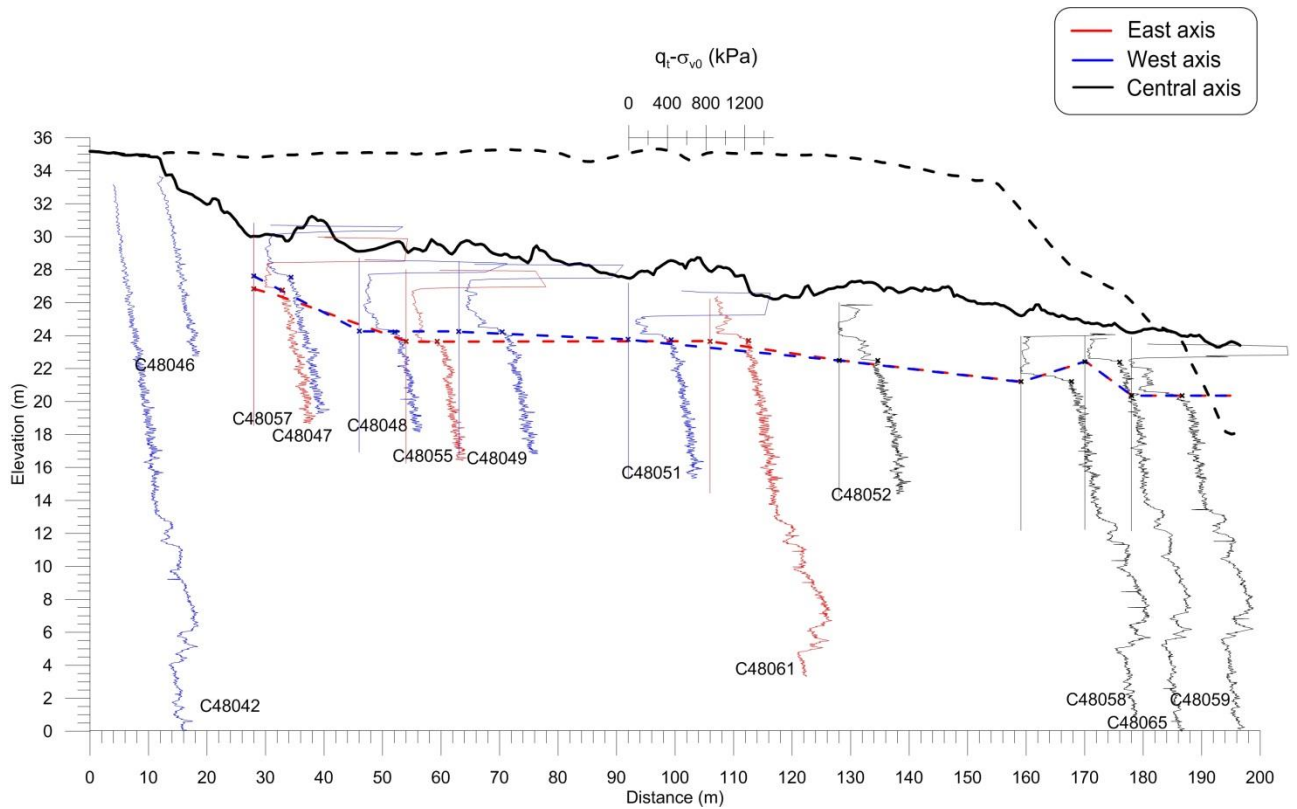
On figure 5, the elevation of the failure surface along those two axes was compared. CPTUs from the east axis are presented in red, those from the west axis in blue and those from the central axis in black. The initial topography of the slope before the event is shown by a dashed line and the final topography by a full line. It can be observed that the elevation of the failure surface is almost identical along the two axes and close to the horizontal between a distance of 45 and 110 m. The elevation of the failure surface then slightly decreases after a distance of 110 m. The abrupt rise of the elevation observed for the sounding C48065, around a distance of 168 m, is possibly due to an error during the elevation survey.

Figure 5. Cross section A showing the comparison of the elevation of the failure surface along the east axis in red and the west axis in blue (Initial topography is depicted by a black dashed line and the final topography by a full black line)

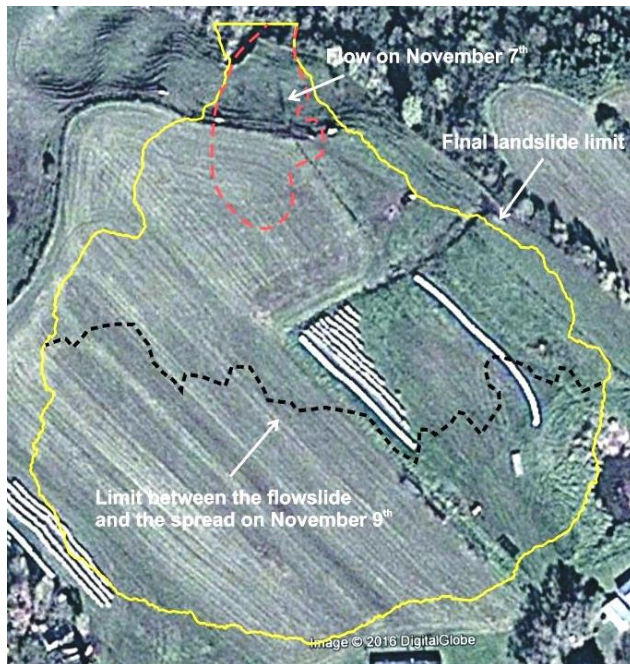
Figure 6. Delineation of the first episode of flow on November 7th in red dashed line and the limit between the flowslide and the spread of the main event on November 9th in black dashed line (aerial photograph taken from Google Earth - 2016)

With the first pictures taken by the landowner on November 7th, it was possible to delimit approximately the first flow that took place on that date (see red dashed line on figure 6). On November 9th, the MSP took some pictures, and

At about 23h30 on November 9th, the landowner was awakened by a big noise and observed the complete failure of his land. As described in section 5, this major event could be separated in two different types of landslide: flow and spread. The black dashed line on figure 6 shows the separation between those two episodes. It is assumed that the two events took place in a short period of time, as the landowner did not perceive two different landslides. It is important to point out that the orientation of the study toward a two-event landslide was not confirmed by any visual witnesses.

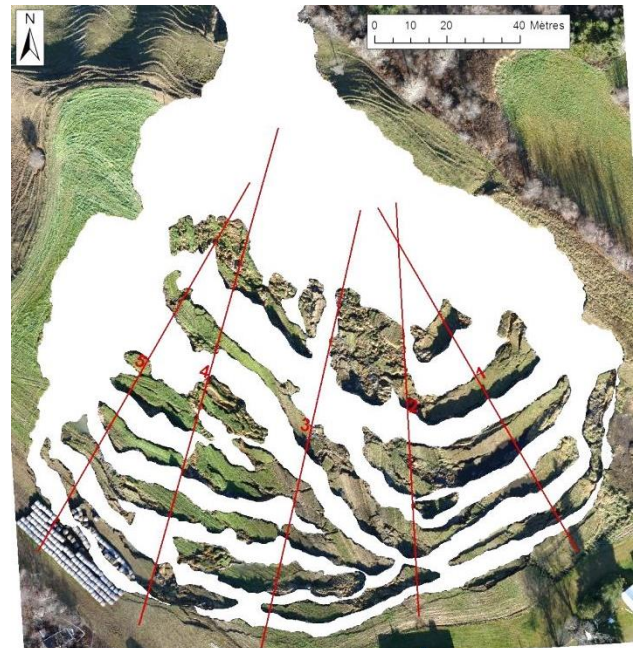
photographs taken after the event. On this picture, the grabens were delimited with a photo-processing software and extracted separately as objects (see figure 7). Afterward, with ArcGIS software, the grabens were approximately placed manually to their original position using the georeferencing tool. Visual clues like lines in the field, location of pits and the vegetation helped to reassemble the puzzle.

Figure 7. Delimitation of the grabens and the location of the 5 cross sections

The second method used 5 cross sections traced parallel to the flow direction of the debris (see figure 7). The initial and final topography along those axes were extracted from the lidar's data. The grabens and the horsts were placed as closely as possible along those cross sections to their initial location. Figure 8 shows an example for the fourth cross section. The failure surface is depicted in purple dashed line, the initial topography in black dashed line and the grabens are in green. Part a) shows the final location of the grabens and part b) the approximate relocation of those grabens and horsts along the initial topography. The limit of the spread is also shown in part b); it is at the position of 66 m in this case.

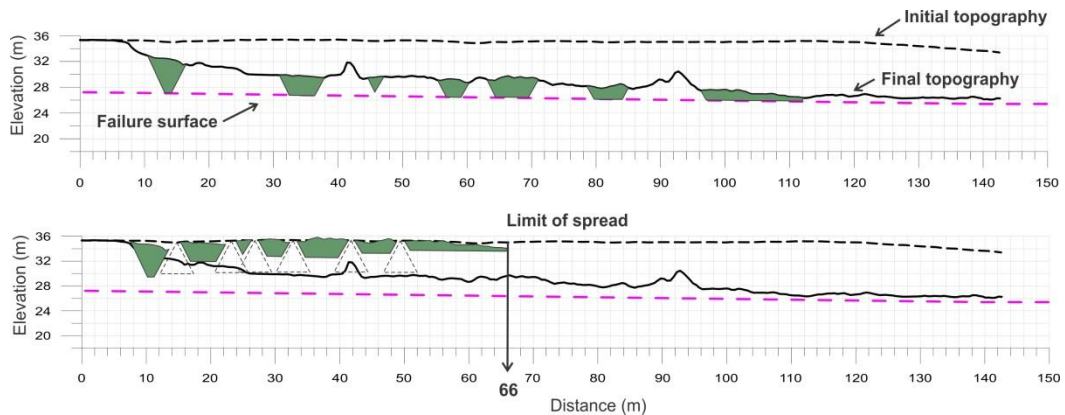
Figure 8. Cross section 4; part a) Final position of the grabens along the final topography, part b) Estimated initial location of the grabens and the horsts along the initial topography

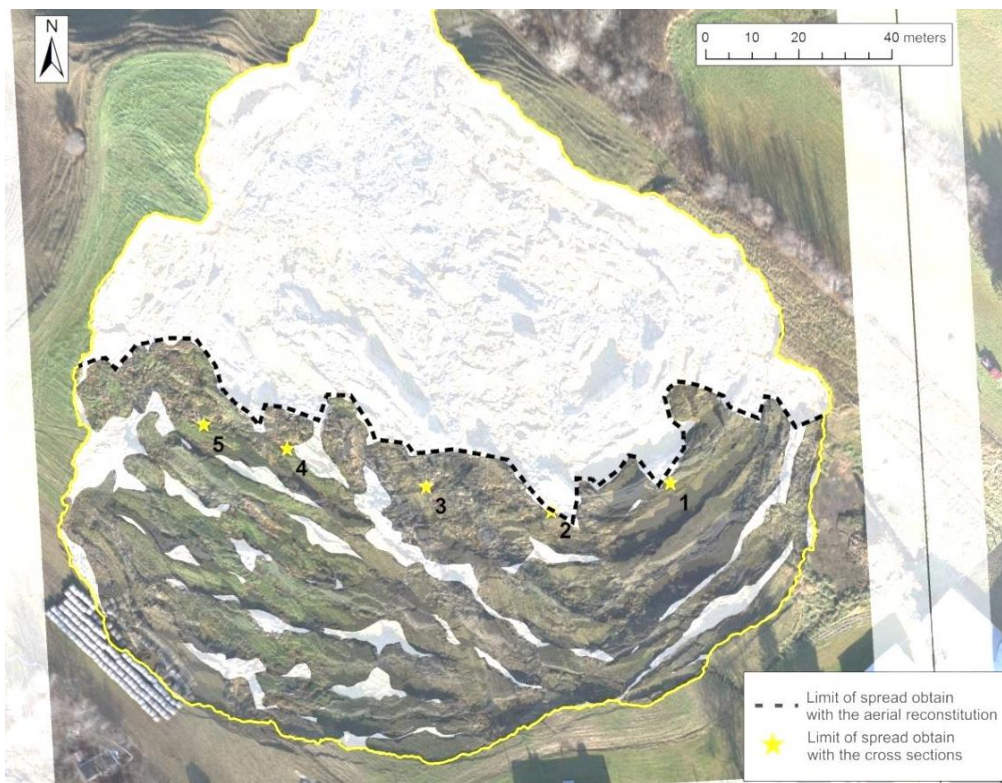
The 5 cross sections gave 5 limits for the spread that were then compared to the aerial reconstitution. Figure 9 shows the final reconstitution; the black dashed line depicted the limit of spread obtained from the aerial reconstitution and the 5 yellow stars represent the limit of spread obtained from each cross section. For the first and second cross sections the limits fit perfectly. For the three others, there is a difference of several meters. This can be explained by the fact that reconstitution with the cross sections does not take into account that some grabens were deformed and reoriented during the spread. Hence, the initial and final emplacement of those grabens may not

Figure 9. Final reconstitution of the land involved in the spread showing the two methods; aerial reconstitution and cross section reconstitution (aerial photograph taken after the event)

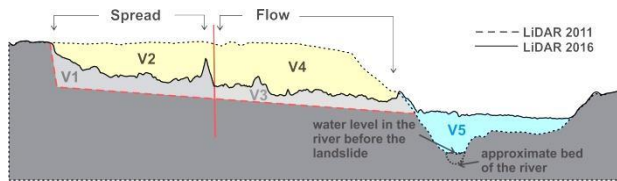
Figure 10. Sketch of the different volumes calculated

With this assumption, the portion of the intact land involved in the spread refers to V1 plus V2 and appears to be equivalent to the volume of the debris remaining in the crater, i.e. V1 plus V3. Those two volumes are similar with values of respectively 98 862 m³ and 96 764 m³, confirming that the limit is nearly exact. Also, the portion of the land involved in the flowslide refers to V3 plus V4 (98 337 m³) and should be equivalent to the volume of the debris, which refers to V2 plus V4 (100 435 m³). Since all the debris went out of the crater, the volume V5 (69 324 m³) of debris in the river would also belong to the flowslide debris and should be equivalent to the two other volumes. The first volumes are effectively similar, but the value of V5 is quite smaller than the other values that are around 100 000 m³.

The difference between this value and the two others is possibly due to the quantity of debris under the water surface of the river, which is not taken into account in the analysis. Effectively, because lidar surveys cannot penetrate water, the topography given by the 2011 lidar (before the event) shows the water level in the river at this moment. However, a major quantity of debris could have deposited at the bottom of the river, and then be neglected in the calculation of the volumes. It is known that the thickness of water in the river is approximately 1 m. Also, the debris from the flowslide progressed on a distance of roughly 680 m (up and down the river) and the river is about 15 m wide. With this ascertainment, a volume of 10 200 m³ of debris can be added to the previous volume V5, giving a value of 79 524 m³. This value is closer to the one expected of 100 000 m³, but the calculation for the volume of debris in the water is approximate. The rest of the volume is probably under the water that flooded the upstream part of the river.
