Case Study: Remediation of a Riverbank Slope Failure in the Canadian Prairies

Bernie Mills & Hamid Karimpour
Stantec Consulting Ltd., Calgary, Alberta, Canada

John Richmond
Enbridge Pipelines Inc., Edmonton, Alberta, Canada

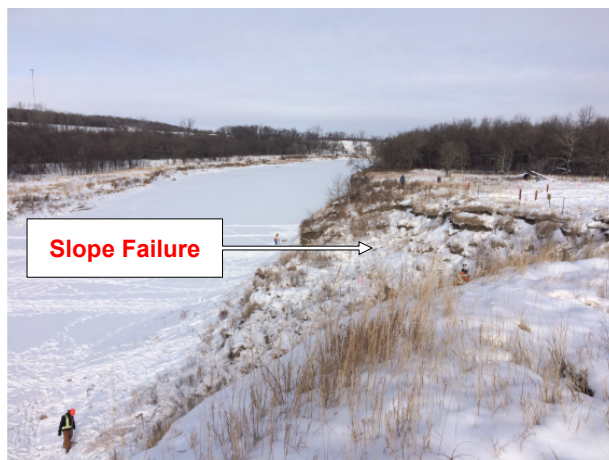
Figure 2. Riverbank slope failure, January 2016 (East bank of Souris River looking north or downstream)

As shown on Figure 2, the slope failure occurred on the east bank of the Souris River within the ROW. Figure 3 shows a modeled cross-section through the center of the failure. Figure 3 also shows the location of a "low-density" area at the toe of the slope at the river edge that was identified by the geophysical survey as a "bedrock anomaly". As described in more detail below, this low-density area was identified as a weak toe condition and considered as a major contributing factor to the slope failure mechanism.

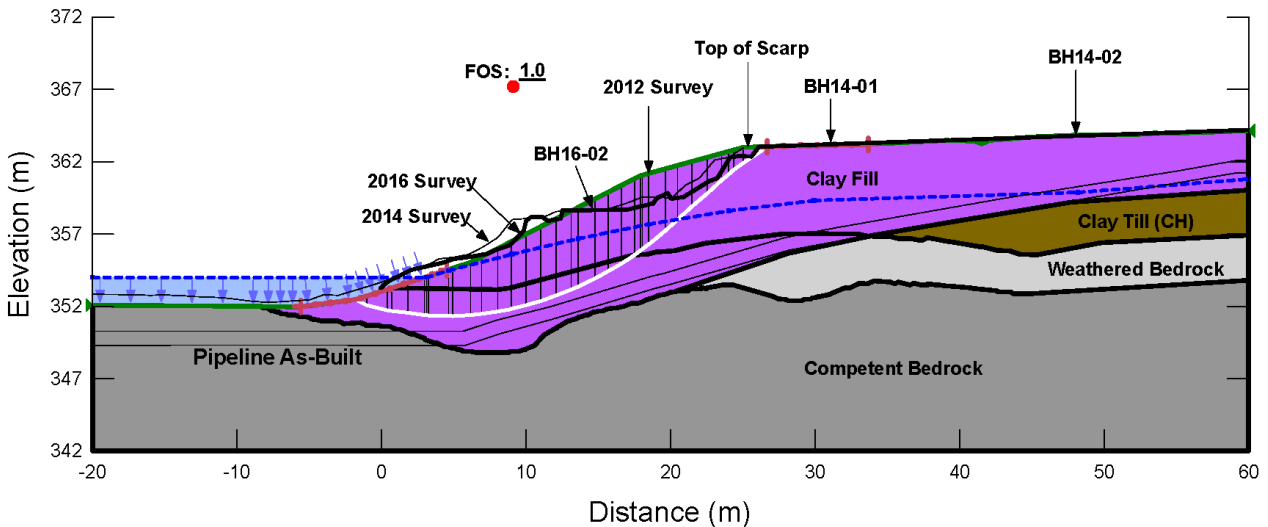
Borehole BH16-02 was drilled to a depth of 9.7 m within the center and at mid-slope within the slope failure. The stratigraphic sequence encountered in BH16-02 consisted of 3.8 m of fill overlying clay shale bedrock. Figure 3 shows the approximate location of BH16-02.

Figure 3. Cross-section through riverbank slope failure

A traditional back analysis method was used to model the failure condition as shown in Figure 3. This back analysis was carried out to estimate the soil and bedrock strength parameters for a state of failure at a factor of safety of near unity. Based on the results of the back analysis, the effective strength soil parameters were assessed as shown in Table 1.

As stated above, the slip surface at the SI location installed in BH16-02 was measured to be in the general vicinity of the overburden/bedrock transition. The position of the circular slip surface is consistent with the analyzed slip surface as shown in Figure 3.

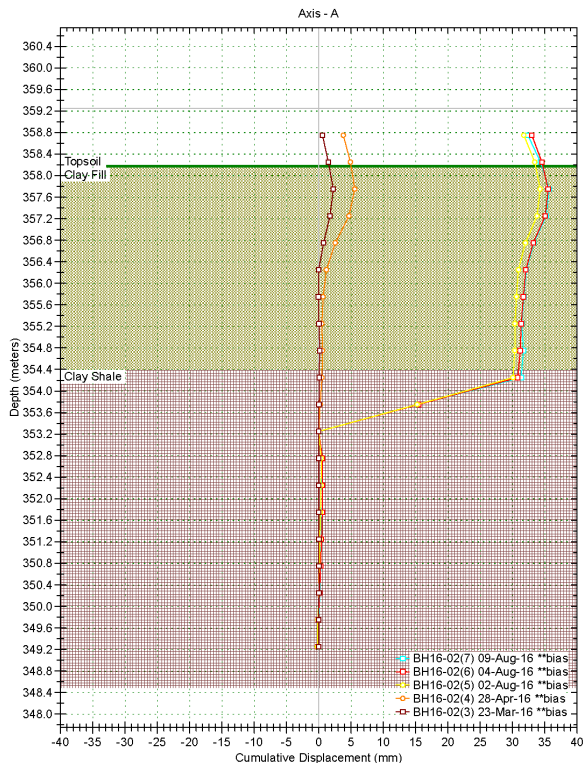
Over the period from fall 2014 to spring 2016, lateral displacements measured in the 2014 boreholes ranged from 5 mm to 20 mm and the displacements were all within the overburden above the bedrock. In BH 16-02 mid-slope within the slope failure, lateral displacements were measured to be up to 35 mm over a period of four months in 2016. The lateral displacements were measured to be as deep as elevation 353.2 m, in the transition from overburden to bedrock as shown on Figure 4.

Figure 4. Cumulative lateral displacement data plotted with depth in BH-16-02.

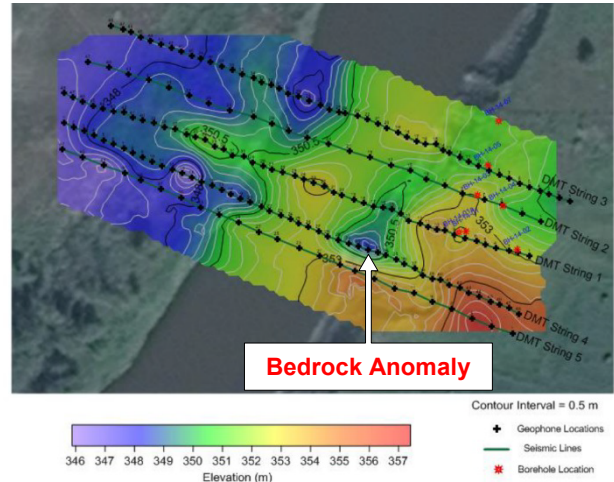
- A bedrock anomaly feature, consisting of an area with lower bedrock elevation, was identified at the toe of the riverbank slope failure as shown on Figure 5. This bedrock anomaly was a depressional feature of the bedrock surface at the toe of the slope. As described in more detail below, the anomaly appeared to be an area of possible bedrock disturbance by mechanical excavation during the installation of the 1998 pipeline.

Figure 5. Interpreted competent bedrock surface from geophysical survey showing the “bedrock anomaly”

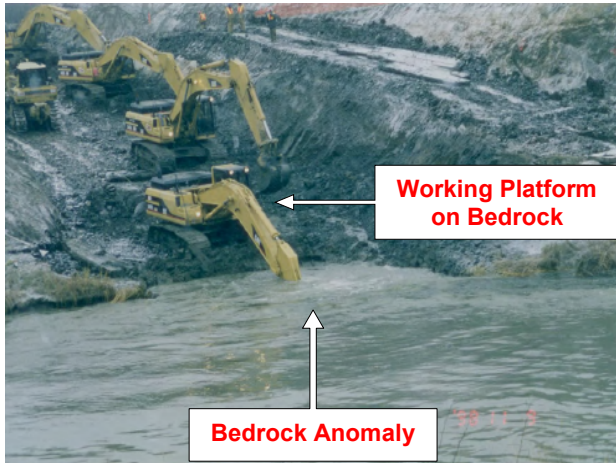
The hypothesis is that the relatively deep excavation in the river channel as shown on Figure 6 resulted in removal of the natural bedrock toe support at this location. The bedrock removal by mechanical excavation may have resulted in a weak toe condition at this location. The bedrock excavation at the toe of the slope also appeared to have been relatively wide at the river edge. This weak condition at the toe of the slope may have been more susceptible to wash out and disturbance by the flow and energy of the river as compared to the surrounding bedrock. Also, there is indication that the failure slip plane is consistent with the elevation of the working platform on bedrock as shown on Figure 6. The above explanation is considered a major contributing factor to the riverbank slope failure. Also, there is indication of backfill placement in the winter during the original construction in 1998/1999, which can often be problematic for fine grained soils.

Figure 6. Construction of pipeline in 1998/1999 and possible bedrock anomaly

All evidence suggested that the slope failure was relatively shallow, and the slip surface was at the contact between the overburden/bedrock surface along the original working platform of the 1998/1999 pipeline construction as shown on Figure 6.

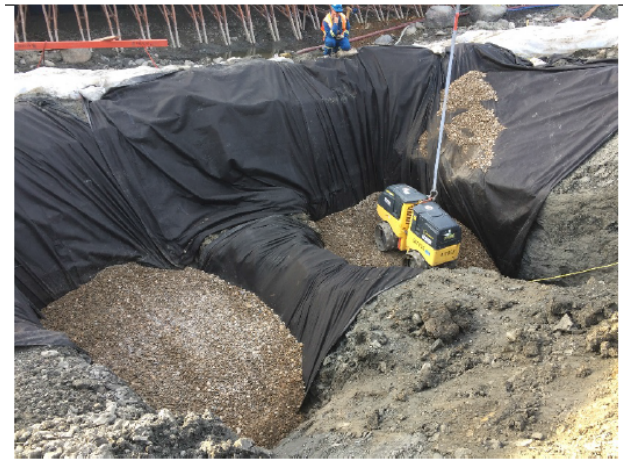
- The original design assumed there was a high probability of a low-density infill referred to as the bedrock anomaly that had resulted in a weak toe condition. It was confirmed that the bedrock anomaly did in fact exist and consisted of a soft clay infill. The soft clay infill was removed and replaced with imported free draining granular materials wrapped in non-woven geotextile as shown on Figure 10. The bedrock anomaly crossed over two pipelines.

Figure 10. Remote control compactor compacting granular backfill after removal of soft clay infill in the bedrock anomaly at the river bottom near the toe of the slope

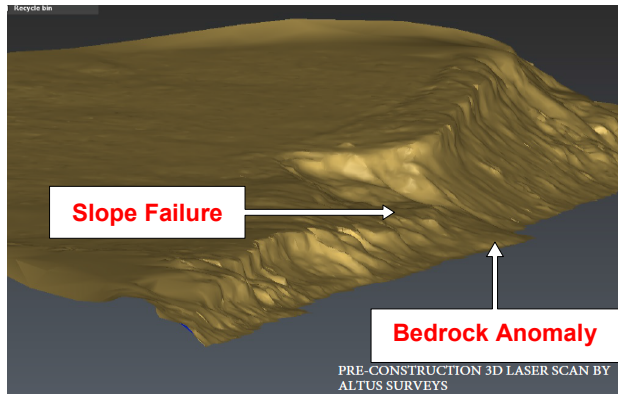
Figure 11. Pre-construction 3D laser scan showing site conditions and riverbank slope failure before remediation

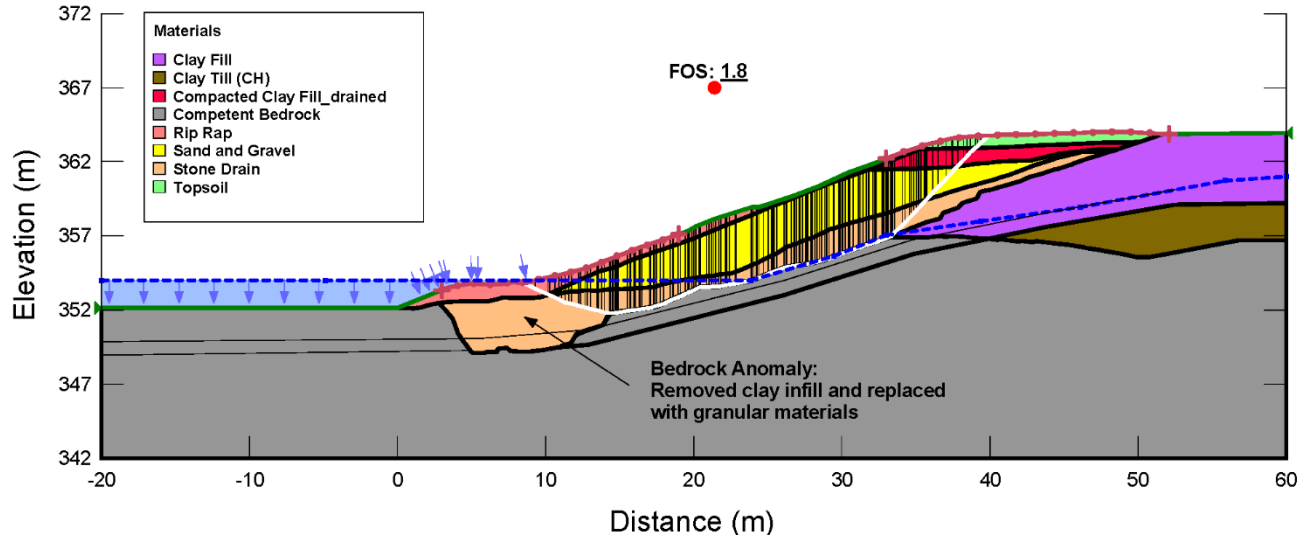
A slope stability analysis was carried out for several as-built cross-sections including a section through the zone of the bedrock anomaly as shown on Figure 14. The factor of safety for the remediated slope sections ranged from 1.5 to 1.8 and met the required factor of safety of 1.5 for the long-term condition.

Figure 14. Slope stability analysis of the remediated slope.

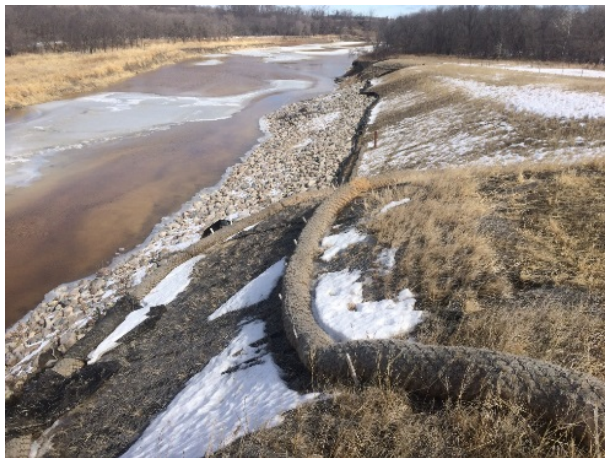
On March 28, 2018 Stantec returned to the site to observe the conditions across the remediated slope and to take SI and VW piezometer readings. As shown on Figure 15, the remediated slope is meeting the original design intent with no apparent erosion or slope instabilities observed.

Figure 15. Final Remediated Surface 16 months after construction, March 2018 (view looking north).
