# Highway 27:10 – Replacement of Red Deer River Bridge East of Morrin, Alberta: Abutment Stability Pile Wall

Stephen Coulter & Donald Proudfoot  
*Thurber Engineering Ltd., Edmonton, Alberta, Canada*  
Malika Ali & Yingyi Li  
*Jacobs Engineering Inc., Edmonton, Alberta, Canada*

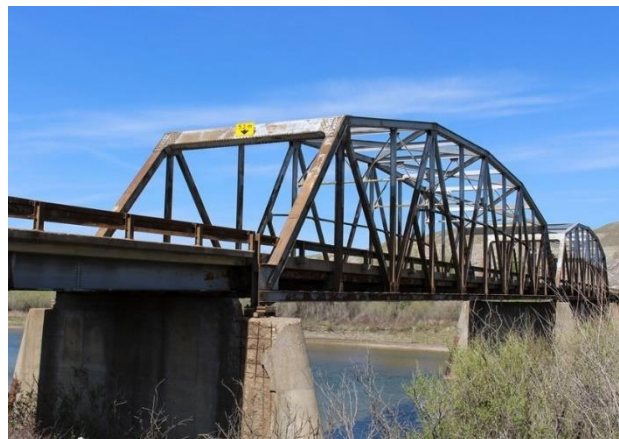
Figure 2. Existing bridge configuration looking from west to east

The bridge was approximately 178 m long, with a 7.3 m wide roadway, and featured two 61 m long through truss spans with 28 m long rolled beam spans at both ends. The four-span bridge was supported by abutments founded on driven steel H-piles and three concrete river piers founded on driven untreated timber piles. Figure 2 presents a photograph of the structure along the Red Deer River.

Based on assessment of the bridge by its owner, Alberta Transportation (AT), the bridge had neared the end of its service life due to its poor condition, as well as due to

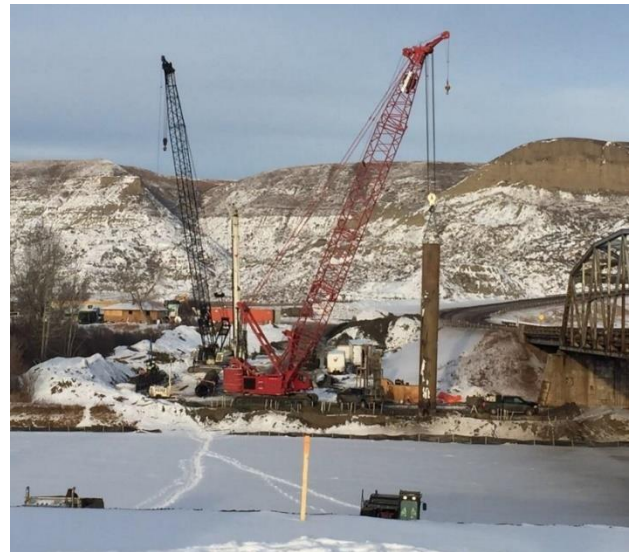
Figure 6. Typical cast-in-place pile installation setup

The pile wall was completed between October 12, 2017 and January 22, 2018 prior to placing abutment fill. Figure 6 shows a typical setup of the Soilmec SR-65 piling rig and additional cranes used for casing and reinforcement bar handling and installation. As shown in Figure 6, the pile wall was constructed on the lower terrace at the toe of the future abutment fill, located immediately north of the easternmost existing bridge pier.

The installation of the piles was completed at a slower rate than initially planned due to the variability of the subsurface stratigraphy as well as the difficult conditions related to drilling in saturated conditions next to the Red Deer River. During drilling, sectional steel casing was vibrated into the pile holes to provide a cut-off and seal from groundwater that was seeping into the pile from the water bearing sand and gravel layers. The steel casing was also used to eliminate sloughing into the test holes during auger advancement.

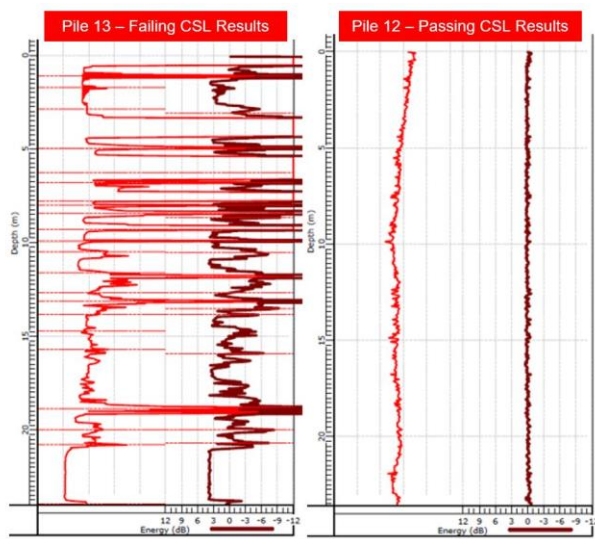
Figure 7. Typical failing and passing CSL result signals

The failing CSL result signal shown in Figure 7 was typical for 10 of the failed piles. The irregular signal pattern was postulated by the testing subcontractor as possible debonding between the CSL tubes and the surrounding concrete, rather than poor quality concrete.

Besides the possibility of debonding effects in 10 of the piles, two of the piles showed signs of possible defects affecting up to 15% of the cross-sectional area of the pile, and four of the piles showed signs of possible “soft-toe” conditions where the concrete at the toe of the pile may not have properly cured. Four of the piles showed multiple possible defect modes.

Following the receipt and analysis of the CSL results, the construction records were reviewed for any source of possible defect. As discussed in Section 3.2, there was no identifiable construction anomaly that would lead to consistently defective piles, therefore it was considered possible that there may be an issue with the CSL testing method or configuration.

Considering this additional testing, and in accordance with the review of the construction observation records, there was no reason to believe that any of the piles had defects as indicated in the initial CSL testing. It was decided by the owner and the consultant team that it was probable that the CSL tube debonding effect offered by the contractor was plausible.

- Complete PIT testing on all of the 15 piles
- Two of the piles should be cored in order to evaluate the condition of the installed concrete. The cores would be evaluated visually and would be further tested for compressive strength and density in a laboratory.
- Complete further CSL testing using reamed and/or flushed existing CSL tubes that had been previously blocked, as well as using the above core holes to advance the CSL probes.

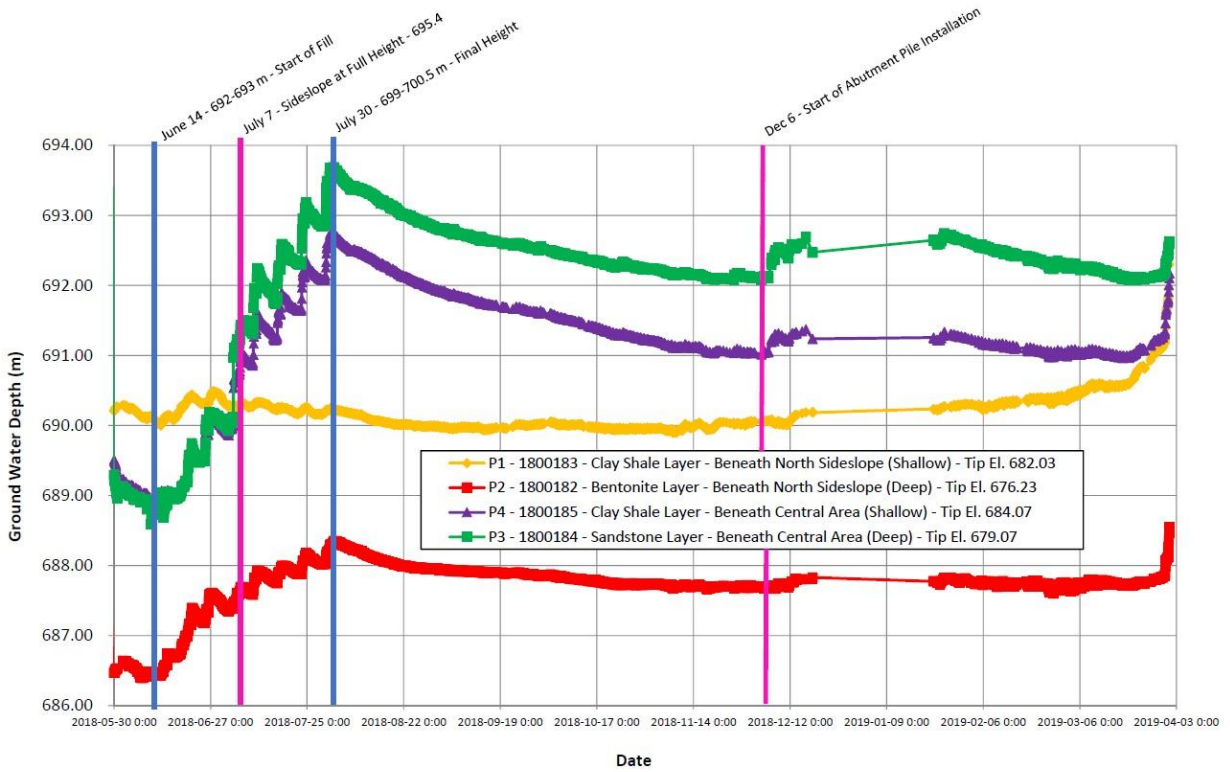
Figure 8. Vibrating wire piezometer response beneath east abutment fill footprint

The response of the vibrating wire piezometers generally shows a step-mode increase corresponding to the incremental 1 m weekly loading intervals over the fill construction period followed by pore pressure dissipation over the following months. It should be noted that until July 1, 2018 both P3 and P4 appear to be hydraulically linked until the instruments experienced an offset (of unknown source) from each other on that date. From that date forward the responses of these two instruments continued to mirror each other but featured this offset, indicating that they most likely remained hydraulically linked.

A maximum water pressure head increase of approximately 4.5 m was experienced in the sandstone bedrock beneath the full abutment height with an increase in pressure head of approximately 4.0 m in the clay shale layer above it. The pore pressure response of the piezometers beneath the north side-slope was less pronounced with a pore pressure increase of approximately 2.0 m in the bentonite layer and an even subtler response observed in the overlying clay shale layer.

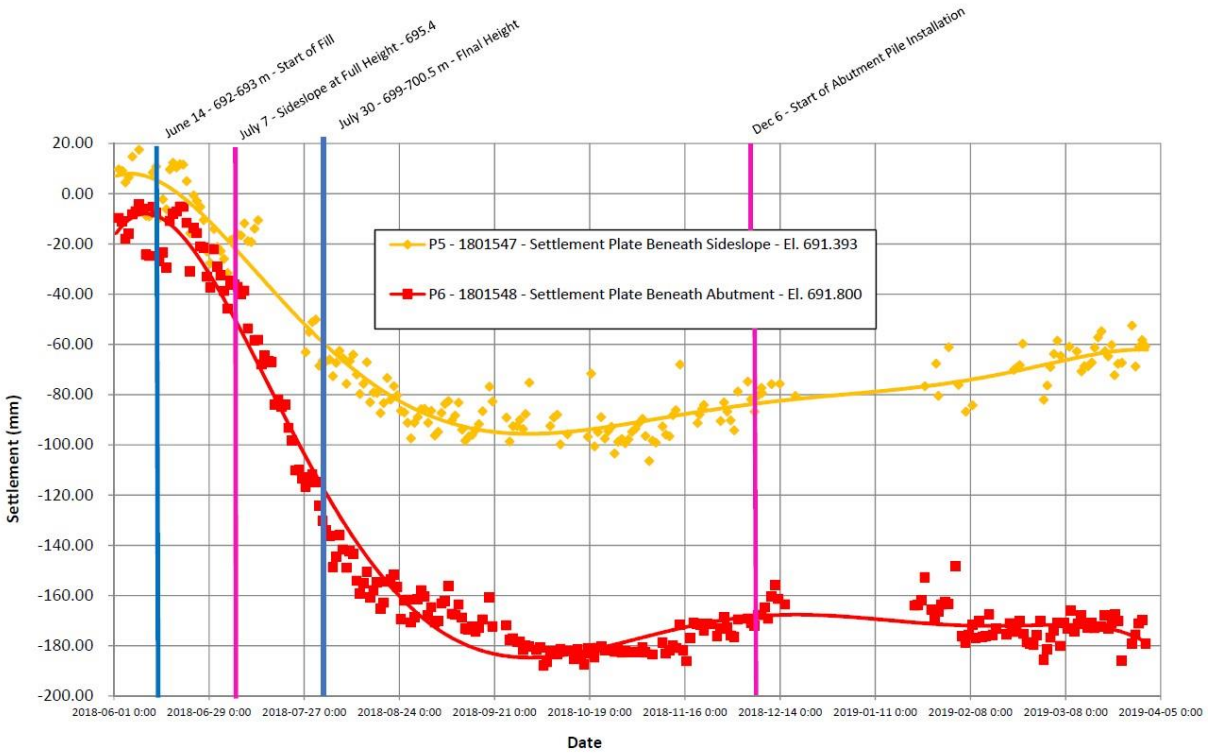
Figure 9. Vibrating wire settlement plate response beneath east abutment fill footprint

As illustrated on Figure 9, the settlement experienced at the interface of the bottom of the abutment fill and the native ground also began to develop during the abutment fill construction period. The points shown on the plot are daily readings with a plotted polynomial trendline. These instruments were observed to have some daily variability in their response, most likely owing to atmospheric conditions (pressure and temperature). The rebound encountered in both instruments around October 2018 coincided with colder temperatures and eventual ground freezing at the site, and it is suggested that this change in seasons slightly affected the behavior in the two settlement plates. This understanding may be supported by the observation that the curves begin to turn slightly downward again near the end of the reading period in April 2019 during spring thawing conditions. The long-term response of the settlement plates is discussed in Section 3.5.

Referring to Figure 9, it was observed that the consolidation settlement of the subsurface had been substantially completed by approximately mid-October 2018, with a total of approximately 180 mm of settlement for the central abutment area and 95 mm for the north side-slope area. This amount of settlement compared very well to the 175 mm of elastic and consolidation settlement that had been predicted during the initial geotechnical design, using standard consolidation theory analyses and Settle3D software.
