# Stabilization of Rail Track Bed Mile 9.0 – 9.1, CN, Dundas Subdivision

Colin Alston, P.Eng.  
*Alston Geotechnical Consultants Inc.*  
Markham, Ontario, Canada  
Mario Ruel, Ing.  
*Geotechnical Consultant, Montreal, Quebec, Canada*

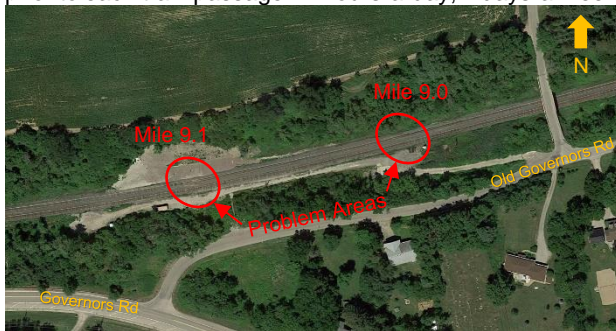
Although the original south track experienced few abnormal maintenance needs, the north rail track has experienced ongoing settlement and stability problems as a result of groundwater issues. The presence of a high water pressure in an underlying soil layer has resulted in internal erosion and the development of near vertical “pipes” daylighting in the subgrade. Soil from the underlying sand aquifer layer has transported to the ground surface with consequential surface settlement. In 1995, the severity of such unpredictable track settlement in the more recently constructed north track was affecting railway operations in two sections of track, at Mile 9.0 and Mile 9.1, this necessitated that a watchman be stationed at the site to carry out an inspection of the affected length of rail tracks prior to each train passage 24 hours-a-day, 7 days-a-week.

Figure 2. Areas of track settlement

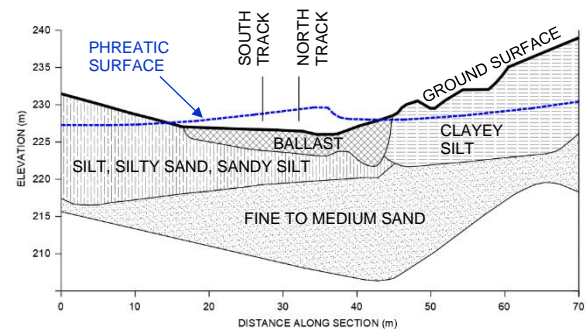
to a depth of about 10 to 12 m. That layer is underlain by a layer of silt which is exposed in the cutting side slopes and extends to a depth of approximately 20 m below the base of the tableland, which is approximately 3 to 5 m below the base of the rail cutting. In turn, the silt layer is underlain by a thick stratum consisting of layered silty fine to medium sand which includes seams of finer grained materials, the gradation of the sand becomes coarser with depth. Nearby homes and farms drew water from wells positioned in this stratum. In the base of the cutting, the rail tracks lie on rail ballast and sub-ballast granular fill materials. The fill extends to a depth of about 2 m below the base of the cutting, which illustrates the amount of track re-alignment which has been required in the past to maintain serviceability. A cross section through the cutting showing layer distribution and groundwater pressure is shown in Figure 3 below.

Figure 3. Soil Profile and Phreatic Surface

Water pressures within the underlying layered silty sand deposit are seasonally dependent and were up to about 4 m above the base of the cutting. The presence of the noted high water pressures resulted in breakouts of groundwater in the base of the rail cutting. The breakouts occurred through eroded “pipes” which extended from the underlying layered sand stratum to the cutting base, the breakout seepage transported sand material from the underlying sand deposit to the ground surface with consequential settlement at rail track level. In 1996, the consequences of soil erosion and transportation of soils from the sand stratum namely, large and unpredictable settlement of the north track was requiring that the north track be re-levelled and realigned every few days. Also, safe railway operation required that a watchman be on site on a round-the-clock basis.

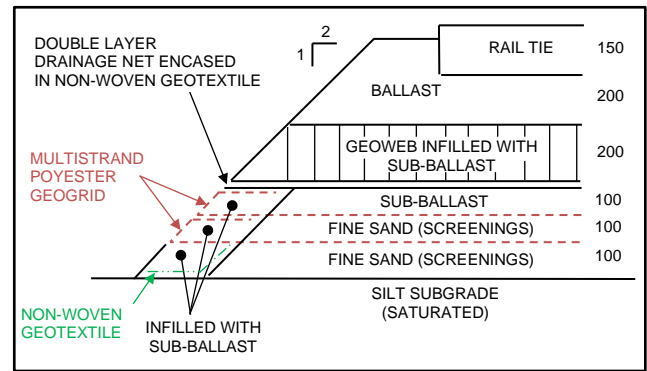
Figure 4. Track Bed Reinforcement Design 1996

The track bed design was also required to include a system to allow for upward seepage of pressurized groundwater and for collection of that groundwater. Prior experience with construction of subdrains at the site had shown that well graded granular material which had been used as surround to those subdrains had become plugged with silt over a period of time, rendering the drains ineffective. Thus, in order to curtail soil movement and to improve the longevity of the groundwater collection system, a filtering layer of limestone screenings was laid on the subgrade at the base of the track bed (Cedergren, 1989). The selected design of reinforced track bed is shown in Figure 4 and described below:

- subgrade
- 100 mm limestone screenings
- multi strand polyester geogrid laid parallel to rail track
- 100 mm limestone screenings
- multi strand polyester geogrid laid transverse to rail track
- 100 mm sub-ballast
- double layer drainage net encased in non-woven geotextile
- 50 mm sub-ballast
- 200 mm deep geocell infilled with sub-ballast
- 50 mm thick sub-ballast
- 200 mm thick ballast (to underside of rail tie).

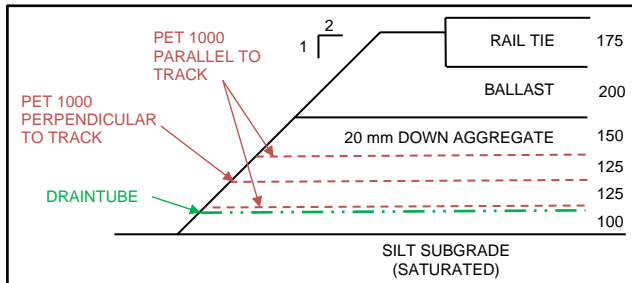
As noted, performance of the reconstructed, reinforced sections of track continued to behave in a satisfactory manner. However, a significant development of internal erosion and piping occurred in 2014 in a location immediately north of the north rail track, immediately east of the westerly section of the reinforced track bed (Mile 9.1). At that time, it was decided that the affected section of track should be reconstructed utilizing geosynthetic reinforcement. To improve design, newer methods which included the probable benefit of including multiple layers of reinforcement in controlling potential settlement were available to complement prior design methods (Collin, 1997). Also available at that time was ultra-high strength woven geotextile material. Geosynthetic manufacturers were able to provide data to quantify the relationship between applied load and strain at low strain values. For the affected section of track bed, high modulus polyester woven geotextile with an ultimate tensile strength of 1000 kN/m in the main direction was selected as the reinforcement. The results of specific tensile tests carried out by the Manufacturer showed that the material would experience a strain of 1% at an applied load of 80 kN/m, which value was used for design. Collection and control of upward groundwater seepage was provided by installation of a "Drain Tube" layer beneath the lowest sheet of reinforcement; this composite comprises 2 layers of non-woven geotextile with included drain pipes set at 0.25 m horizontal spacings. The drain pipes were laid perpendicular to the track and discharged to the north side ditch. The adopted track bed design is shown in Figure 5 and is described below:

Figure 5. Track Bed Reinforcement Design 2014

- subgrade
- 100 mm depth of 20 mm down crushed limestone
- "Drain Tube" set perpendicular to rail track
- Woven geotextile with main direction parallel to rail tracks
- 125 mm depth of 20 mm down crushed limestone
- Woven geotextile with main direction perpendicular to rail track
- 125 mm depth of 20 mm down crushed limestone
- Woven geotextile set parallel to rail tracks
- 125 mm crushed limestone
- 200 mm ballast

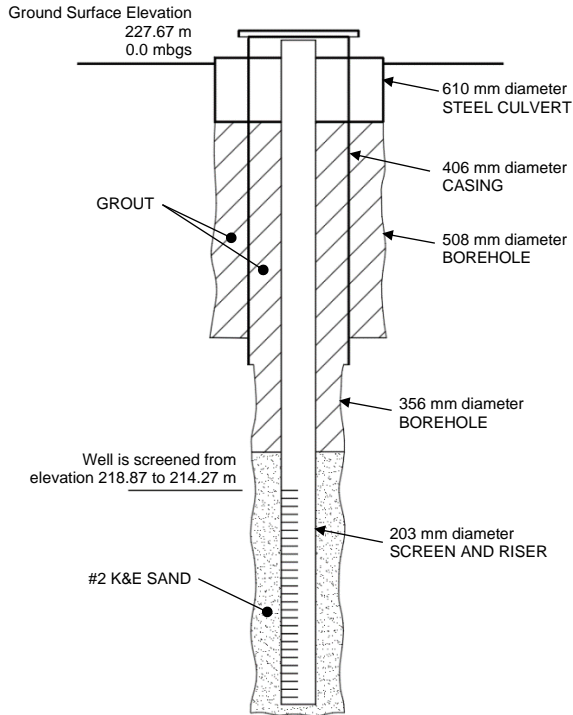
Figure 6. Construction detail of test well

In order to determine the aquifer characteristics of the underlying layered sand stratum, a test well was constructed. To reduce the impact of complexities associated with the installation of a test well in a stratum characterized by high above ground water pressures, a 2 m high granular pad was constructed on the north side of the north track to provide an elevated platform, in the vicinity of the proposed depressurizing wells. Through the adoption of an installation system involving a succession of telescoping casing to support the sides of the well boring, each successive section of casing was installed and sealed to prevent side leakage before proceeding to the next, smaller diameter casing. Heavy-weight drilling muds were used to control the water pressures in the casing throughout the installation process. A 200 mm diameter by 4.5 m long well screen was installed below the riser in the

depth range from about 6.5 to 11 m below the base of the rail cutting for the pumping test.

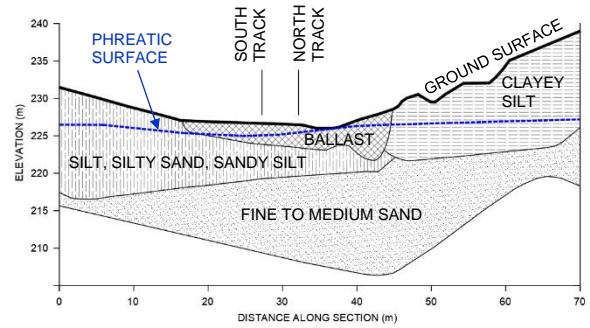
Following placing the relief wells in service, it was found that the wells could operate passively to lower the phreatic surface to below the base of the cutting.

Maintaining a phreatic surface at that level eliminates the propensity for internal erosion and piping to develop in the soil profile beneath the rail track bed.

Figure 7. Phreatic Surface Following Depressurization
