Cofferdam Failure - Geotechnical Lesson Learned

Silvana Micic, Stan Gonsalves & TaeChul Kim
Exp Services Inc., Brampton, Ontario, Canada

The existing Kabinakagami River Bridge located on Highway 11, approximately 32 km west of Hearst, Ontario, was replaced with a new bridge structure in 2008-2009. During construction of the West Abutment, the cofferdam failed and the construction was delayed. After the failure, the subsequent geotechnical investigation, commissioned by the Contractor was carried out in December 2008. Based on the results of that investigation, the Contractor contended that the borehole soil data shown in the Contract Documents was significantly different than what was actually encountered in the site during the sheet pile and H-pile installation. It was claimed that the existing soil conditions had contributed to problems encountered during the cofferdam installation and to its failure. Consequently, the third-party verification of the subsurface conditions in the area of interest was requested. To verify the subsurface conditions and clarify discrepancies in data collected during pre-failure and post-failure geotechnical investigations, the additional geotechnic

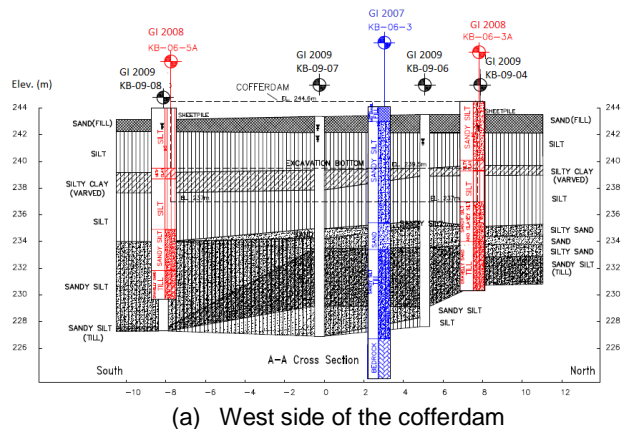
(a) West side of the cofferdam

- GI 2007 did not identify the silt clay layer in their BHs near the north-west corner of the cofferdam near Elevation 239 m. This layer was identified in GI 2008 and GI 2009, although thickness and levels differ slightly (refer to Figure 3.a).

- GI 2008 did not identify a thin layer of sand near Elevation 234 m in their BHs at north-west corner, while both GI 2007 and GI 2009 documented this layer (refer to Figure 3.a).

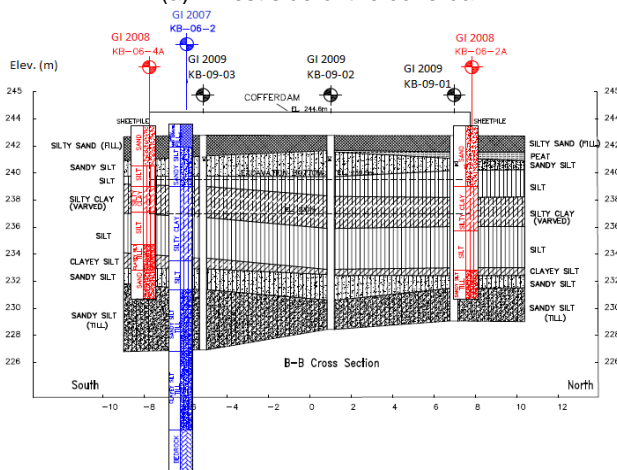
(b) East side of the cofferdam

- GI 2007 identified a thicker layer of silty clay extending to below Elevation 234 m in the south-east corner. GI 2008 and GI 2009 borings in the vicinity identified the material below Elevation 237 m as silt (refer to Figure 3.b).

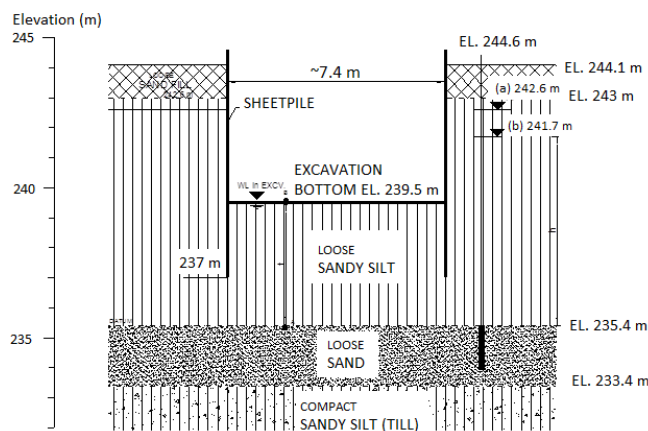
Figure 4. Cofferdam excavation in sandy silt overlaying a sand layer (KB-06-3, GI 2007)

Table 2 presents the summary of the calculation for the potential of piping. As can be seen, the factor of safety against piping for the given hydro-stratigraphic conditions is between 1.12 and 1.5 suggesting the potential for piping failure in the cofferdam. The Canadian Foundation Engineering Manual (CFEM) requires a minimum factor of safety of 1.2 against base instability for basal heave in layered soils which consist of soft to medium stiff cohesive soils and loose sand (CFEM, 4th Edition; Section 26.11.1.3; Pg. 411) or/and 1.43 against base heave of layered soils due to water pressures confined by intervening low permeability soils (CFEM, 4th Edition; Section 22.3.1.1; Pg. 341). The table also illustrates the sensitivity of the actual groundwater level to the factor of safety.

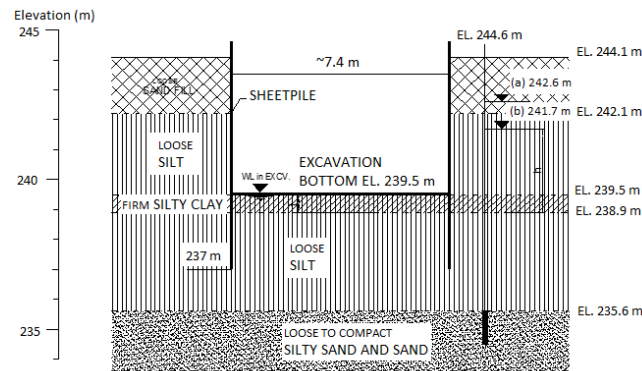
Figure 5. Cofferdam excavation in silty clay with lower more permeable silt and sand

Table 3 presents the summary of the calculation for assessment of the potential for basal heave of the excavation in silty clay. The results presented in Table 3 show that the factor of safety for basal heave is below 1.0 indicating that the 0.6 m thick silty clay layer was not thick enough to prevent basal heave of the excavation which is consistent with observations after the failure. It appears that the thickness of the silty clay layer should be more than 1.6 m (to satisfy the CFEM requirement of FS=1.2 against base instability for basal heave in layered soils which consist of soft to medium stiff cohesive soils and loose sand (CFEM) or 2.0 m (to satisfy the CFEM requirement of FS=1.43 against base heave of layered soils due to water pressures confined by intervening low permeability soils (CFEM) to avoid the potential of basal heave. If the silty clay layer below the excavation bottom was 0.6 m thick, the maximum hydraulic pressure head allowable during

excavation should not exceed the Elevation of 239.9 m to satisfy the CFEM requirement of FS=1.2 or 239.75 m to satisfy the CFEM requirement of FS=1.43. To allow safe excavation of the cofferdam, the weight of soil/material at the base should be increased, and/or the level of the hydraulic head in the water bearing soil should be lowered.

It should be noted that the GI 2007 Foundation Investigation and Design Report recommended the need to account for basal heave due to flow of water beneath the sheet piling in the design of shoring. It is recommended that basal heave and seepage be controlled by extending the shoring below the proposed excavation depth and placing a working mat of concrete, i.e., tremie concrete or a mud mat, at the base of the excavation. Dewatering is recommended to be carried out from within the shoring. If the geometry of the foundations precludes the use of tremie concrete to control groundwater flow, dewatering the excavation with well points was suggested by installing a second set of sheet piles around the first set and installing the well points between the two sets of sheet piles.

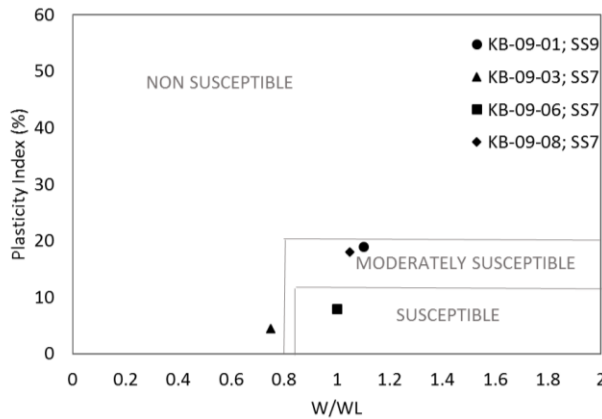
Figure 6. Liquefaction assessment on silty clay (data from GI 2009)

Based on the above criteria, two evaluation charts presented on Figures 6 and 7 were made to assess the liquefaction potential of silty clay and lower silt, based on the Atterberg limit test results obtained in the GI 2009. Figure 6 shows four (4) data points for silty clay on the liquefaction assessment chart. It can be seen that one data point falls in the liquefaction susceptible zone, one in the non-liquefaction zone, and two in the moderate liquefaction zone. It appears that the silty clay layer is, in general, "moderately susceptible" to liquefaction. Figure 7 shows that lower silt is "susceptible" to liquefaction.

As a conclusion, the silty clay and lower silt are susceptible to liquefaction under vibration loads. Thus, the vibration introduced by the pile-driving might lead to a significant loss of strength in silty clay and lower silt layers. Consequently, the factor of safety of the cofferdam stability could decrease due to pile-driving.

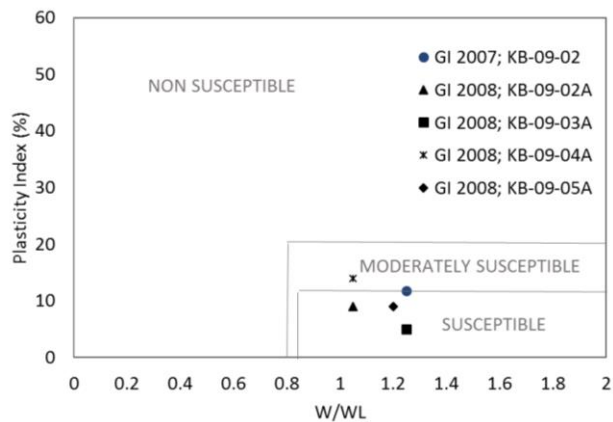
Figure 8. Liquefaction assessment on silty clay (data from GI 2007 and GI 2008)

In addition, Figure 8 evaluates liquefaction potential of silty clay based on data from the GI 2007 and GI 2008, suggesting that silty clay is "moderately susceptible" or "susceptible" to liquefaction. This is consistent with the assessment based on the test results from the GI 2009.
