Remediation of Slope Failure in the Application of Lightweight Fill and Timber Piles on Highway 17 in Ontario

Tae C. Kim, Silvana Micic, & Stan Gonsalves
EXP Services Inc., Brampton, Ontario, Canada.
Ken Ahmad
Ministry of Transportation Ontario, Toronto, Canada.

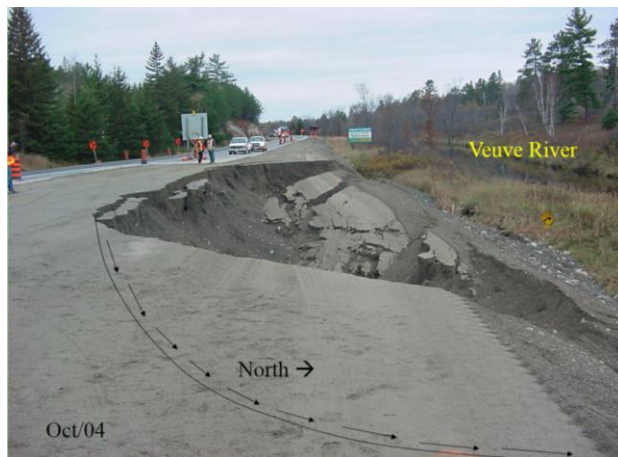
Between the evening of October 19 and the morning of October 20, 2004, the detour embankment failed causing the newly placed fill to collapse. The failure extended along a length of highway approximately 50m. The head scarp of the failure was located at the north edge of pavement of the original highway and material moved into Veuve river as shown attached Photo 1.

Photo 1. Original failure

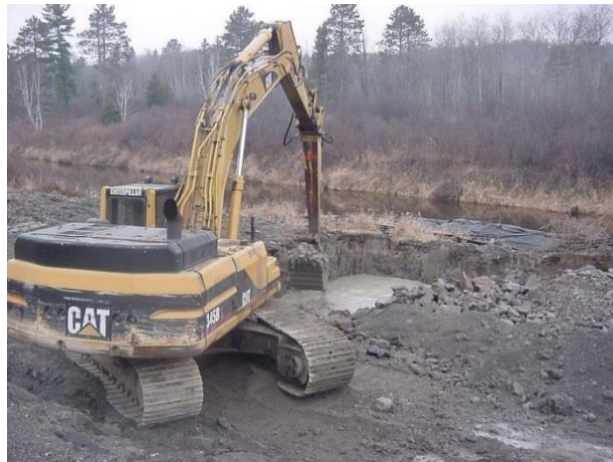
Photo 2. Shear key construction

Remediation of Original failure involved excavation and construction of rock-filled shear key (5m deep and 5m wide) to intercept the subsurface shear plane/ shear zone

to stabilize the slope, as shown in Photo 2. Rockfill was well-graded angular material with median diameter of 0.3 to 0.5m and maximum 1m. All debris was also excavated in the river channel.

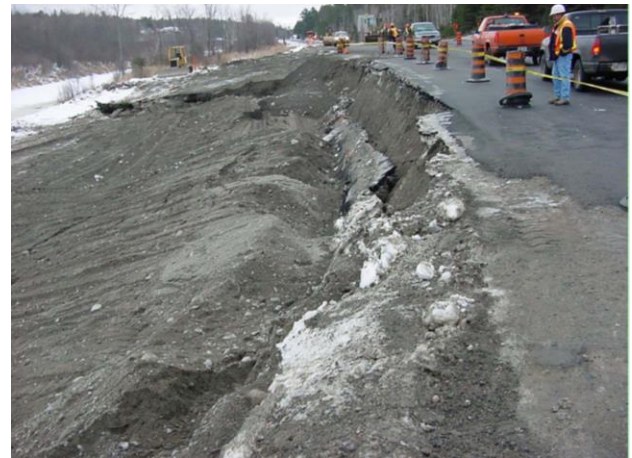
Following the installation of the rock-filled shear key and the reinstatement of the highway embankment, a second failure of the highway embankment occurred on December 10, 2004 following final grading activities. Photo 3 shows the second failure. This failure was obviously deep seated and likely extended below the shear key. The reason of the failure relative to the original slope stability assessment was postulated and the following observations was drawn:

1. The steep cuts required for the shear key installation (even though the excavation was done in short sections) might cause local instability and movement of the silty clay material below Elev.199 m thereby reducing the shear strength as a result of remodeling.

2. Water infiltration by heavy rain along the previous sliding surface during the shear key installation process might act to be remolded and lubricated along disturb zones. This might cause movement of any pre-existing localized soft zones within the silty clay material resulting in instability at deeper levels.

3. During construction there might be unusual loading in terms of fill materials at the upper slope and near the toe, including equipment, etc. These loads and associated vibrations caused by this construction activity might cause movement within the silty clay material beneath the shear key resulting in remodeling and reduction in strength.

4. There might be a non-conservative interpretation of shear strength between Elev. 199 and 194 m in the initial assessment, and/or variations (lower) in the shear strength within the failure are not reflected by the borehole data.

5. There could be some over excavation during removal of material in the river deposited during the initial failure thereby reducing the resisting forces for potential deeper failure.

6. A combination of all the above elements could incrementally participate the second failure.

Photo 3. Second failure

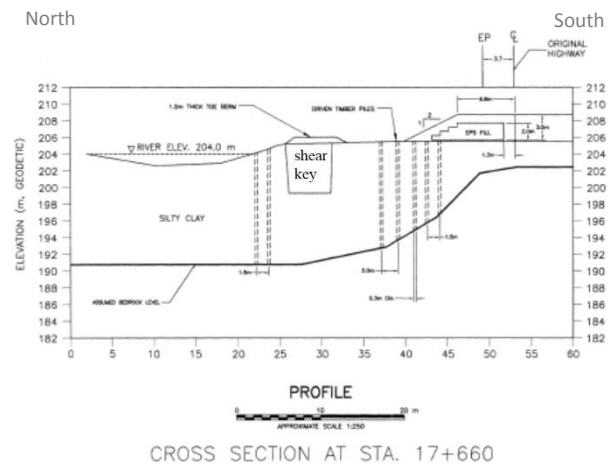
Figure 6. Timber piles, shear key, and EPS embankment

Stability analyses were carried out on the overall critical slip surface with all recommended remedial works in place. For the undrained shear strength of $C_u = 12$ kPa for the in-situ soft silty clay material and full bank saturation, the estimated factor of safety of the overall critical slip surface was 1.33. This estimated factor of safety increased to 1.35

assuming a groundwater level at the base of the lightweight fill.

- Upper bank offloading consisting of EPS fill to reconstruct the highway embankment.
- A 1.0 m thick lower toe berm consisting of a free draining rockfill material.
- The 257 timber piles to be installed.

- The toe berm had a top Elev. of 206 m and be constructed to a minimum of 5 m wide, as shown in Figure 6.

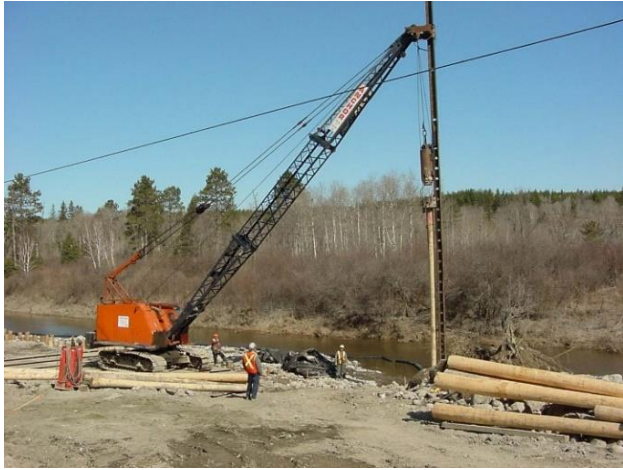
Photo 4. Timber pile installation

- All pile had a minimum top diameter of 0.3 m
- The plan location and anticipated length of the 257 timber piles are shown on Figure 5. All piles were driven to refusal (Photo 4).

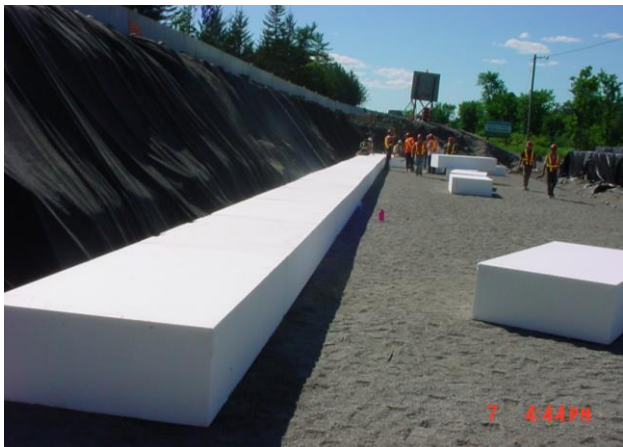
Photo 5. EPS fill placement

- The subgrade soils at the base of the EPS fill placement was prepared and proof rolled to a minimum of 95% of the SPMD Subgrade was sloped to the north a minimum of 2% to promote drainage.
- A minimum of 0.15 m of clear stone gravel (OPSS 1004) or HL-8 course aggregate was placed beneath the EPS. A non-woven geotextile separator (Terrafix 270R or equal) was placed between the subgrade soils and the clear stone gravel.
- The plan limits of the EPS fill are shown on Figure 7 and Photo 5.
- The lightweight fill was installed to the approximate dimensions shown on Figure 7 following all manufacturers' specifications.

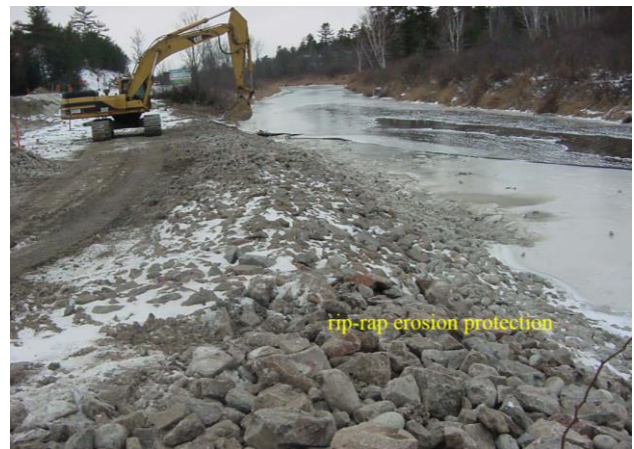
Photo 6. Rip-rap erosion protection in the river channel

- After all remedial works were constructed, the failed material within the river channel was removed.
- All material removed from the river channel immediately upon excavation.
- After the river channel was reinstated to its original pre-failure condition, a layer of rockfill riprap was installed. The rockfill rip rap have a mean diameter of 0.3 m, and a maximum diameter of 0.45 m, and be placed to approximately 0.6 m thick, the rip rap extended out into the river channel 3 m, and extended up to the bank to Elev. 206 m.
