Preliminary Design For Seepage Remediation at a Small, Remote Dam – Case Study of Lac La Ronge Dam in Northern Saskatchewan

Ryan Kozun & Allen Kelly
Clifton Associates Ltd, Regina, Saskatchewan, Canada
Imteaz Bhuiyan & Jasyn Henry
Water Security Agency, Regina, Saskatchewan, Canada

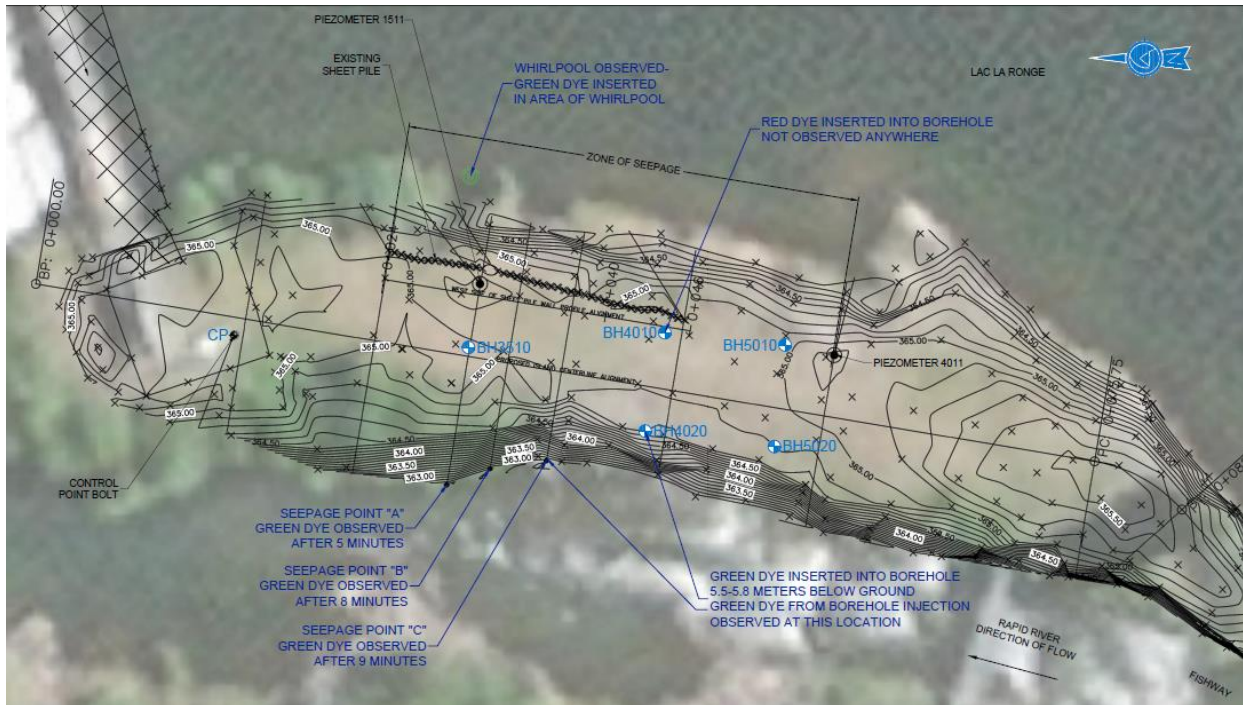
Figure 6.1. Plan view of Lac La Ronge Dam Embankment with Borehole Location

Tracer tests are widely used in hydrogeology to assess the direction and velocity of groundwater (Battaglia et al., 2016). During packer testing, different colours of tracer dye (red and green) were used to visually observe water flow through the dam structure. Observations were made on the left and right sides of the dam. Refer to Figure 6.1 for the following discussion.

A small whirlpool on the upstream right side of the dam had historically been observed and was observed during the October 2018 field investigation. Green tracer dye was placed in the small whirlpool and was observed at three separate locations along the downstream side of the dam. Tracer dye was seen at Location 1 (adjacent to the water/dam interface) after 5 minutes, at Location 2 (adjacent to the water/dam interface) after 8 minutes, and at Location 3 (south of the bedrock outcrop) after 9 minutes. Green tracer dye was also placed in Borehole BH4020 during drilling and was observed at Location 3 (south of the bedrock outcrop) when drilling was occurring at approximately 5.5 to 5.8 mbgs.

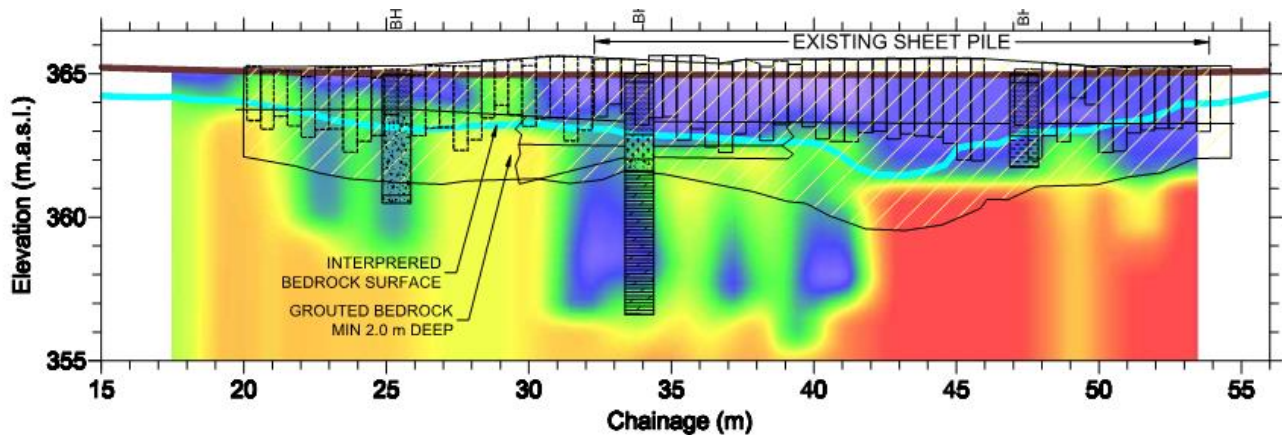
Figure 7.1. Geophysical comparison of dam stratigraphy with conventional drill program.

The V_s cross-section modelled two areas beneath the interpreted bedrock surface with lower than expected shear wave velocities. These areas are roughly coincident with zones where the GPR data returned secondary signal reflections and diffractions and hence were interpreted to be related to bedrock weathering or fracturing. The primary GPR anomaly and low shear wave velocity zone occurs toward the southern portion of the metal sheet wall, another anomalous zone was identified approximately 10 m further south.

The geophysical data was combined with borehole information to show the relationship between the geophysics and the measured bedrock surface (Figure 7.1). The top of bedrock was within 1 metre of the

interpreted bedrock surface. The highly fractured zones observed in the field also aligned with the geophysical data.

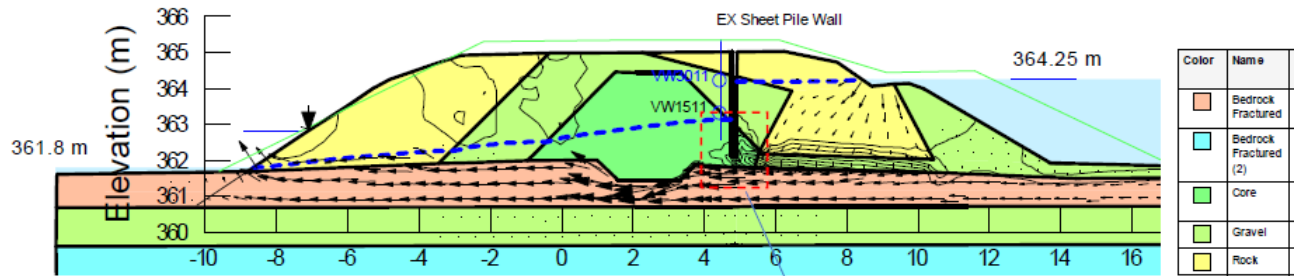
Figure 7.2 Phreatic surface through existing dam section prior to remediation

Seepage analyses of the existing structure were based on observed seepage discharge locations, dam geometry (including existing sheet pile cutoff), piezometer tip elevations installed in the core (which were observed to be under suction) and recorded lake levels. The critical section intersects the 2017 sheet pile cutoff as shown on Figure 7.2; which also illustrates the probable location of the phreatic surface if no further work was completed.

Given that the observed seepage flow was substantial but carried no fines would indicate the principal seepage pathway is not likely through the core but rather through the fractured bedrock. Accordingly, consideration of seepage control options focused on that pathway, acknowledging that gradients through the core must also be controlled.
