# Geotechnical instrumentation of a tangent cast-in-place pile wall in Peace River, Alberta

Luis A. Martinez, Mauricio Pinheiro, Lilianne Landry-Paré & W. Chris Workman  
*Thurber Engineering Ltd., Calgary, AB, Canada*

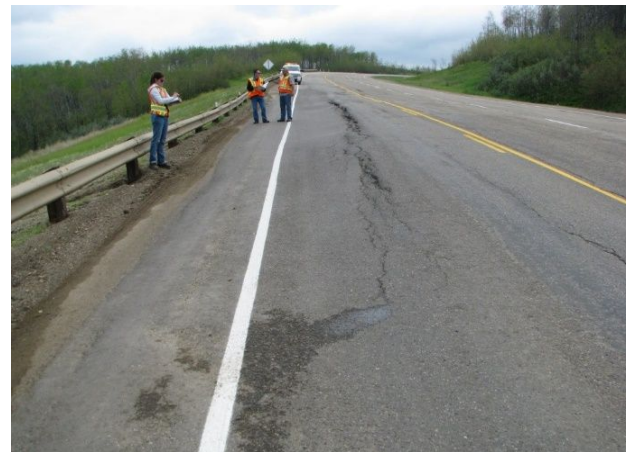
On June 27, 2012, the south slope of the sidehill road embankment on Highway 986:01, 3.3 km west from the Weberville Bridge, near Peace River, failed (Figure 1). The failure resulted on a sudden drop in the pavement on the east-bound lane of about 100 mm deep and 33 m long. The embankment was about 21.5 m high with side-slopes in the order of 3H:1V. A 900 mm CSP culvert traversed under the embankment.

Figure 1. Drop in the pavement on the east-bound lane of the embankment on Highway 986:01 in June 2012

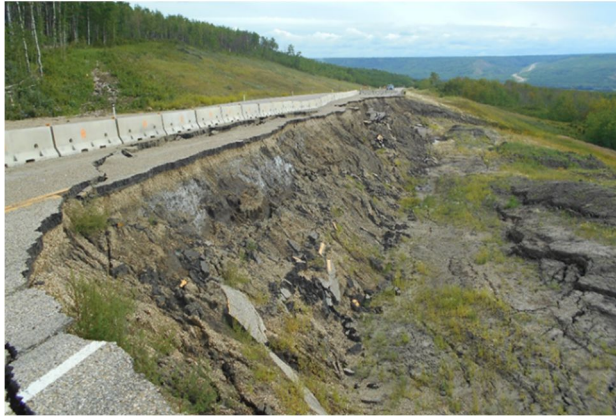
The final design was in the tendering process when the slope damage retrogressed further north on July 23, 2015, affecting the existing detour built in 2013. The drop in the pavement had grown to about 6.5 m deep and 130 m long.

Bulging and backscarps were observed throughout the embankment south slope (Figure 2).

Figure 2. Further retrogressed south slope in July 2015, showing a 6.5 m drop in the pavement.

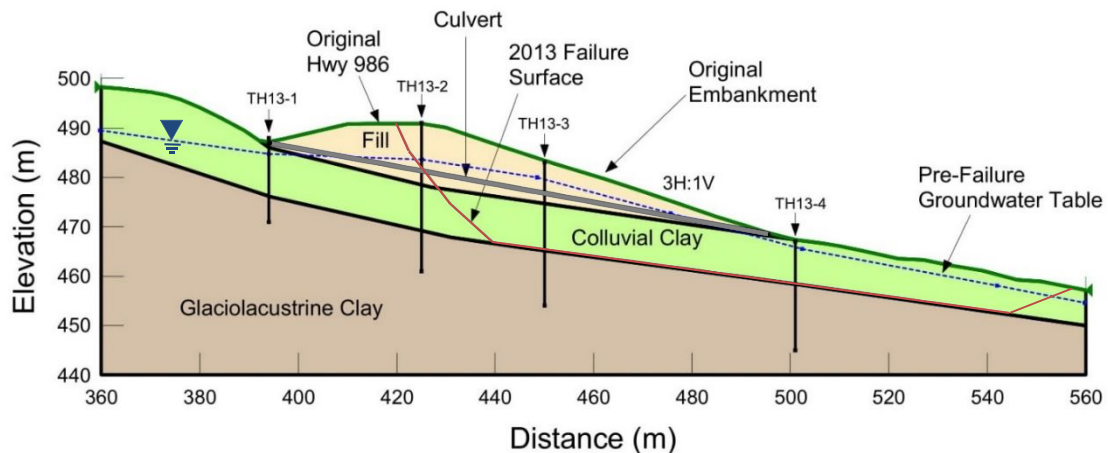
The SIs were substantially sheared just after installation. The existing CSP culvert traversing under the embankment was sheared at about 69 m from the culvert outlet. This was consistent with the location of the slip surface interpreted from the SIs (Figure 3).

The groundwater table interpreted from the pneumatic piezometers is plotted on Figure 3. It shows that the groundwater table was locally high in the vicinity of the culvert breakage.

Figure 3. Test hole locations and subsurface conditions prior to the September 2013 event

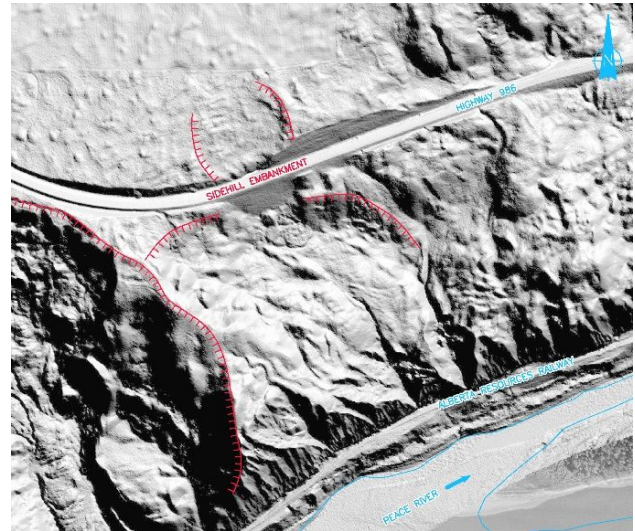
Assessment of the bare earth LiDAR data available for the site (prior to embankment failure, Figure 4) suggests that the road embankment may have been constructed on an area where ancient landslide retrogression has occurred. This is noted by the ancient slope backscarps located north and south of the embankment. A large deep-seated ancient slope failure is also apparent just west of the site as shown on the LiDAR image. However, this ancient failure does not represent a current potential risk to the road embankment.

Figure 4. Bare earth LiDAR data prior to the sidehill embankment failure including location of ancient slope backscarps

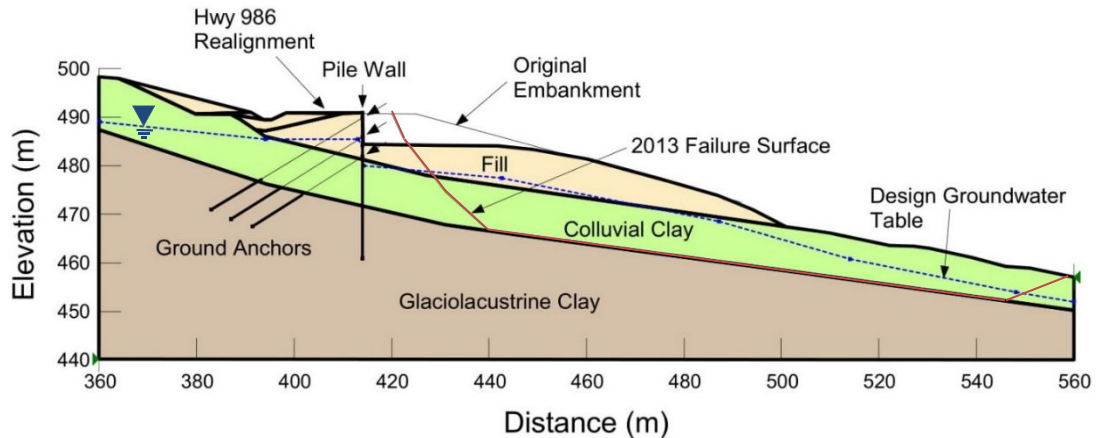
Figure 5. Design section showing the pile wall, ground anchors, and realigned Highway 986:01

To protect the new highway alignment from future slide retrogressions, a pile wall supported by three rows of ground anchors was built along the south edge of the new highway. The design section is presented in Figure 5. The pile wall is 142 m long and includes a concrete pile cap 2.1 m tall and 118 tangent cast-in-place concrete piles. The piles are 27.8 m in length and 1.2 m in diameter.

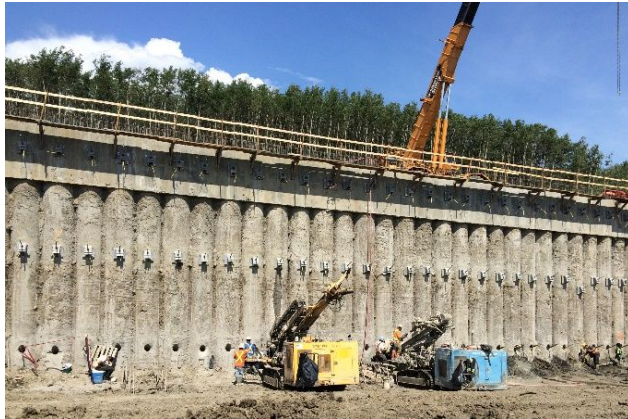
Figure 6. Initial excavation of the area immediately south of the pile wall to a depth of 10.5 m below the pile cap to allow for anchor installation.

The area immediately south of the pile wall was initially excavated to 10.5 m (Figure 6) to allow the installation of the lower row of anchors. Then, this area was backfilled to just below the middle row of ground anchors (Figure 7). After excavation and backfilling, the south slope was regraded down to the toe of the embankment to provide positive drainage away from the wall. The backscarps from previous slope retrogressions were also backfilled.

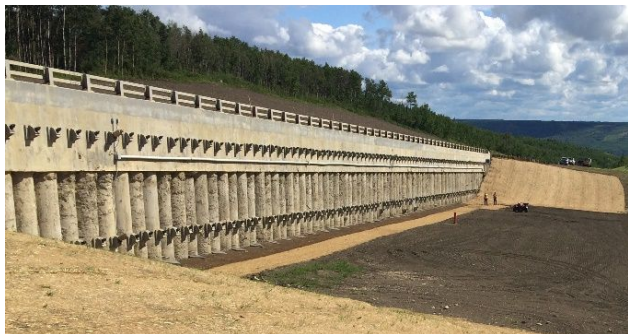
Figure 7. Pile wall completed and south slope of the embankment backfilled to final grade just below the middle row of ground anchors.

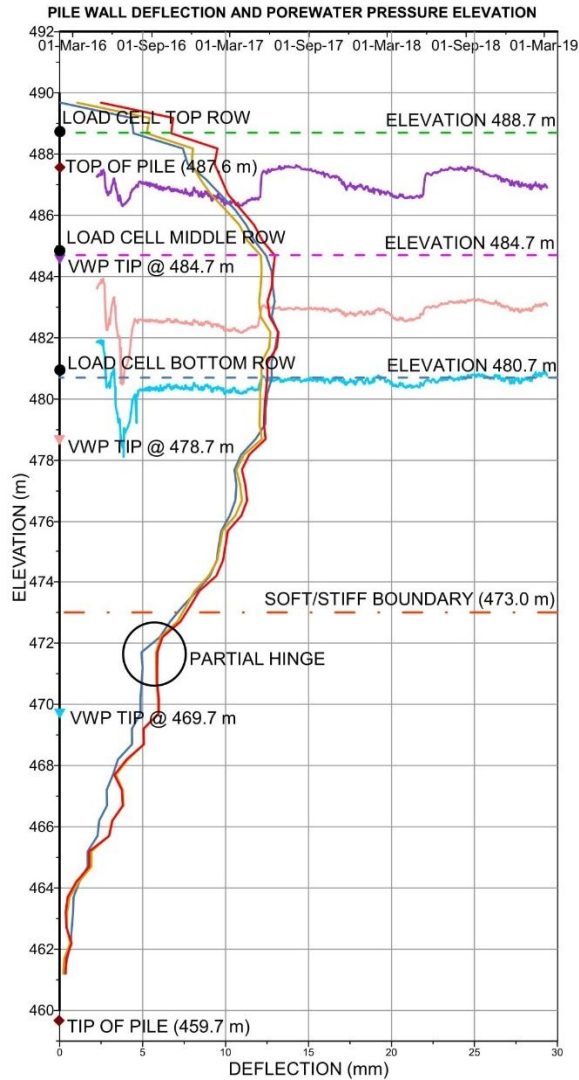
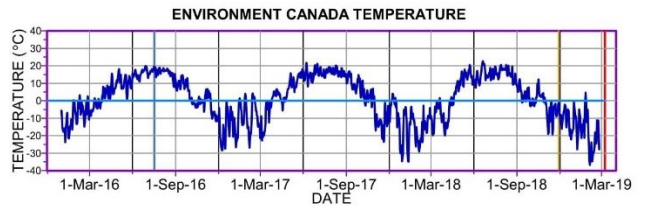
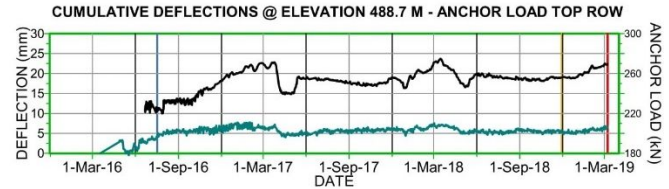
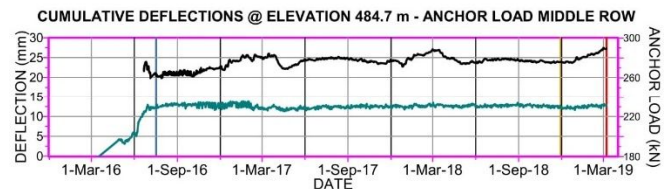
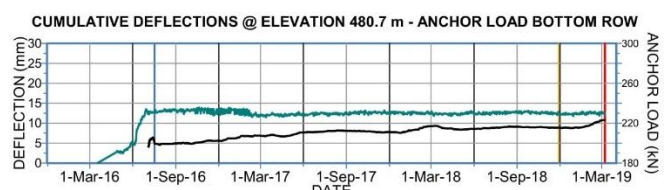
The vertical plot on the left-hand side presents the pile deflections on July 17, 2016 (just shortly after wall construction and backfilling of the south slope), November 30, 2018, and March 8, 2019. This plot reveals that deflections mainly occurred during construction and that the maximum pile deflection to date is about 13 mm. The maximum deflection is regarded as small for this type of wall. The left-hand side plot also shows the groundwater head elevation versus time from the three VWPs installed behind the pile. The VWP readings suggest that there may be a shallow and deeper groundwater regimes. The shallow regime is shown by the response of the upper two VWPs. The deeper regime behavior is captured by the response of the lowest VWP. The shallow regime appears to be impacting mainly the road embankment and appears to respond rapidly to spring snowmelt events such as the ones that occurred in May 2017 and 2018.

The responses of the upper two anchor load cells suggest a gradual load increase during the winter followed by a rapid load decrease as the air temperature rises above zero degree Celsius in early spring. Note that these loads increased again shortly after due to the rapid rise of the shallow groundwater associated with spring snowmelt. The response of the lowest load cell suggests that the anchor load at this elevation is neither sensitive to winter nor spring snowmelt. This may be because the lowest row of anchors is covered by 4.5 m of fill, thus protecting them from temperature changes. Also, spring snowmelt was found to impact only the shallow groundwater which in turn only acts on the upper two rows of anchors.

Figure 8. Instrumentation results. Left-hand side plot: pile deflections at different selected dates, VWP tip locations, and water head elevations with time. Right-hand side plots: temperature, deflections at anchor head locations and anchor loads with time.

The maximum anchor load recorded was about 290 kN which is well below preproduction test results (460 kN). Furthermore, since the bond length of the anchors is well within the glaciolacustrine clay (therefore, controlled by the deeper groundwater regime), the capacity of the anchors is neither very sensitive to winter nor spring snowmelt.

The pile deflections at the anchor elevations (as shown on Figure 8, horizontal plots on the right-hand side) also reveal that these are not very sensitive to winter or spring snowmelt.

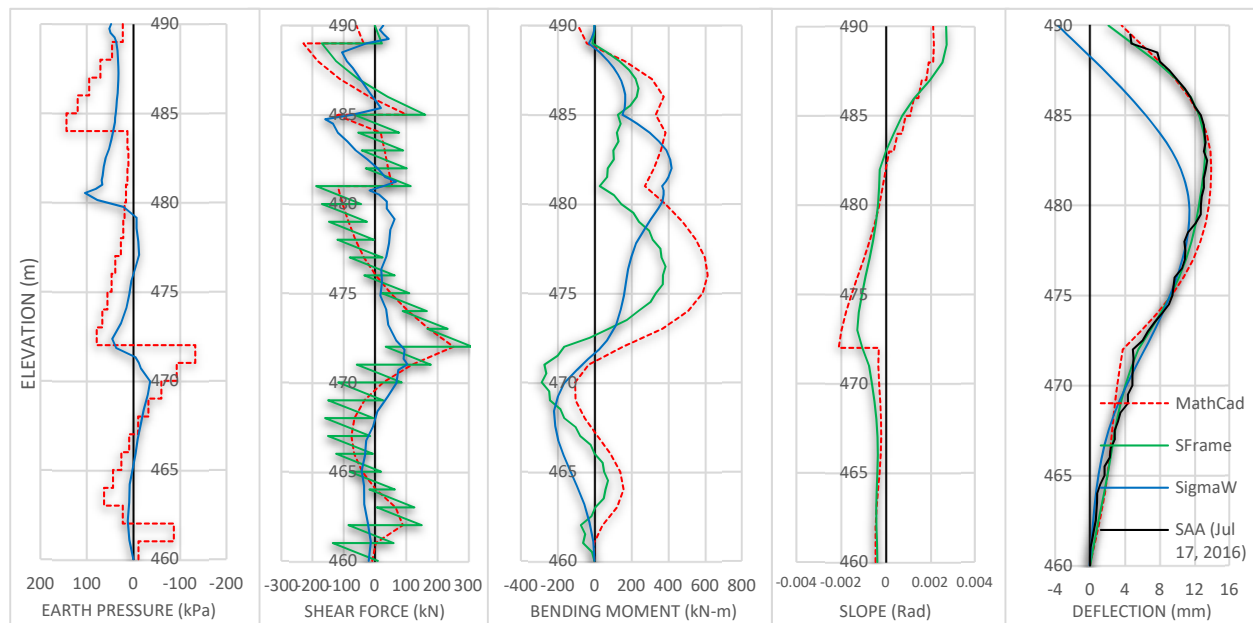
The average bending stiffness ( $EI$ ) that was used for the pile in the analysis was  $1,500 \text{ MN/m}^2$ . Figure 9 presents the results of the Mathcad analysis in terms of resultant earth pressures, shear forces, bending moments, slopes and lateral deflections. Figure 9e, in particular, compares the Mathcad deflections with the measured deflections as of July 17, 2016. An excellent agreement is obtained between these two. A partial hinge had to be added between two one-meter segments at elevation 472 m in order to better match the measured deflections. Evidence for the partial hinge can be found in the measured pile deflections reported in Figure 8 (note circled area on the left-hand side plot, at elevation 472 m). This partial hinge is most likely the result of internal stresses being transferred from the concrete to the reinforcing steel as the pile cracked in response to deflections. Other less significant hinges developed in the upper portion of the piles, likely induced by the anchor forces. These hinges were also added to the Mathcad model to improve the matching between measured and calculated deflections. They can be seen in the slope plot (Figure 9d) as discontinuities in the curve.

The back calculated shear forces and bending moments in Figure 9b and c, respectively, are lower than the shear resistance of 617 kN and bending moment resistance of 1395 kN·m and give an assurance that the pile wall is structurally sound for the design loads.

Figure 9. Results of the soil-structure interaction analysis using various methods of analyses: (a) resultant earth pressures, (b) shear forces, (c) bending moments, (d) slopes and (e) deflections along the pile.

The results of the finite-element analysis are presented in Figure 9. While pile deflections are relatively comparable among the three programs, shear forces and bending moments are not. On average, the internal forces estimated from SIGMA/W are [higher] [lower] than those calculated from Mathcad and S-Frame. Note that the addition of plastic hinges in beam elements is not supported by SIGMA/W. An attempt was made to introduce weaker (less stiff) sections in the pile element; however, this strategy did not improve the results noticeably.

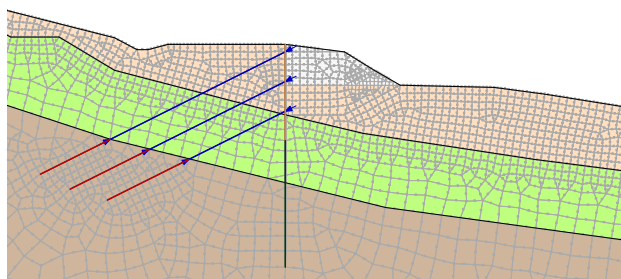
Figure 10. Closeout of the model geometry at the final stage of construction, as implemented in SIGMA/W.
