# Hazard identification, stability assessment and risk mitigation overview of near-surface openings and pillars at the former Mine Principale, in Chibougamau, Quebec

Eliane Cabot, Adam Coulson and James Tod  
*Wood, Environment & Infrastructure Solutions, Mississauga, ON, Canada*  
Scott McNicoll and Simon Delattre  
*Wood, Environment & Infrastructure Solutions, Montreal, QC, Canada*  
Henrik Rasmussen  
*Ministère de l'Énergie et des Ressources naturelles (MERN), Quebec, QC, Canada*  
Carl Gauthier  
*WSP, Quebec, QC, Canada*

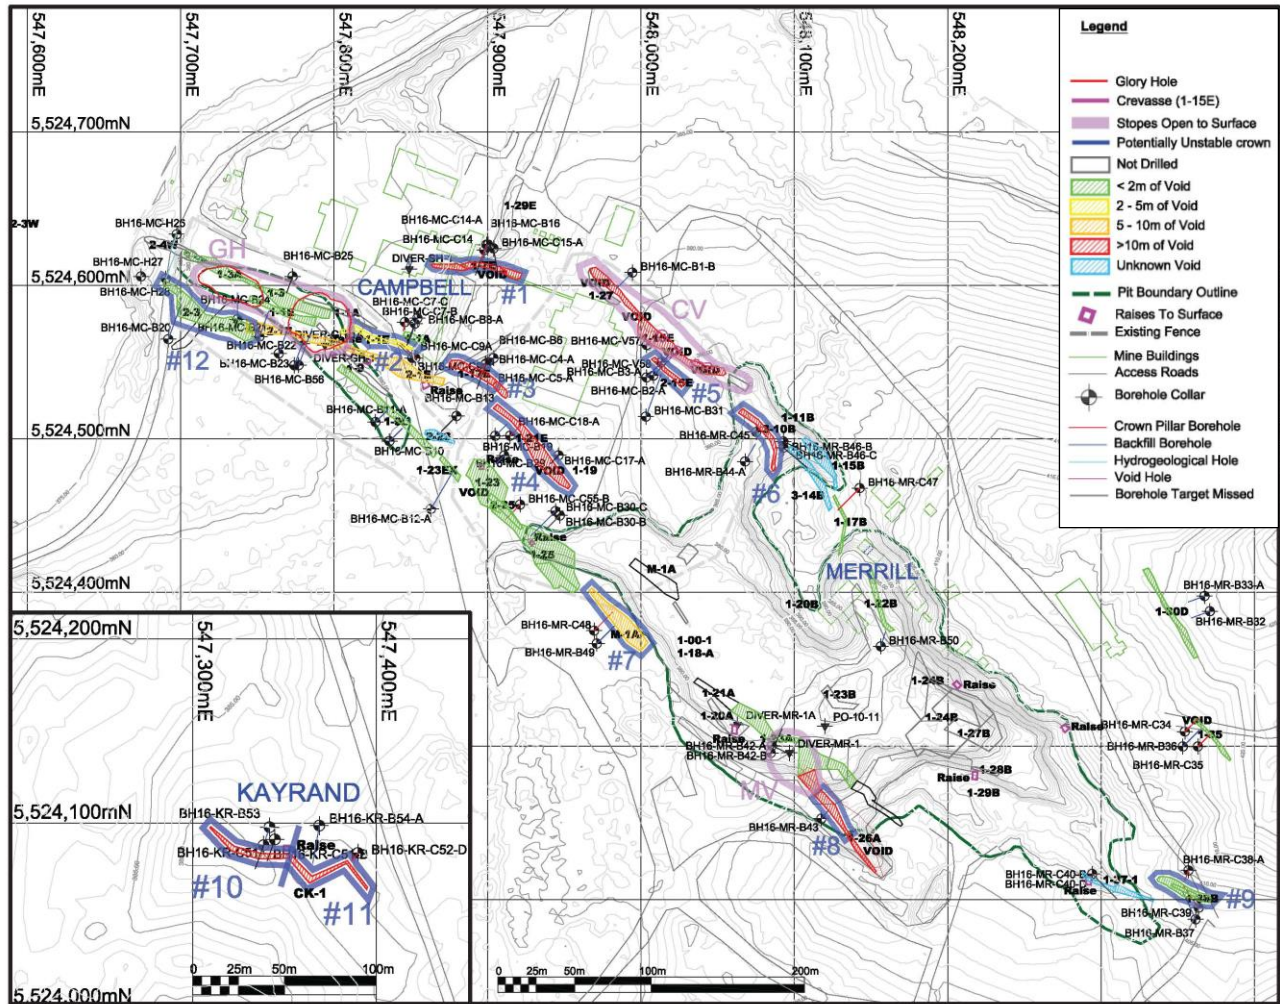
Figure 5: Risk assessment map showing estimated slope void heights and identifying potentially unstable slopes / crown pillar areas for further analysis

The determined hazard results obtained are summarized on a heat map (Figure 5), where void ranges are shown by targeted stope. Of the 25 stopes assessed (over the initial 29 targeted stopes), the following conclusions were drawn:

- Nine (9) stopes were found to be of no immediate concern and required no remediation;
- 12 stopes were found to be potentially unstable and required further analysis;
- Two (2) areas (encompassing four stopes) clearly required remediation: the Glory Holes (GH) and the Crevasse area (CV) or stope 1-15E.

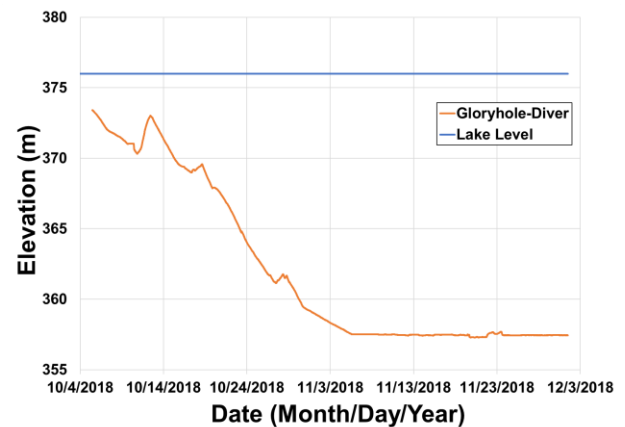
The water drawdown is shown in Figure 6, which indicates the water level was drawn down over a period of four weeks. The first week of pumping was performed using one 95 HP pump, which was subsequently replaced by two 60 HP pumps after a mechanical breakdown. Water levels were measured at several locations to identify any variation across the site and were compared to the lake level. Data loggers were used along with a water tape for cross-verification.

Figure 6: Water level drawn down over time

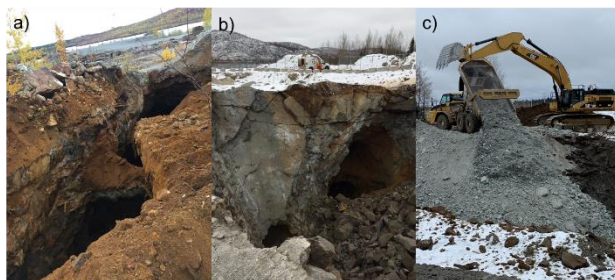
Stopes 1-15E and 1-21E, which had factors of safety as low as 1.3 and less than 1, respectively, are located close to surface. These stopes had a maximum of 7 m of overburden, composed of gravel and tailings for stope 1-15E and 4 m of mine waste for 1-21E. To secure these stopes, the overburden was excavated and the crowns or side pillars (in between crevasses) were blasted, and the stopes backfilled from the surface, first with coarse material (to within 2 m from the surface) and then capped with fine material (Figure 7).

Figure 7: Stope 1-15E a) Initial crevasses b) Opening exposed after blast c) Backfilling

The top soil/fill excavated to access the stope crowns was then replaced on top of the fill to help revegetate the area.

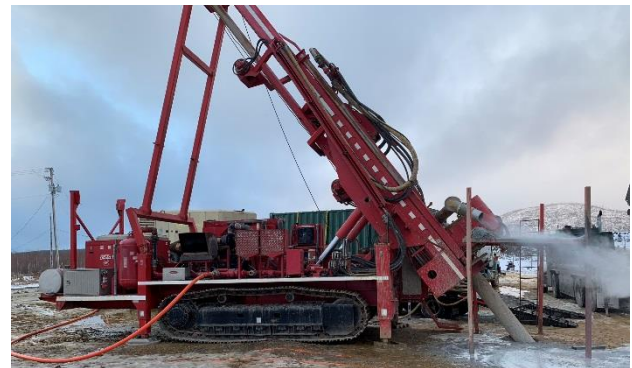
Stopes 1-17E and M-1A had factors of safety less than 1. They were found at depth, approximately 17 m and 21 m (bgs). The stopes were covered with backfill and construction debris from the destruction of either the mill or the office buildings on site, consisting of dry/dangerous material such as wood, metal and possibly asbestos (as this side of the pit had been used as a landfill during demolition). Stope M-1A had uneven rock cover due to the

Figure 8: Drilling of backfill hole (12-inch) at stope M-1A

benching on the south pit wall above it. These stopes were backfilled via large-diameter (12-inch) boreholes as described earlier (Figure 8).
