GEOTECHNICAL ASPECTS OF STABILIZATION OF HIGH, STEEP, ACTIVELY-ERODING SHORELINE CLIFFS - THE SCARBOROUGH BLUFFS, LAKE ONTARIO

M.A.J. (Fred) Matich, P.Eng., MAJM Corporation Ltd., Ontario, Canada;
R.D. Powell, P.Eng., P.E., Klohn Crippen Consultants Ltd. Ontario, Canada;
B.E. Denney, P.Eng., Toronto and Region Conservation Authority, Ontario, Canada;
and T.C. Kenney, P.Eng., Professor Emeritus, University of Toronto, Ontario, Canada.

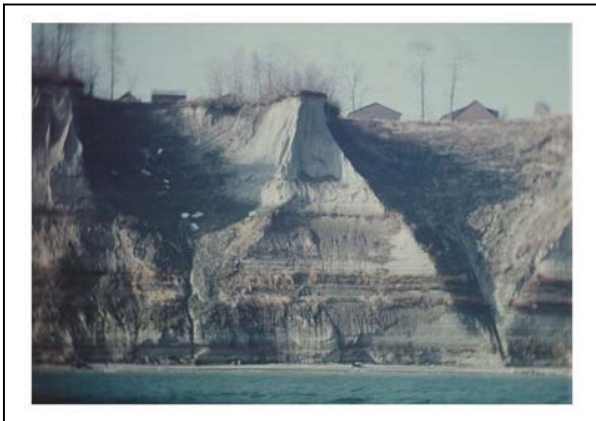
Figure 1. Example of Gully Development (Geocon, 1980)

As illustrated on Figures 1 and 2 a prominent feature is the intersection of gullies along the central portion of the Bluffs. The presence of these gullies is directly related to the position of the abandoned Lake Iroquois shoreline and/or areas where there is channelled surface or groundwater movement. The significance of their presence, in regard to slope stability, is two-fold. Firstly, they provide an outlet for groundwater movement, thus draining the adjoining tableland and, secondly, where the gullies are closely-spaced they provide for a higher reserve of stability on account of their three dimensional effect.

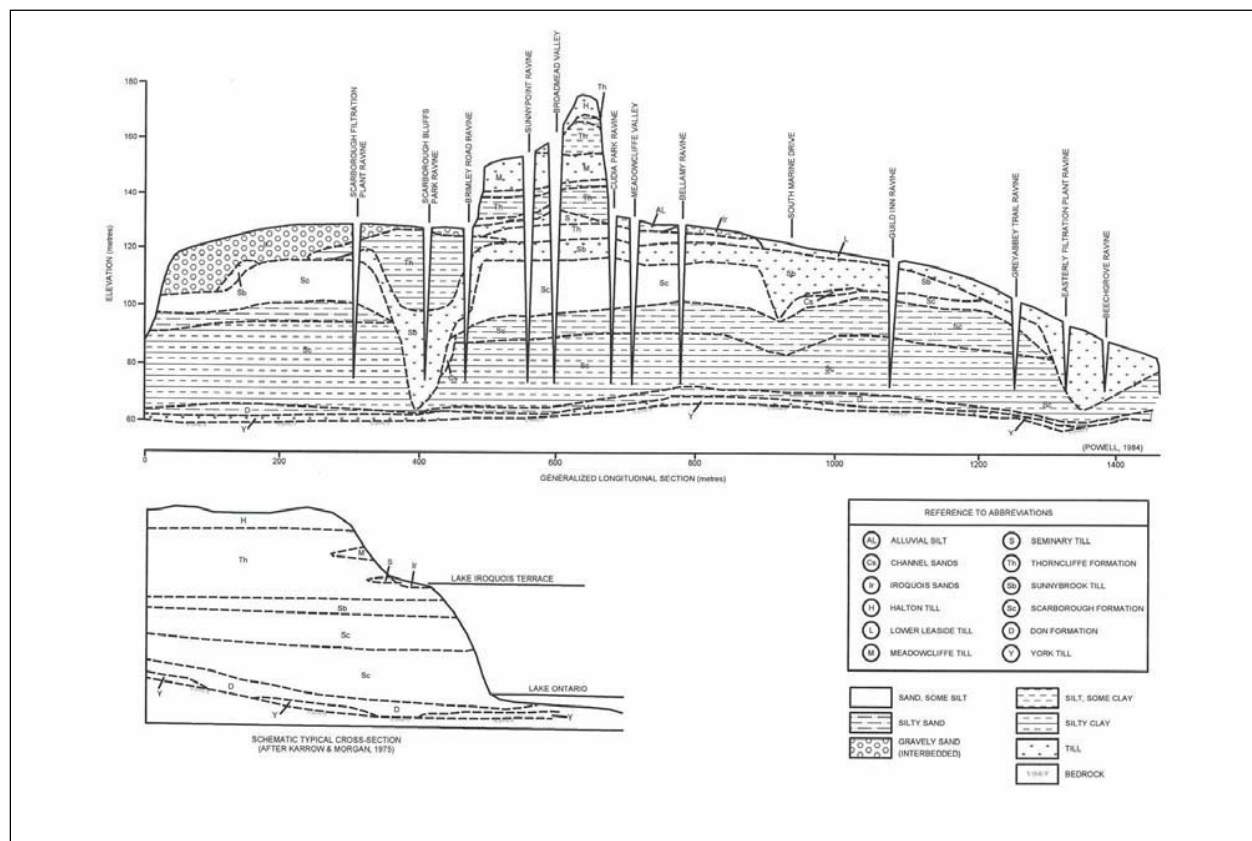
A generalized stratigraphy along the length of the Bluffs as produced by Sado and Powell (1984) is shown on Figure 2 along with a schematic cross-section excerpted from Karrow and Morgan (1975).

Figure 2. Generalized Stratigraphy (Sado & Powell, 1984)

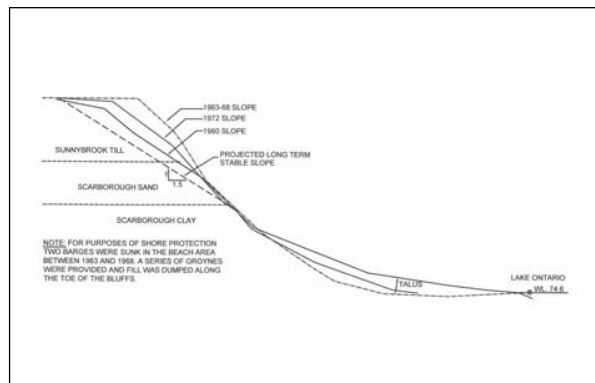
To better evaluate the rates of retreat along the Bluffs, historic mapping and aerial photography were again compiled and various crest positions were triangulated to common features and then compared to one another. Based on this analysis for a 68-year time frame (1922 to 1980), an average annual rate of retreat was determined to be 0.38 m/year (Geocon, 1982). However, at any one place the annual rates tended to be misleading in the sense that some tableland may be lost instantaneously (such as in the case of a block failure), whereas other areas erode progressively with time. To better assess the way in which the Bluffs tended to retrogress, a series of cross-sections were developed and compared using topographic mapping from 1972 and 1980. This work not only assisted in evaluating the way in which the slopes retreated but also how the slopes tended to self-stabilize when the toe protection was provided. Figure 3 illustrates one of the profiles developed from this work.

Figure 3. Example of Rates of Retreat Profile (Geocon, 1982)

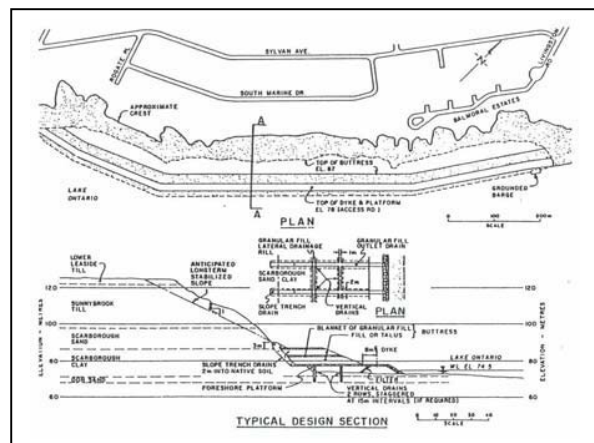
The one section of the Bluffs where self-stabilization was not considered applicable was at South Marine Drive where the observed slides were generally deeper than the surficial slides which were prevalent elsewhere. Erosion trends in both the short and long terms had been substantially above the norm for the Bluffs elsewhere. To put this in perspective, the average crest retreat for the Bluffs was 0.38 metres per year, whereas the average crest retreat along the South Marine Drive sector was 1.3 metres per year. Based on these figures, over 30 homes as well as the roadways and services were considered to be endangered in the South Marine Drive area.

Figure 4. Stabilization Measures at South Marine Drive (Parker et al 1986)

At this location extensive buttressing of the slope and incorporation of drainage measure were carried out. See Figure 4. Parker et al 1986 present a detailed description of this work.

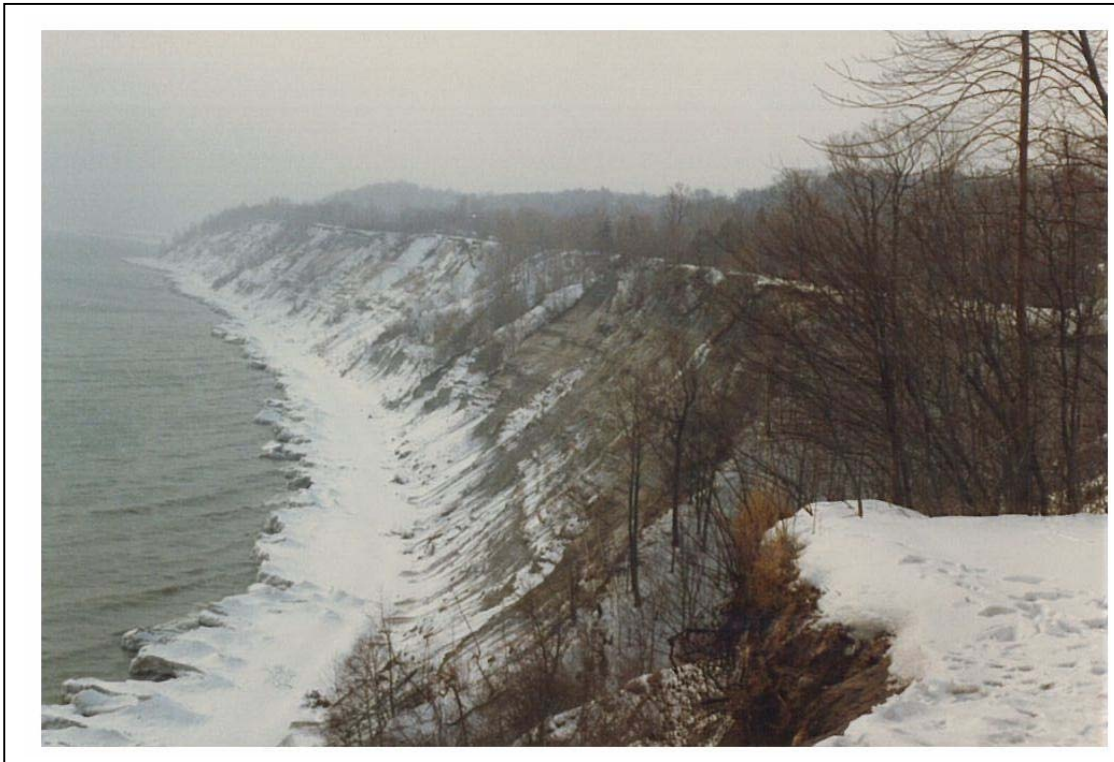
Figure 5. Looking west along Sylvan Avenue area prior to stabilization works. (Geocon, 1982)

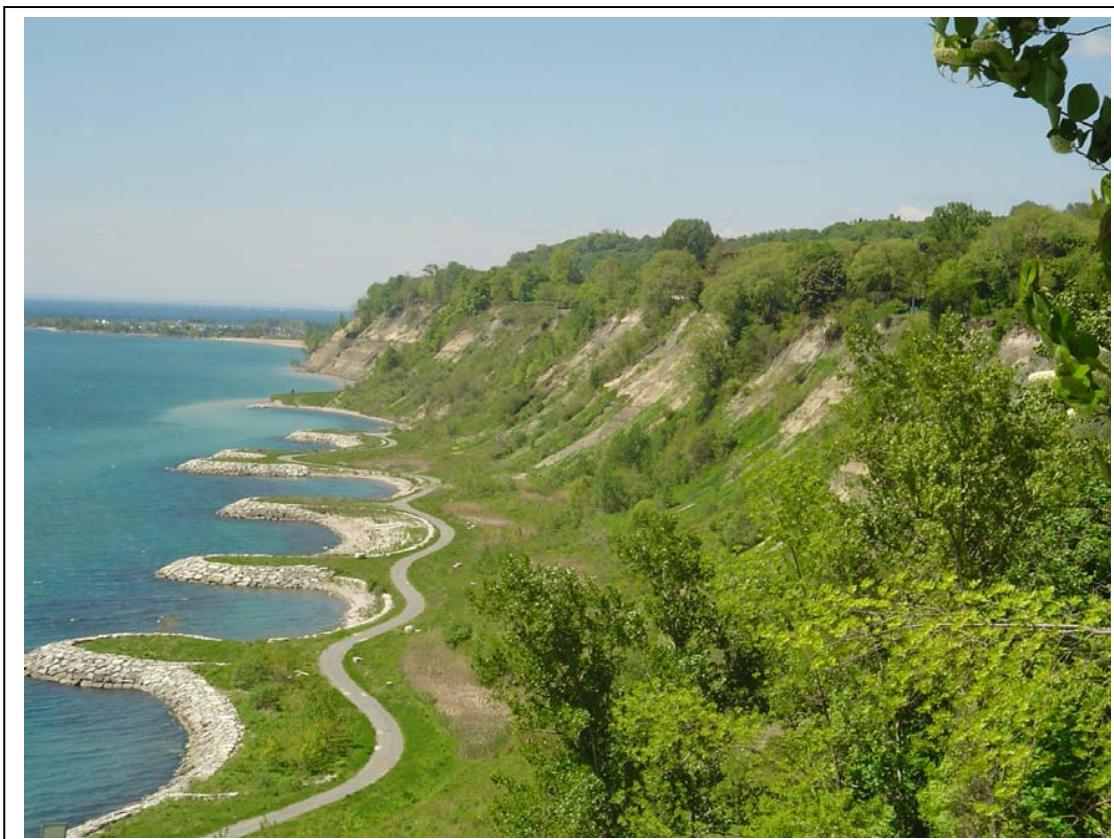
From a recent site reconnaissance of the works completed to date, the process of self-stabilization has been successful. This is illustrated by Figures 5 and 6 which illustrate views of one sector of the Bluffs taken about 20 years apart.

Figure 6. Looking west along Sylvan Avenue area in 2004 showing stabilization works
