# The Khyex River flowslide, a recent landslide near Prince Rupert, British Columbia

James W. Schwab, B.C. Ministry of Forests, P.O. Bag 6000, Smithers BC Canada VOJ 2NO Andrée Blais-Stevens, Geological Survey of Canada, 601 Booth Street, Ottawa ON Canada K1A 0E8 Marten Geertsema, B.C. Ministry of Forests, 1011 4th Ave., Prince George, BC Canada V2L 3H9

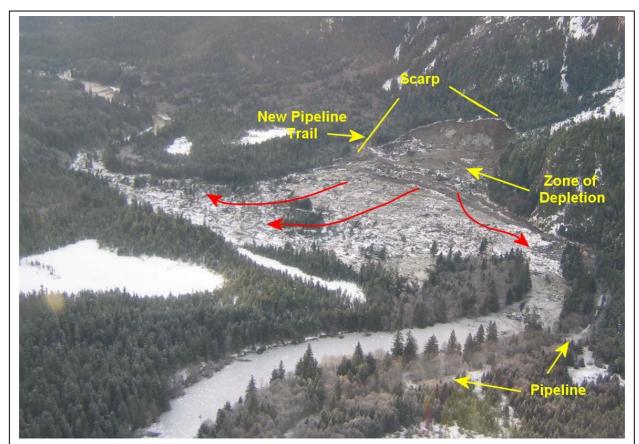
Figure 2. View down valley of the Khyex landslide. Photographed by Tim Keegan, December 9, 2003. Red arrows show direction of movement. The river is filled with displaced material over a distance of 1.7 km.

The Khyex landslide involved glaciomarine sediments as well as rubble from the colluvial cone (Figures 2 and 5). About 4.7 M m<sup>3</sup> of sediments were displaced in the landslide, which cover an area of 32 ha, with 13 ha in the zone of depletion. The landslide flowed across the Khyex floodplain and filled the river over a length of 1.7 km. Displaced material flowed up and down the river and caused flooding upstream for a distance of 10 km. The slide is characterized by a steep main scarp, 45 m high by 345 m wide, and controlled by the smooth bedrock surface of the valley wall. The flanks or lateral scarps are found within glaciomarine sediments. Slope of the original ground surface over much of the zone of depletion was about 4.5° with the colluvial cone considerably steeper at about 30°. The present slope through the zone of depletion is about 2.5° tending toward a flat plain within the zone of deposition. Estimated retrogression from the assumed point of initiation on the riverbank is about 480 m. Pre-failure bank height was about 10 m. The landslide is classified as an extremely rapid, retrogressive liquefaction earthflow according to the classification of Cruden and Varnes (1996), or a clay flowslide according to the classification of Hungr et al. (2001).

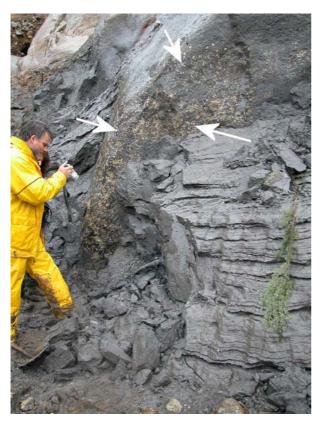
The surficial geology of the area was mapped and described by Clague (1984). The area was isostatically depressed during deglaciation (11-12ka BP), which caused coastal river valleys, including the Skeena and Khyex, to be inundated by marine waters. Glaciomarine sediments were deposited as glaciers melted and retreated up the Khyex Valley. The upper elevation of glaciomarine sediments found in the near vicinity of the landslide within the Khyex Valley was about 30 masl. Laminated glaciomarine silts and clays, 5-10 m thick, were found on the bedrock surface at the head scarp of the Khyex landslide (Figure 3). Overlying this unit is

Figure 3. Laminated silts and clays. Bedrock wall is speckled with remnant barnacle traces (arrows).

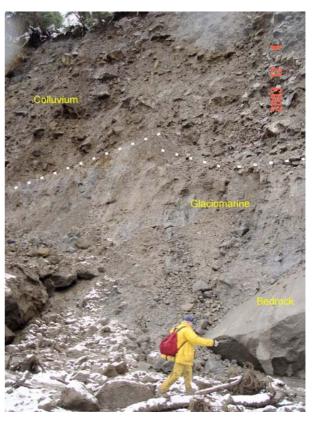
Figure 4. Sediments exposed at the headscarp.

Analysis was undertaken of three grab samples of the dark grey glaciomarine sediments that remained along the bedrock surface in the main scarp. Particle size analysis showed sand, silt and clay in the order of 5-13 %, 45-48%, 41-47%, respectively (Table 1). The material is classified as a clayey silt. Natural moisture content was relatively low (24 to 32%), compared with sensitive sediments. This may in part be due to freezing of the samples. Liquid limits were about 30% and plastic limits 19%. Plasticity indices ranged from 9.2 to 12.4 and liquidity indices, from These values may not be indicative of conditions at the rupture surface, and are somewhat low compared with sensitive soils in eastern Canada (Mitchell and Markell, 1974). They are, however, similar to the range of values of the nearby large rapid flowslides at Mink Creek and Lakelse Lake that occurred near Terrace British Columbia (Geertsema and Schwab, 1995). The glaciomarine sediments at Khyex and in the Terrace area have a much lower amount of primary minerals (rock flour) than phyllosilicates (true clay minerals) in the clay fraction and are dominated by silt. Hence, low liquidity indices may reflect a lack of cementation due to a paucity of primary minerals (Quigley, 1980) and a high silt content.

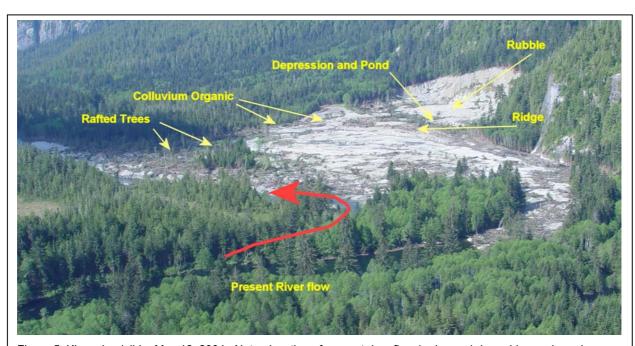
Figure 5. Khyex landslide, May 18, 2004. Note: location of present river flow (red arrow), long ridge and pond location.

occupy about 25% of the zone of depletion. This rubble originates from the colluvial cone/snow avalanche track that collapsed into the zone of depletion in the days following the landslide. Remaining in the zone of depletion are a few transverse ridges situated close to the front of the zone of depletion or the original river bank. The largest ridge extends about 300 m almost across the zone of depletion (Figure 5). Behind the ridge is the lowest portion of the zone of depletion, now filled with water. One large prism of glaciomarine mud remains in the northern portion of the spoil. Much of the material that appears as possible prisms and ridges is capped with sand and gravel. The strong remoulding of material, found within the zone of depletion and across the valley flat, suggests that movement was by flowing rather than spreading. There is little evidence to indicate lateral spreading in that there is a distinct lack of rib features in the zone of depletion. Also, no rotational blocks that tend to occur just prior to the cessation of movement were found along the back scarp and southern lateral scarp. Flow followed the bedrock of the valley wall along the north flank; hence, all materials were transported along the bedrock face. Only remoulded materials remain along the face. Patches of trees remaining upright on an organic mat appear to have rafted across the floodplain and down river. Numerous active mud volcanoes (silty in texture) were found throughout the zone of depletion in December 2003 (Figure 6). These mud volcanoes were likely created, as remoulded mud de-watered, forcing liquid mud and water upwards. They were found in and around zones of liquefied sediments. Further study is required to determine the exact origin of these features.

A depression that remains in the zone of depletion below the back scarp (Figure 5) does not fit well with models of retrogressive spreading by repeated back wall failure (Odenstad 1951; Carson 1977). Repeated retrogressive failure occurs until the backscarp is supported and the translational sliding stops. This should result in an up sloping surface in the zone of depletion. Instead, a large depression remained between the main back scarp and the main body of the zone of depletion. A factor however, that may have contributed to the lack of a sloping surface could possibly be the control exerted on retrogression by the bedrock of the valley wall. Further evidence against retrogressive failure is the lack of rotational blocks along the lateral scarps on the south side given that the main scarp and north flank of the landslide are controlled by bedrock. Rotational blocks are believed to be transitional forms between translational sliding and cessation of movement in retrogressive landslides.
