Application of a Landslide Risk Management System to the Saskatchewan Highway Network

An overview of the risk management system and its application to landslides near Shaunavon (C.S. 37-02) and Prince Albert (C.S. 302-02), Saskatchewan are provided. Details of the subsequent slope stability investigations and analysis are included.

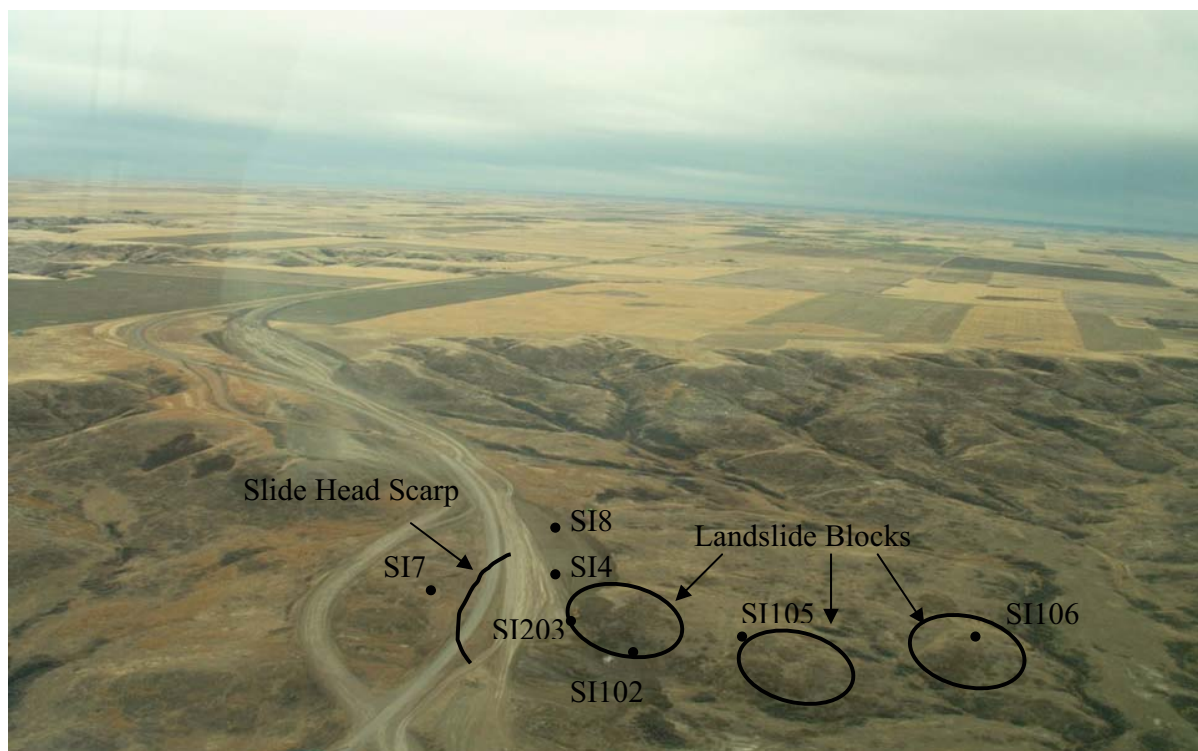
Figure 3: Approximate location of landslide and slope inclinometers at Frenchman River Valley.

In the fall of 2003, a landslide was reactivated during realignment of Highway 37 (Control Section 37-02) on the south wall of the Frenchman River Valley, Figure 3. A large fill section was placed immediately west of the existing road, resulting in a head scarp which dropped 150 m of the existing highway by 100 mm over a period of a few days.

Immediate action was taken to detour traffic around the landslide and halt construction of the fill section. An airphoto assessment of the site indicated there were three landslide blocks below the existing road, Figure 3 and a block above the existing road. The existing road was in a cut section between two blocks.

Inclinometer readings indicated movement between elevations 885 m to 895 m along a bentonitic rich zone within marine shale. The rate of movement progressively increased from 0.3 mm/day in the lower block (SI6) to 0.9 mm/day in the upper block (SI3/SI203). The block above the road (SI7) did not appear to be moving. The rates of movement indicated the lower and middle blocks were moving independently from the upper block which was loaded with the road fill.

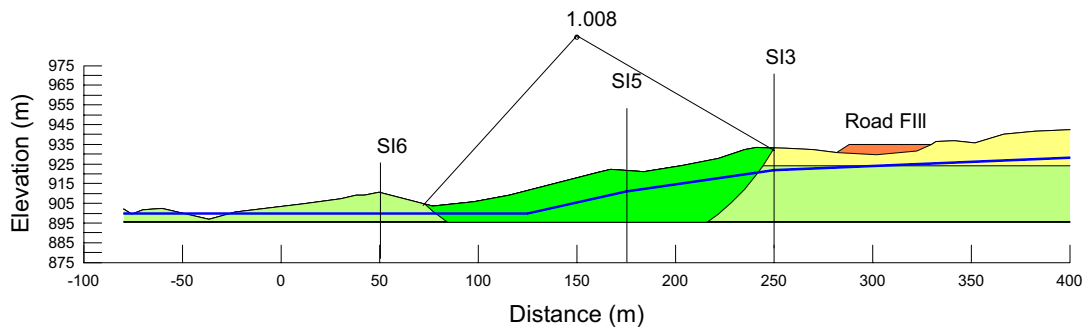
Figure 4: Slope stability of middle block.

The stratigraphy, porewater pressures, laboratory testing and depth of movement were used in conjunction with a digital terrain model to conduct two and three dimensional slope stability modelling. Results of stability modelling indicated the location of the landslide toe was very sensitive to minor changes in the stability model, Figures 4 and 5. The stability modelling also showed the extent of the critical failure did not extend back into the road fill which was believed to have reactivated the landslide. The stability model confirmed the upper block was moving independently from the lower and middle blocks.

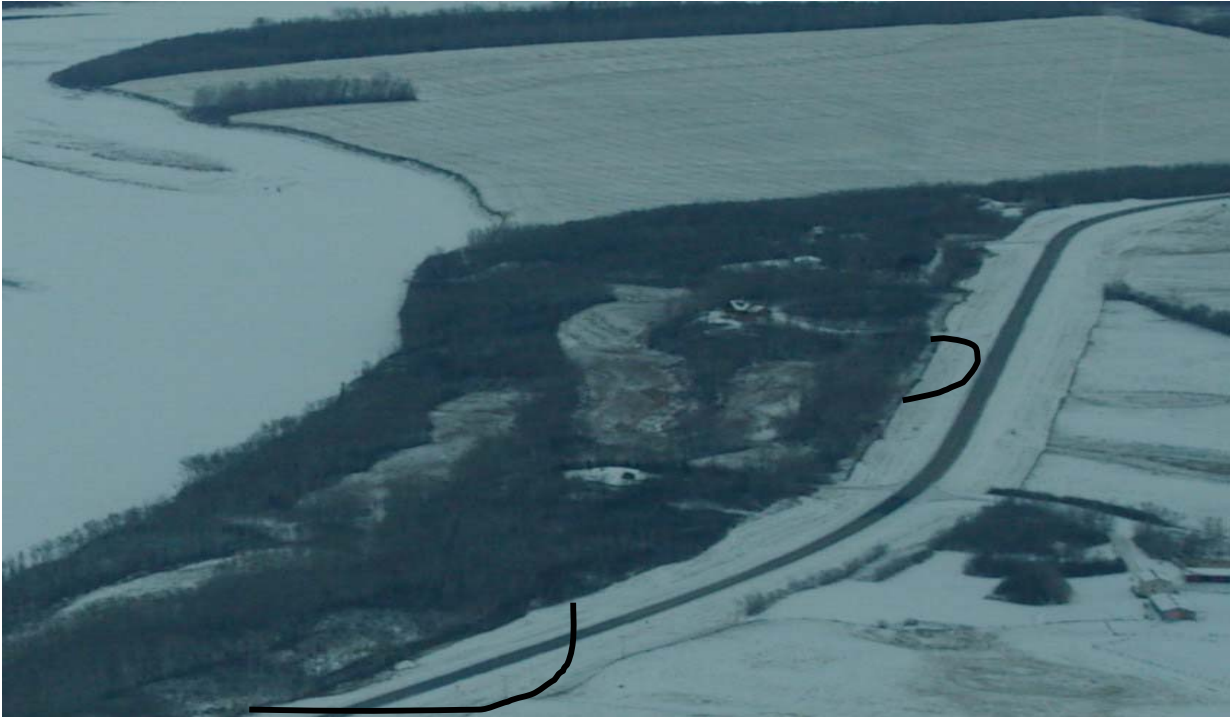
Figure 7: Prince Albert Highway 302 landslide extents. Landslide 4.5 km from penitentiary at bottom left

Two landslides approximately 3.5 km and 4.5 km west of the Saskatchewan Penitentiary at Prince Albert are impacting Highway 302 (Control Section 302-02), Figure 7. The highway is located adjacent the North Saskatchewan River which is actively eroding its river bank, resulting in large retrogressive failures, Figure 8. There are three distinct slump blocks between the highway and the river bank. Locally, there is groundwater discharge along the river bank in the two landslide areas which contributes to the instability of the river bank.

The first failure at 3.5 km west has affected the north shoulder, but the west bound lane is in good condition. The length of the failure at the highway right-of-way was 110 m and the vertical displacement in the sideslope of the highway embankment was 230 mm. The highway at this location is a fill section constructed over the edge of

The second failure at 4.5 km west affects a fill section constructed over a drainage channel. A fourth slump block was forming which crossed the highway into the upslope ditch. The landslide was estimated to be approximately 180 m long along the south shoulder of the highway. A dip in the highway at the west extent of the landslide was evident and signed by SHT.

A risk assessment of the second failure indicated the failure posed a greater risk to the road and public safety. A PF of 15 was assigned to the landslide for the aforementioned reasons of the first failure. A CF of 10 was used because of the risk of road closure and a public safety issue in the event of a sudden large movement. The resulting risk level was 150 which classified the landslide as urgent. Daily inspections and additional instrumentation were recommended.

A slope inclinometer was already in place along the east edge of the landslide above the third slump block; however, another slope inclinometer and a pneumatic piezometer nest were installed in the third slump block immediately below the landslide. The investigation of remedial options is ongoing.

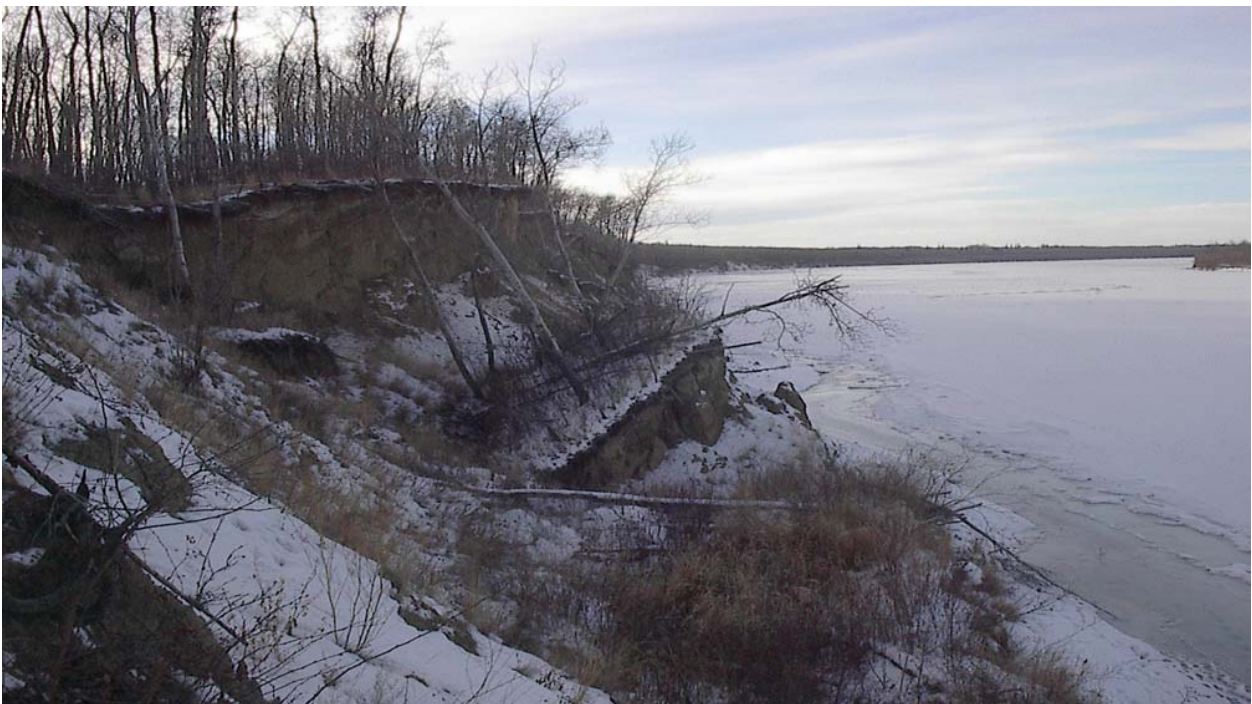
Figure 8: Active erosion along North Saskatchewan River bank
