## THE ENVIRONMENTAL IMPACT OF THE UNDERGROUND CONSTRUCTIONS. CASE STUDY – “MILLENNIUM BUSINESS CENTRE”

Eng. V. Ciugudean-Toma, S.C. METROUL S.A, Bucharest, Romania

Eng. I. Stefanescu, S.C. METROUL S.A, Bucharest, Romania

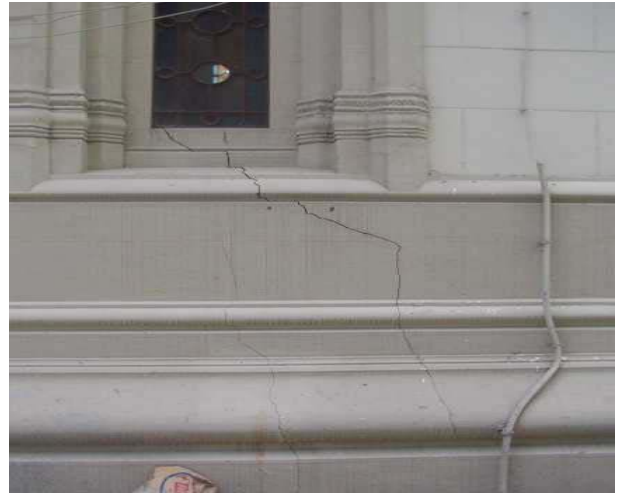
Figure 3. Fissures along Armenian Church wall.

- local collapse of the basement pavement, fissures in foundations and carrying brick walls at the Armenian School,
- fissures in the pavements and basement walls at the Armenian Library,
- increasing some of the old fissures and appearance some new cracks at the Armenian Church,
- fissures down to the pavements parallel with the long side of the precincts with diaphragm walls,
- settlements of the building from Arcului 4
- alterations (limited areas) of the ground stiffness condition from the precincts of buildings placed on Arcului 6, 8 and 10.

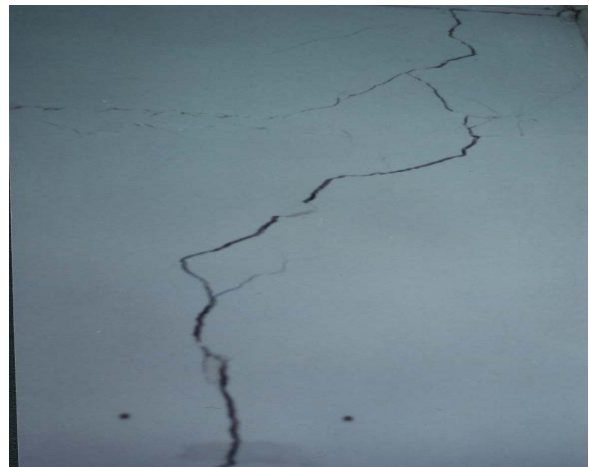
Figure 4. Fissures inside the Armenian School.

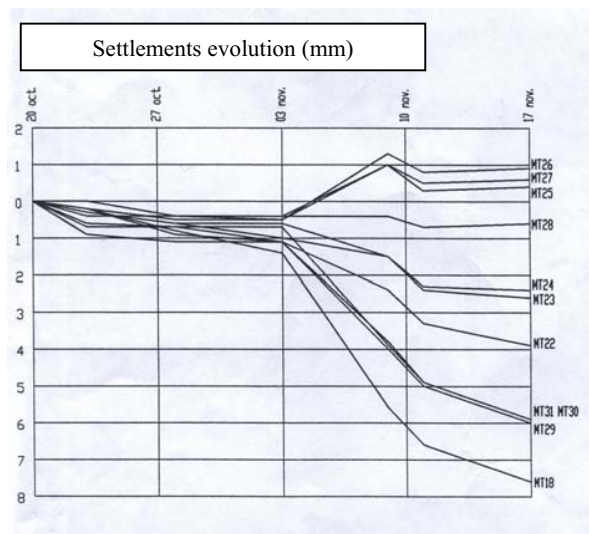
Uneven settlements were as follows (Figure 5):

- 2.5 - 3.0cm at the Armenian Library,
- 1.0 - 5.0cm at the Armenian School,
- 0.0 - 2.5cm at the Armenian Church.

Figure 5. Settlement evolution diagram

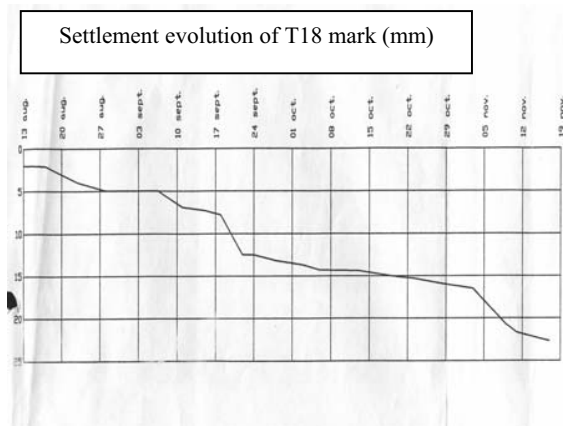
Considering the high density of buildings nearby Millennium Business Centre, and their ages (built on 1910-1915) but also the intense traffic on both thoroughfares, a topometric marks system has been installed in the area since the beginning of the works. These were mensurated and revealed the settlements values of the structures (figure 6).

Figure 6. Settlements diagram

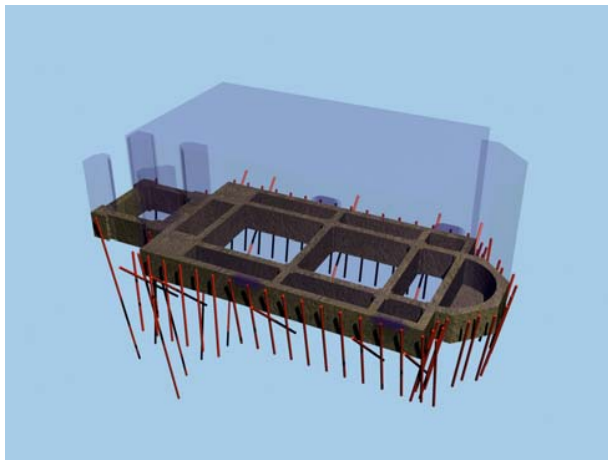
Figure 9. Consolidation groutings at Armenian Church

- immediate interventions for settlements stabilization and continuous erosion of the buildings by groutings at the foundation area,
- final works for the emergency groutings which weren't finished,
- sinked tubes in the basements in order to obtain a compensation of the loosening material by injection and also to bring back the initial state of the ground under the interior walls,
- consolidation performance by groutings using the drillings equipped with socket tubes. The borings were placed outside the buildings, so that the loose ground under the foundations could be consolidated,

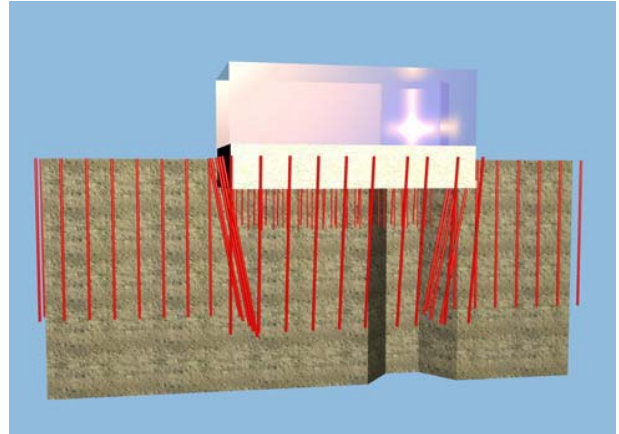
Figure 10. Consolidation groutings at Armenian Library

- sinked tubes into the ground disposed on plane in order to obtain a support for external walls stabilization. Their position wasn't accessible for the boring tool and the degradation situation imposed immediate intervention.

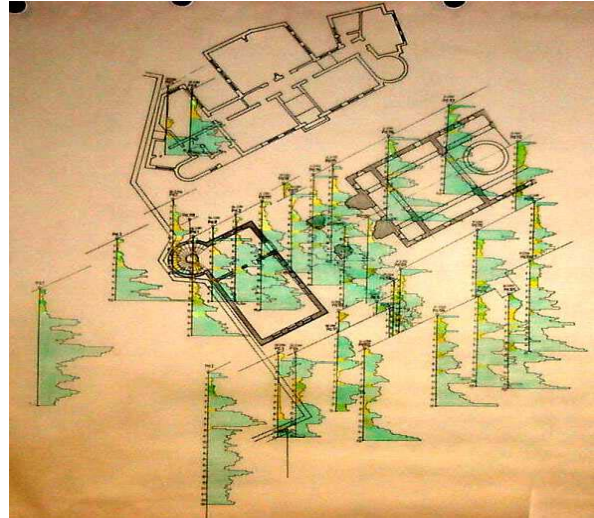
The site positions for penetration tests were chosen on a half distance between two grouting drillings so that the minimum values for consolidation results could be revealed (Figure 11).

Figure 11. Diagrams of penetration tests

- by comparison the points had positive results reflected in major increasing of the penetration resistance as a consequence of improving the state of the ground after groutings
- the points with lower resistance than the standards ones were corresponding with some limited levels marked by significant increase at penetration resistance.

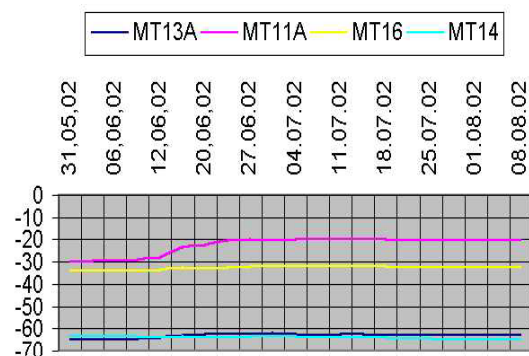
- insert a volume of cca 565mc stone, volume resulted after the grouting stable fluid was strengthen,
- complete stabilization of the settlements (figure 12),

Figure 12. Settlements stabilization

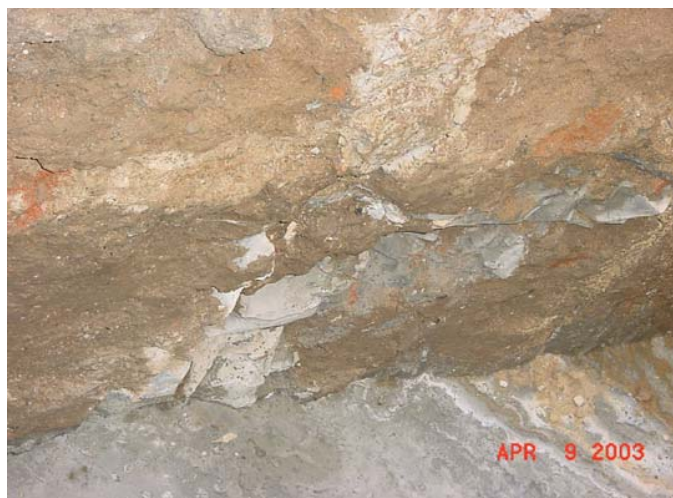
The real confirmation for the consolidation at Armenian Cultural Centre precincts came at once with certification for ground foundation in order to start consolidation works for Armenian Church, when diggings revealed injection areas on chaotic directions from 0.50m to -2.5m (foundation quota). Figure 13.

Figure 13. Forward breakdown groutings.
