STABILIZATION OF A HIGHWAY EMBANKMENT FILL OVER AN ARCH CULVERT USING STONE COLUMNS

Robin Tweedie, Thurber Engineering Ltd., Edmonton, Alberta, Canada
Renato Clementino, Thurber Engineering Ltd., Edmonton, Alberta, Canada
Dimitri Papanicolas, Thurber Engineering Ltd., Edmonton, Alberta, Canada
Roger Skirrow, Alberta Transportation, Edmonton, Alberta, Canada
Gabrielle Moser, Alberta Transportation, Edmonton, Alberta, Canada

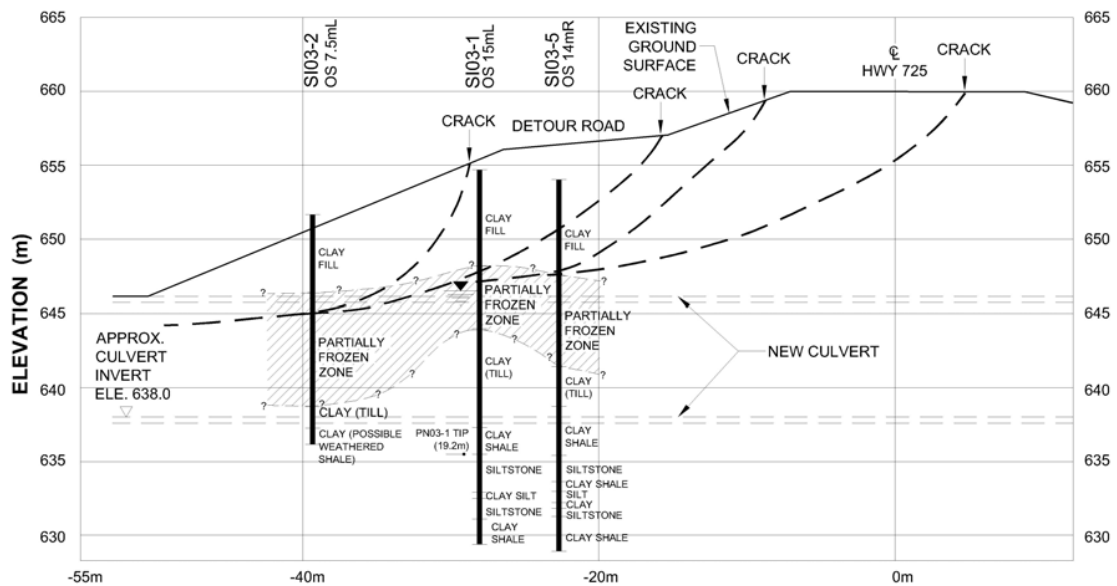
Figure 2. Soil profile of the west slide failure.

When the embankment fill was approximately 2 m below finished highway grade a large slide occurred on the newly constructed embankment side slope above the culvert inlet in late May 2003. The side slope was constructed at a slope angle of 3H:1V and accommodated the detour road near the top of the slope. The back slope above the detour road to the hwy 725 base grade elevation was constructed at a slope angle of 1.5H:1V.

The cracking was first noticed on Saturday (May 24, 2003) at the detour road surface and at the side slope of detour road. On Tuesday (May 27, 2003) the fill failed forming an arc shaped scarp approximately 100 m long at the top of the fill. The scarp dropped approximately 1 m and cracks approximately 10 to 150 mm wide formed. Soil cracks were also observed at the south flank of the slide area.

- Fast fill placement at high moisture content, which may have generated excessive pore pressure in the fill material bringing the effective stresses to unstable condition, or
- Fill placement in a pre-sheared area in the foundation clay reactivating a previous slide.

It was also noted that the backfill around the culvert was well above Optimum Moisture Content and partially frozen (zone of scattered presence of ice and snow in the fill). The failure appeared to be at the interface between the unfrozen and partially frozen fill as shown by the soil profile in Figure 2. There was concern that failure could progress lower into the partially frozen fill during subsequent thawing.

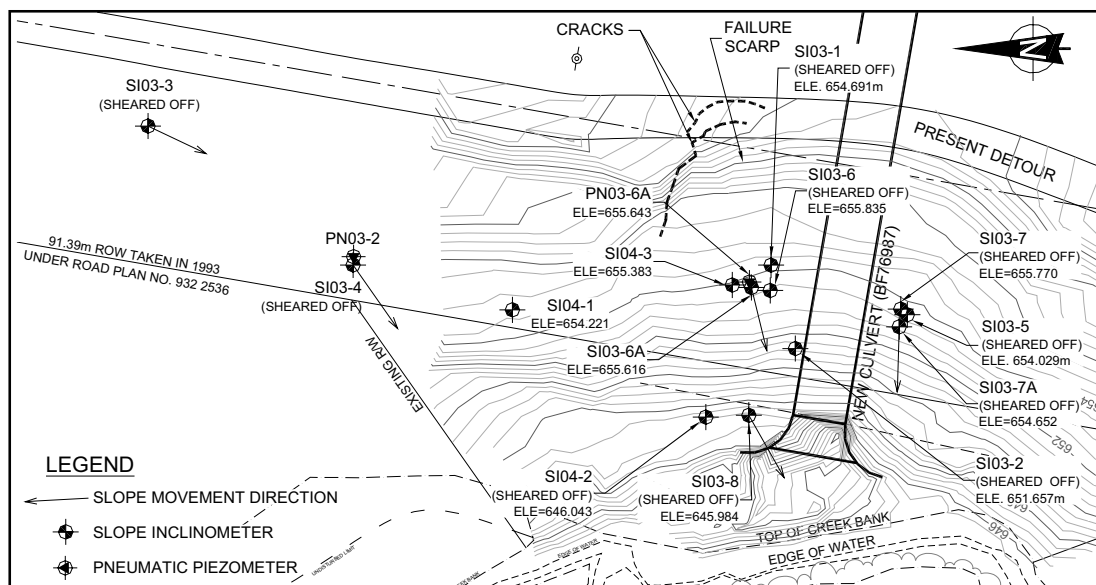
Figure 4. Site plan showing the location of the instrumentation (contour lines represent ground condition after west slide failure)

The locations are shown in Figure 4. The initial inclinometers 03-1 and 03-2 had sheared off at depths of 8.5 m and 6 m, respectively, before they could be initialized one day after installation, indicating the fast rate of slope movements. SI 03-3 and 03-4 installed in the northwest slope did not show any discernible movement over the initial several days.

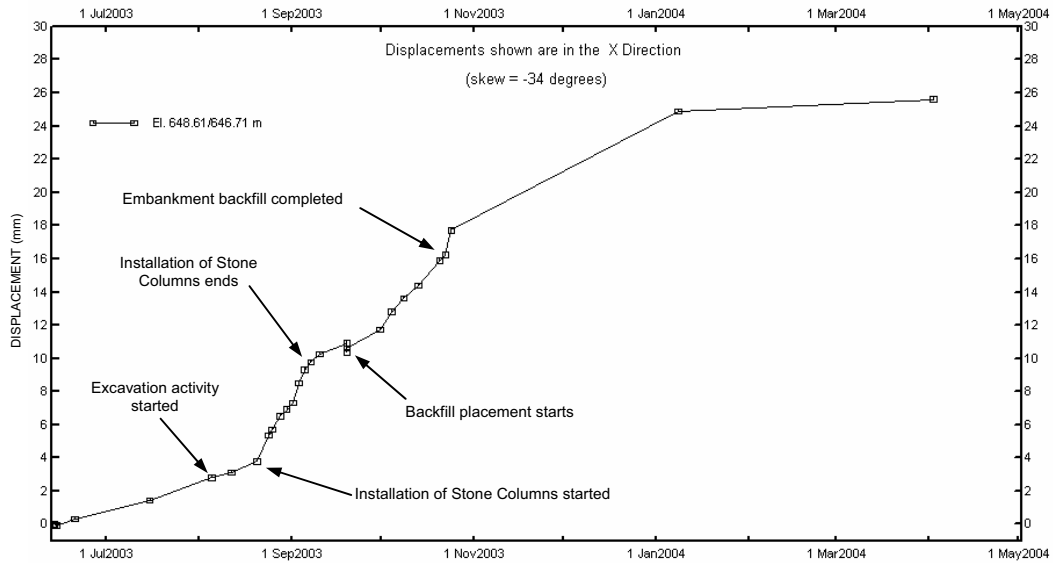
Figure 5. Northwest slope rate of movement with time (SI03-3).

Slope movements in the northwest valley slope were detected at depths of 17.3 and 17.5 m (approx elevation 638.7 and 647 m). These movements increased during the embankment excavation in August 2003, and decreased once backfilling of the embankment was underway. A history of the northwest slope rate movements is shown in Figure 5.

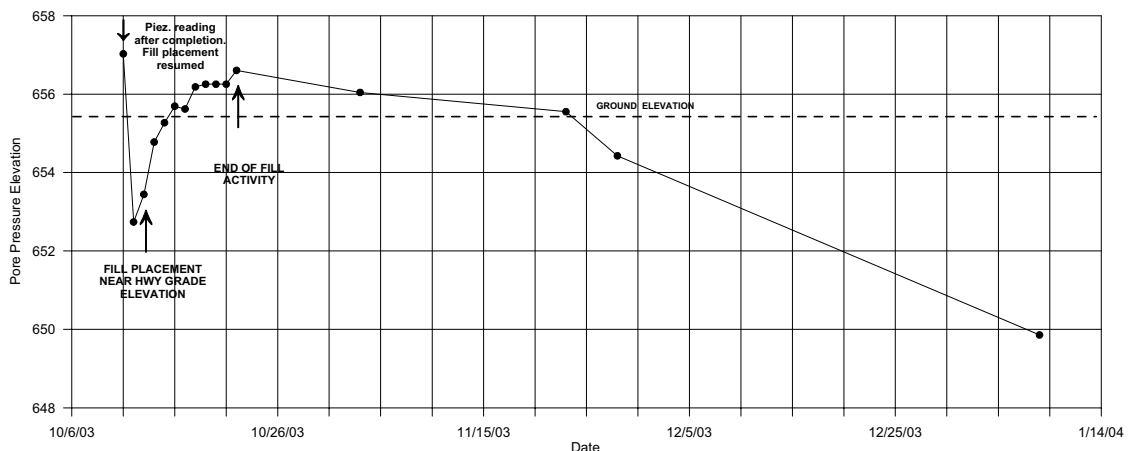
Figure 6. Pore pressure measurement during and after construction.

A pneumatic piezometer was installed in between the stone columns to monitor construction pore pressures during embankment reconstruction. High pore pressures developed in the clay fill during backfilling and significant

lateral spreading occurred within the stone column reinforced zone. The pore pressures have dissipated since construction as shown on Figure 6.

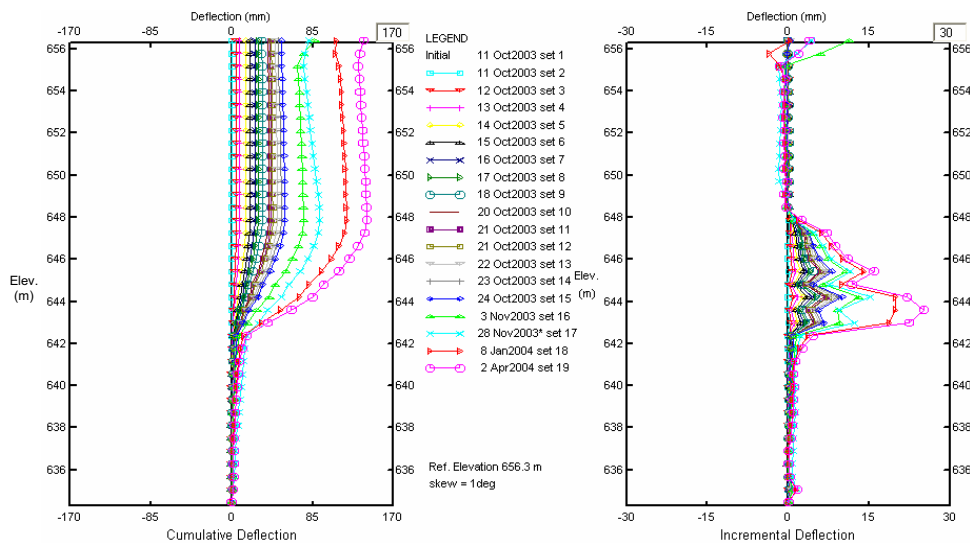
Figure 7 – Slope indicator (SI03-6A) readings at resultant direction.

The west embankment fill initially underwent significant deformation during and following fill construction (Figure7). The movements have slowed down as shown on the rate of movement plot in Figure 8 and the current rate of movement is 82 mm/year.
