Lessons Learned From Failure of High Embankment Excavation Slopes at Culvert Replacement Sites in Alberta

Roger Skirrow, Technical Standards Branch, Alberta Transportation Edmonton, Alberta
Gabrielle Moser, Technical Standards Branch, Alberta Transportation Edmonton, Alberta
Robin Tweedie, Thurber Engineering Ltd., Edmonton, Alberta
Dimitri Papanicolas, Thurber Engineering Ltd., Edmonton, Alberta

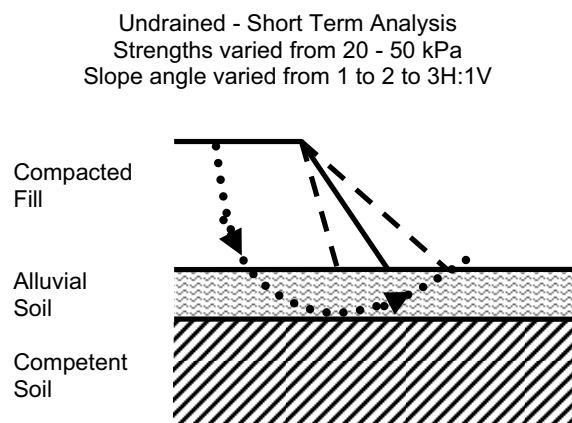
as an aid to gauging the severity of the problem. As shown in Figure 1, the parametric analyses used: excavation depths of 2, 5, 10 and 20 m; cut slopes angles of 1H:1V, 2H:1V and 3H:1V; embankment and foundation undrained strengths of 20 to 50 kPa.

Figure 1: Parametric Slope Stability Analysis

The analysis showed that satisfactory stability conditions were present for the condition of a weak embankment overlying a weak foundation soil for burial depths less than about 6 m. A factor of safety of 1.1, based on an undrained analysis, was used as the acceptance criterion for the stability assessment. The parametric analysis was then related to the risk framework with the results shown on Chart 2.

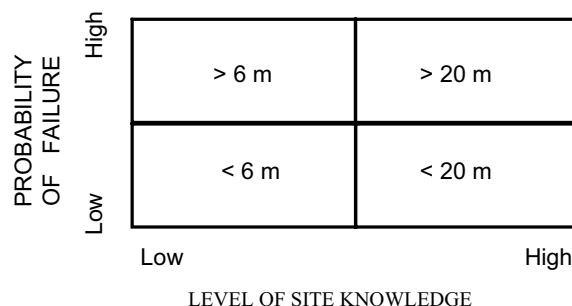
Chart 2: Risk Matrix Related to Stability Analysis

Chart 2 may be interpreted to show that for culvert burial depths of less than 6 m, only a low level of site knowledge is required in order to provide a low probability of failure. For burial depths greater than 6 m a low level of site knowledge may result in a high rate of site failure. A high level of site knowledge produces a low probability of failure for burial depths less than 20 m, while even a high level of site knowledge may be insufficient to produce a low probability of failure for very deep burial depths.

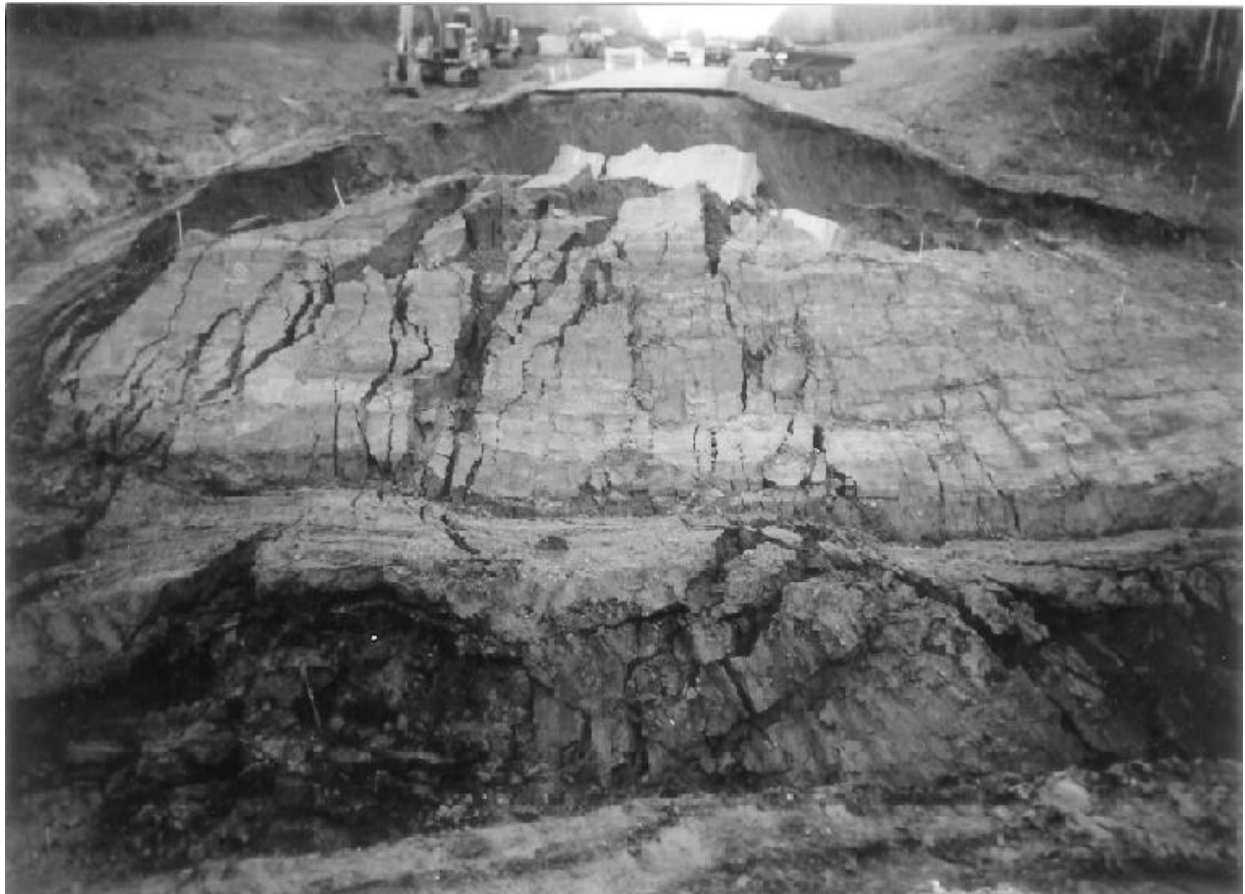
The excavation done for the culvert replacement followed the excavation profile shown on the Department standard drawing S-1418-93 "Installation of Large Steel Pipes". This drawing shows an excavation using 1H:1V sideslopes and a minimum undercut below the culvert base of 0.6 m. One small-scale failure occurred on the east cut slope during excavation. This slide was followed by a large-scale failure that involved the entire west excavation slope, as shown on Figure 2. The exposed cut slopes were further flattened to stable slopes. An additional slide occurred during fill placement that damaged the new culvert.

Work was shut down for several weeks while the situation was evaluated, geotechnical investigations were completed, and obligations and contractual issues were resolved. The slide was attributed to a artesian

groundwater conditions that saturated the lower portion of the embankment fill, and the presence of weak foundation soils; conditions which would have been identified during a geotechnical investigation during the culvert design process.

Figure 2: Excavation Slope Failure, Hwy 88 Culvert Replacement Project
