HYDROLOGY OF THE CENTRAL MANITOBA MINE TAILINGS

Michael W. Gupton, University of Manitoba, Winnipeg, Manitoba
Barbara L. Sherriff, University of Manitoba, Winnipeg, Manitoba
Caius Priscu, AMEC Earth and Environmental, Winnipeg, Manitoba
Jamie F. VanGulck, University of Manitoba, Winnipeg, Manitoba

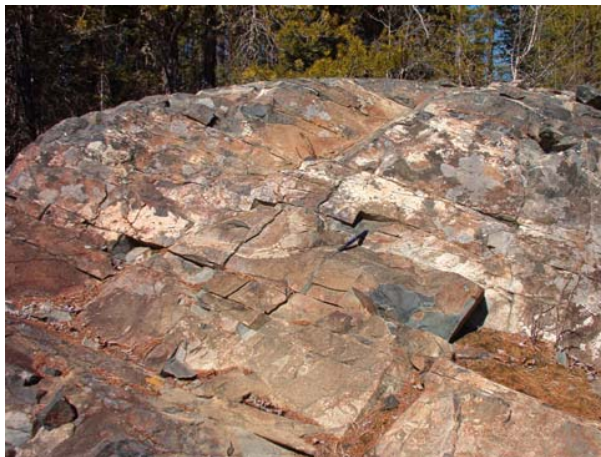
Erosion across the site is most evident in areas adjacent to rock outcrops and coincide with the higher elevations and the location of the tailings discharge point. It was observed that some fractured rock outcrops located adjacent to the tailings deposit, discharged groundwater that drains onto the tailings site as surface water (Figure 2). Erosion was prominent in these areas and exposes non-oxidized material to the atmosphere promoting their oxidation.

Figure 2. Photograph of rock fractures along north boundary rock outcrop.

The upward component of groundwater flow may be the result of groundwater discharging from fractured bedrock beneath the tailings related to the North Carbonate Shear. Rock fractures 0.001 - 0.010 m wide were observed in the

outcrop along the north boundary of the site measured 0.10 - 0.50 m striking 110° azimuth, dipping 60° with fractures measuring 0.10 - 0.30 m normal to those (Figure 2). Water was observed flowing from several fracture locations that were sourcing increasingly expanding rills sprawling onto the tailings in May 2004. In cross-section A - A' (Figure 9) the hydraulic head for October 2003 follows the general shape of the surface topography. May 2004 measurements of hydraulic heads were the highest recorded. Water was observed seeping up out of piezometers # 5 & # 6 further confirming an upward component of groundwater flow at the site. In addition,

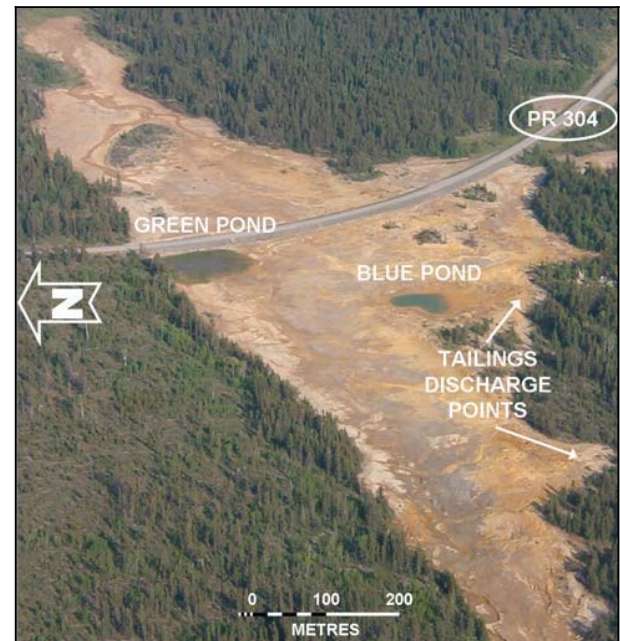
Two ponds located on site were used as landmarks and were referred to as the “blue pond” and the “green pond” (Figure 3). The blue pond is coloured by a high concentration of copper sulphate and a pH of 4.5 resulting in an absence of plant life. The green pond is bounded by the road on the east, has a pH of 7.5. The green pond supports horsetails, frogs, and sandpipers, which is in sharp contrast with the environment developed around the blue pond just 150 m away.

Figure 3. Aerial photo taken May 2003 showing landmarks Green pond, Blue pond, and PR 304 looking easterly.

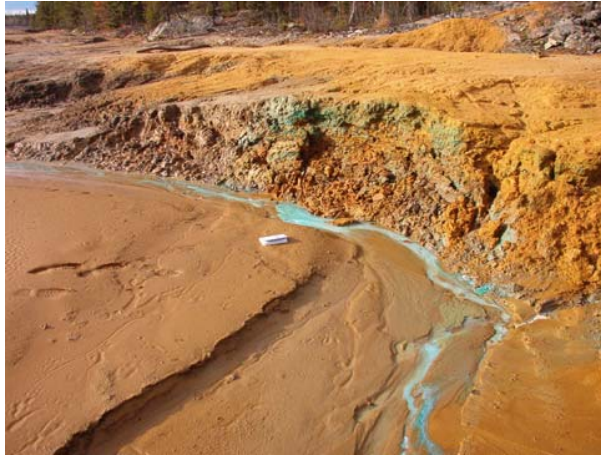
Erosion of oxidized material in areas of high topographic relief has exposed large quantities of underlying sulphide bearing non-oxidized tailings (Figure 5). Desiccation of the

tailings adjacent to the areas of high relief resulted in 0.1 - 0.2 m vertical and 0.1 - 0.3 m horizontal cracks throughout the site perpendicular to the sides of gullies. It is likely that these cracks fill with water during a rainfall event, thereby creating hydrostatic water pressure acting against a block of oxidized tailings material. When the fluid pressure exceeds a critical value, the block of oxidized tailings falls into the gully. This erosion process tends to expose non-oxidized tailings to oxygen and further desiccation and surface crack formation occurs.

Figure 5. Photograph showing erosion and surface drainage near piezometer # 5.

The erosion process continues to occur forming a deeper and wider gully over time. Exposing sulphides contained in the non-oxidized tailings produce acidic conditions, which can promote leaching of metals, such as copper and ferrous iron. Acidic waters are associated mainly with erosional activities of the surficial layers of tailings due to surface runoff (Sherriff et al. 2001). Evaporite minerals precipitate causing red and turquoise colouration.

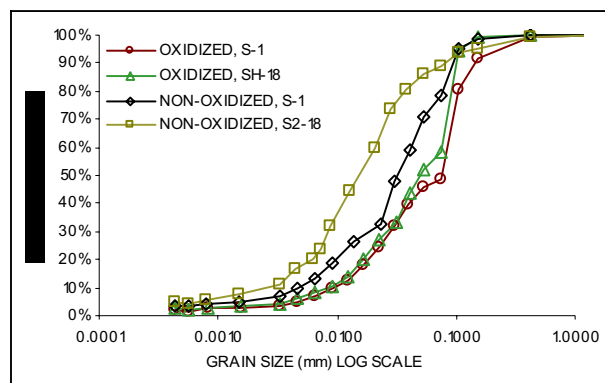
Differential settling resulted in the sand size fraction accumulating closer to the point of discharge along the south side of the deposit and the silt and clay size fraction accumulating further down gradient. Particle size curves for the non-oxidized tailings of samples taken near piezometer # 1 (150 metres from the discharge point) and near piezometer #18 (approximately 500 metres from the discharge point) reveal a dependency of distance from discharge location. The difference in grain size distribution between # 1 and # 18 indicate differential settling with respect to distance from discharge, whereas the oxidized grain size distribution curves from # 1 and # 18 show increased size due to the alteration rim, and not differential settling.

The grain size analysis (Table 2 and Figure 6) indicates that the alteration of the oxidized grains, subsequent to deposition, has increased particle size rather than decreased it by dissolution; however, the specific gravity between oxidized and non-oxidized tailings remained similar.

Figure 6. Grain size distribution curves for oxidized and non-oxidized tailings (sieve and hydrometer analyses).

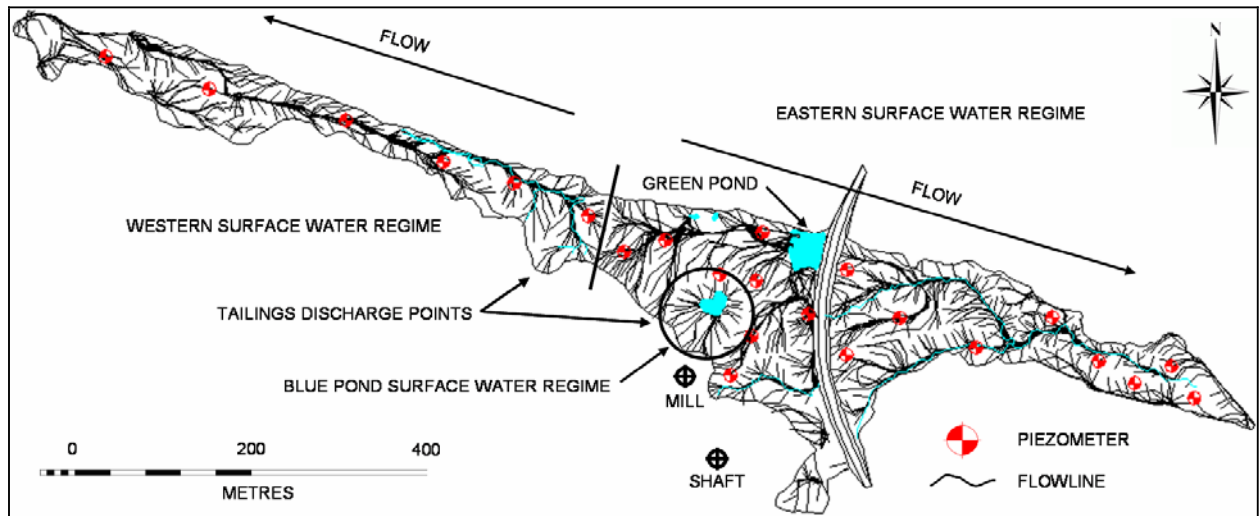
the site (Figure 7). Three separate surface water regimes can be identified, the western, eastern, and the blue pond. The eastern regime has an area of 9.2 ha with surface water flow constricted by the culvert under PR 304. Upon exiting the culvert, surface water flow follows a dendritic pattern traversing the remainder of the site easterly, finally dispersing into a bog. The western regime has an area of 5.8 ha and one central stream flows west draining the tailings area into a bog. The third and smallest surface water regime is the blue pond regime with an area of 1.0 ha. This regime is circular, bowl shaped and hydraulically isolated from the eastern and western regimes. The blue pond drains the surrounding outcrops that included the mill and shaft sites (Figure 7). The surface elevation of the blue pond was approximately 0.30 metres higher than the green pond in June 2003.

Flow lines generated by the DTM coincide with the rock outcrop boundaries, rills, and streams, which were surveyed in June 2003. Each flow line extending from the tailings boundary represents a path for water to drain onto the site from surface drainage from the surrounding soils, outcrops, and/or water discharge from fractures adjacent to the tailings (Figure 7). The green pond is hydraulically isolated due to impoundment from the road on the east, the rock outcrop to the north and topographically high elevations on the south preventing flow into the culvert. Water drains into the green pond from approximately one quarter of the tailings west of PR 304, excluding the blue pond regime (Figure 7).

Figure 7. Digital Terrain Model DTM of the site showing surveyed gullies, flow lines, and the Western, Eastern and Blue Pond surface water regimes.

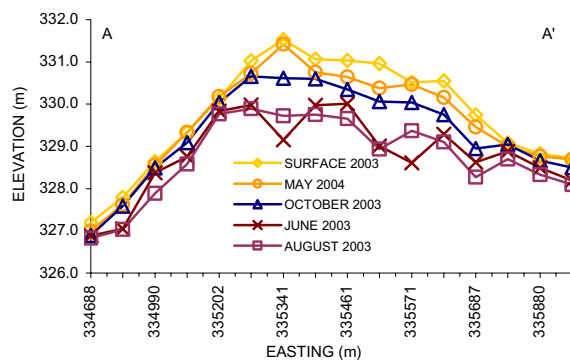
Figure 9. Cross section A-A' showing the surface elevation and groundwater table elevations measured in June, August, October 2003, and May 2004.

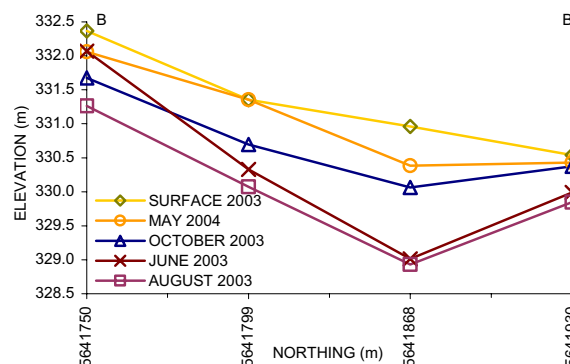
Cross-section B - B' groundwater table measurements (Figure 10) show the hydraulic head is higher at the edges of the site compared to the middle which also indicates recharge to the tailings from the underlying bedrock near the edges of the deposit.

Figure 10. Cross section B-B' showing the surface elevation and groundwater table elevations measured in June, August, October 2003, and May 2004.
