CHARACTERIZATION AND REMEDIATION OF A CHLORIDE-IMPACTED AQUIFER IN NORTHWESTERN ALBERTA

Laurra P. Olmsted, Matrix Solutions Inc., Canada
Robert Boyce, Devon Canada Corporation, Canada

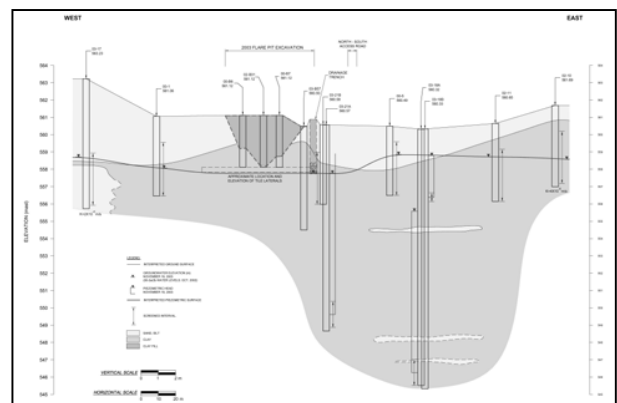
Figure 3: Hydrogeological Cross-Section across the Site.

The soil beneath the site consists primarily of sand overlying fractured clay deposits. The sand unit ranges between 0.8 and 4.5 m thick and is found everywhere beneath the site. The thickest sand deposits are found in the central portion of the site and off-site to the west and southwest. The sand is described as brown to grey, mottled and varying in silt content. It tends to be very fluid, particularly east of the grid road as witnessed during installation of the monitoring well 03-19. The upper surface of the clay is highly variable with channels eroded into it as illustrated on the cross-section (Figure 3). The fractures in the clay unit are sometimes open but are also sand-filled in places. The fractures were larger and/or were more frequent in the upper 5 m of the unit. The clay is described as brown to grey, mottled, firm to stiff with medium to high plasticity. Discontinuous sand lenses within the clay (between 0.1 and 0.3 m thick) were noted between 5.7 and 13.5 m in borehole 03-18a on the eastern part of the site. The thickness of the clay is not known as bedrock was not encountered during drilling. The maximum depth of drilling was 14.8 m bgs.

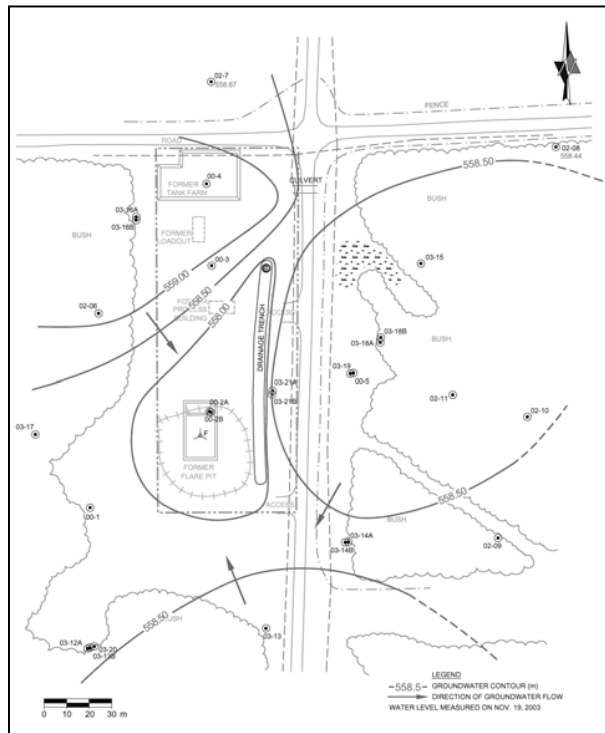
The water table is as shallow as 0.9 m bgs with seasonal fluctuations of 0.6 m. The water table is fairly flat beneath the site, although minor differences in elevation are evident in the centre part of the site, due to delayed

recovery following extraction of water from the culvert. The culvert is currently pumped only during the snow-free months when access to the site is possible. At the time of monitoring, the maximum difference in elevation of the water table is approximately 1 m with the lowest point in the area of the drainage tile, trench and culvert. This is illustrated in Figure 4.

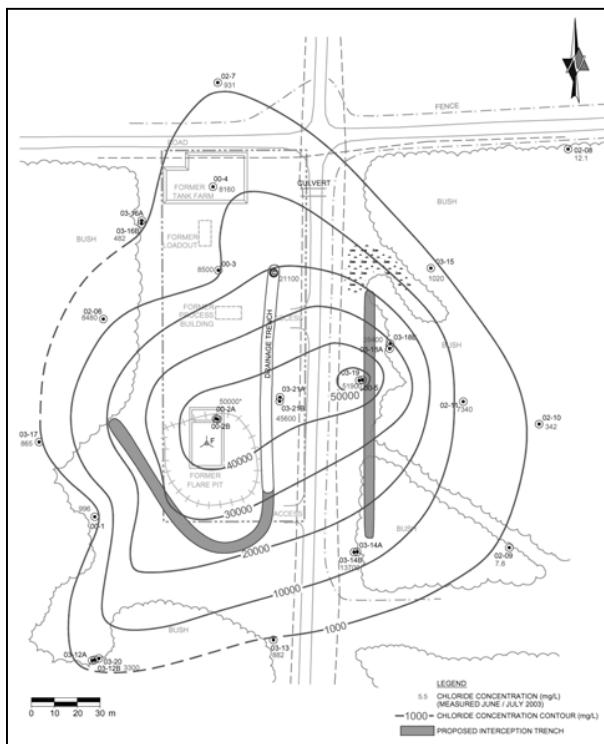
Figure 5: Concentration of Chloride in Groundwater and the Proposed Extension of the Groundwater Recovery System.

Chloride impacts were detected in 22 of the 24 groundwater monitoring wells, located both on the site and off the site to the east. Concentrations of chloride are presented on Figure 5 with the maximum concentration detected in well 00-5 of 51,900 mg/L. The concentration in this well increased from 25,000 to 51,900 mg/L in less than 8 months, prompting remedial measures to be increased.

Produced water impacts to soil and groundwater are widespread. The likely source of the impacts was the former flare pit and the produced water likely migrated from the flare pit through the sand unit during periods of high precipitation. Groundwater impacts appear to attenuate with distance from the source but are observed at radial distances of at least 75m to 130 m from the source. The estimated area of impact is in excess of 54,000 m². Groundwater impacts attenuate with depth but are observed to depths of at least 14.8 m off lease to the east with a concentration of chloride of 9,260 mg/L in monitoring well 03-18a east of the road.

It is proposed that the existing recovery trench would be augmented with additional recovery trenches as shown in Figure 5. The trenches would be excavated to approximately 4.5 m depth and would be filled with gravel. They would be installed with automatic pumps that would empty to an onsite tank, which would be emptied as needed. This system is currently designed for summer-only operation; however it may be augmented to operate

year-round. It is estimated that significant decreases in the chloride concentration within the 10,000 mg/L contour line would be reduced within 30 years based on one pore volume recovery.
