Remedial measures planned to prevent surficial failures

Kenneth L. McCleskey

United States Army Corps of Engineers (USACE), Fort Worth, Texas, USA

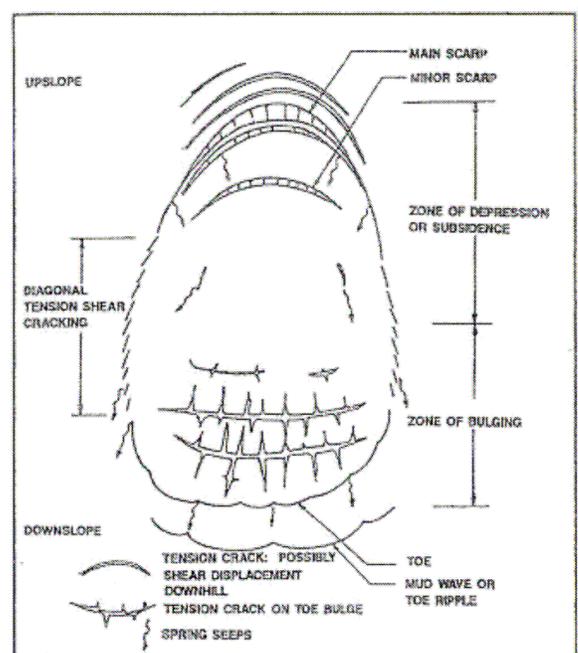
Figure 1 indicates the schematic of typical surficial failure. During summer or periods of drought, desiccation cracks are induced by evaporation of water and the consequent shrinkage of the soil (Omidi et al, 1996). Clay soils tend to shrink during drying due to development of substantial matric suction in the pore structure of fine grained soils. The depth of desiccation cracks were reported in the literature increasing from a few centimetres to over 10m (33 feet) (Nahlawi and Kodikara, 2006). When it rains, water infiltrates into the soil through the desiccation cracks. As the wetting front increases, the permeability parallel to slope increases and thus the seepage occurs parallel to the slope (Day, 1996). Infiltration increases pore water pressure which leads to reduction of shear strength triggering failure (Rahardjo et al, 1994, Cho et al, 2002). Apart from rain fall intensity, other factors such as rainfall characteristics, antecedent precipitation, soil characteristics, topography also

Figure 1. Plan view of typical surficial slope failure (Source: Abramson et al, 2002)

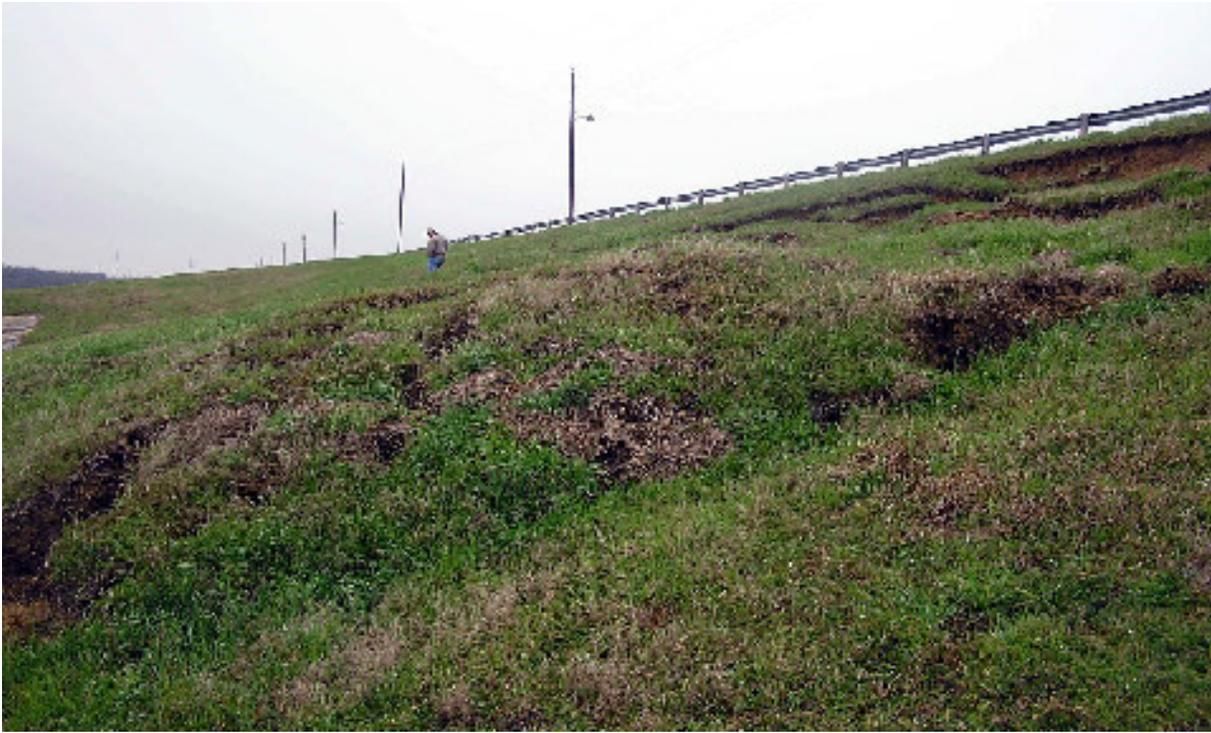
A typical skin slide occurred at Grapevine Dam in Texas State of USA is shown in Figure 2. Various other failures recorded at the same dam is listed in Table 1.

As per the available records the depth of the surficial failure is varying from 0.3 to 2 m. There were occasions that on the same day more than one failure were noticed at different locations. Majority of the failures occurred nearer to the crest on the slopes. It can be seen from table 1 that antecedent rainfall is the primary reason to trigger most of the surficial failures. Analysis of typical failures presented below gives further insight. .

Figure 2. A Surficial slope failure at Grapevine Dam, Texas, USA

The skin slides at Grapevine Dam were repaired using a variety of techniques with varied success. In most cases, initially the loose soil from the skin slide location was removed and after doing proper benching, the bank was repaired with same soil or using borrow pit soil. Subsequently, lime was mixed with soil and the mixed soil was properly filled and compacted as per specifications. The repair costs of the slides are running into millions of dollars.

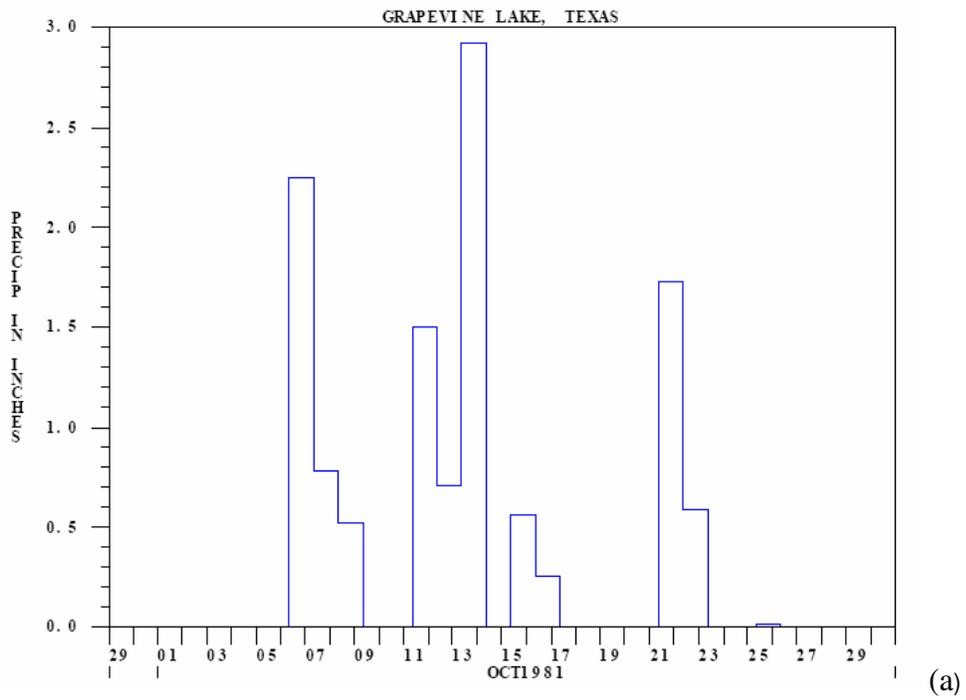
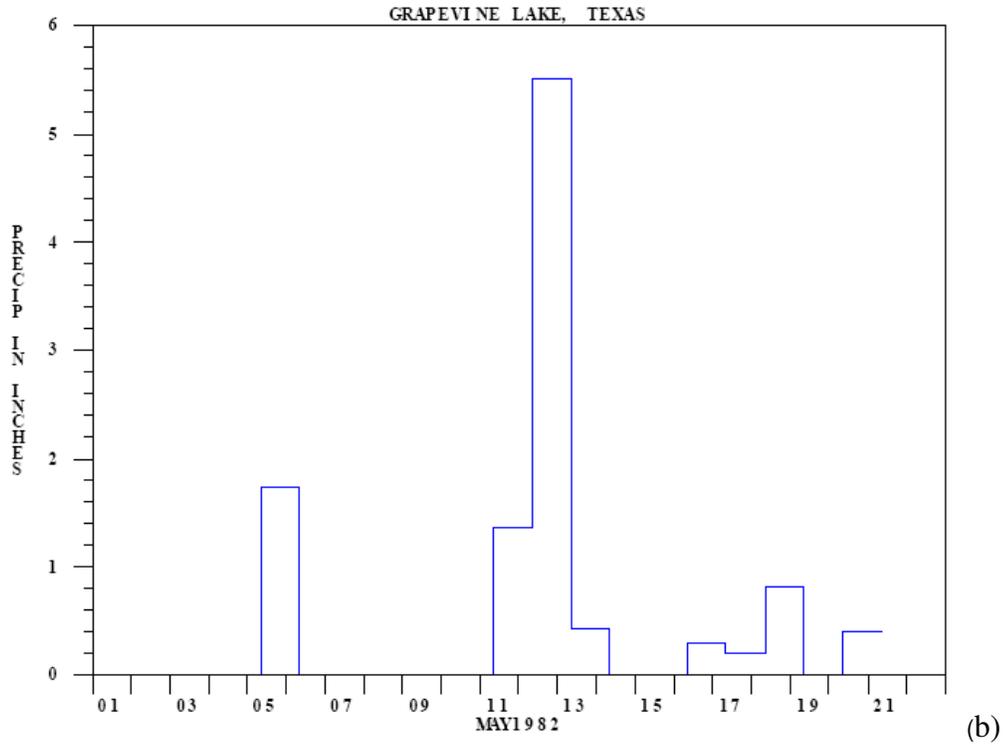
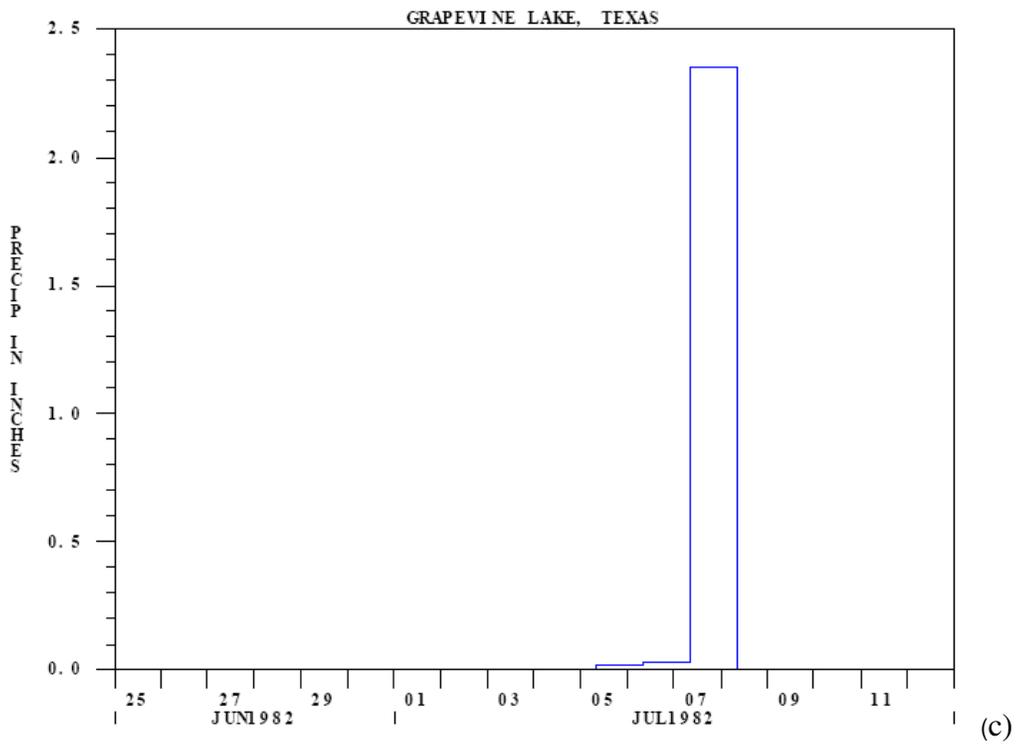
Figure 3. Precipitation graphs showing daily rainfall a) October 1981, b) May 1982 c) July 1982 (Source: USACE)

Figures 3 (a) to (c) gives the details of daily rainfall for few typical failure cases cited in Table 1.

Figure 3(a) revealed that during the month of October 1981, there was rain for about 10 days and the highest intensity of rainfall occurred on October 14th. It can be construed that the infiltration of rain water and extension of the wet front resulted in a reduction of matric suction and shear strength triggering the slope failure observed on October 27th. It can be seen from Figure 3 (b) that there was rain on May 19th, 1982 when the skin slide occurred. This slope failure was preceded by a high intensity rain fall of 140 mm during the week prior as well as intermittent rainfall during the preceding weeks. It can be construed from Figure 3(c) that the failure on July 9th, 1982 was triggered with a rainfall intensity of 40 mm just prior to 2 days. However it was observed that for the failure occurred on March 13th, 1989 there was very scanty rainfall prior to the failure which underlines the caution to be observed while investigating the cause of failures.

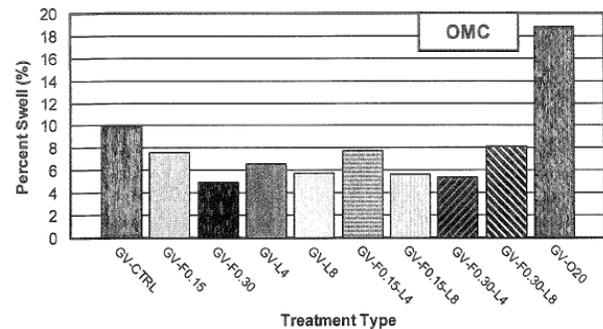
Figure 4. Vertical free swell results

Figures 4 and 5 indicate that swell and strain were controlled when the soil is treated with fiber and lime. Compost-treated soil exhibits high swell and shrinkage with respect to other treatments. However, the inclusion of compost helps preserve soil moisture which mitigates the formation of desiccation cracks.

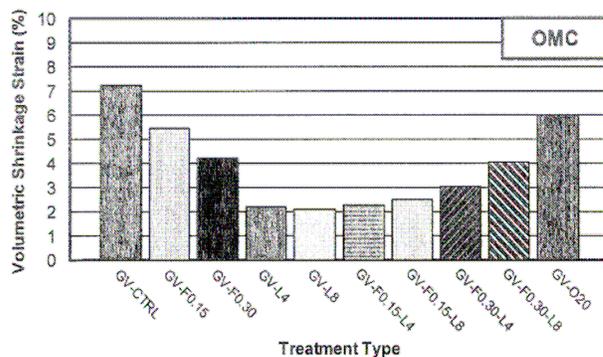
Figure 5. Volumetric shrinkage strain results
