Micropile and Low-Mobility Grouting Foundation Remediation for a Coastal Development in Barbados

J. P. Dittrich, T. G. Carter, J. L. Carvalho
Golder Associates Ltd., Mississauga, Ontario, Canada
 D. A. Bruce
Geosystems L.P., Venetia, Pennsylvania, USA

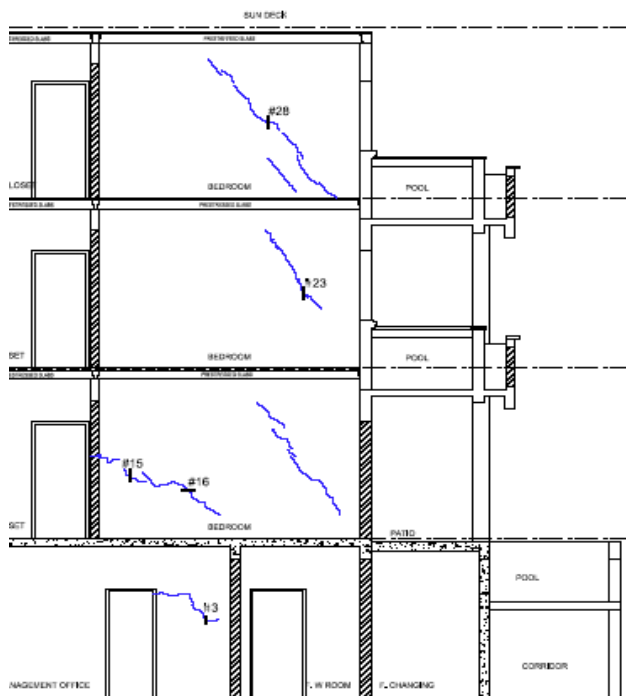
The distress cracking that appeared in the building was generally of several metres in lateral extent and in configurations of structural significance. The cracking appeared on all five levels of the main floors of the building (Level 1 to 5) and also in the basement (Level 0). However, the majority of the cracking was concentrated in the northwest corner of the building, principally in the basement and on the first, second and third floors.

In general the cracking typically comprised $\sim 45^\circ$ oriented flexural shear cracking, however some sub-vertical ($\sim 90^\circ$) cracking was also observed. Based on the data plotted for the cracking, two different frameworks of cracking were identified. One of the sets of 45° flexural shear cracks dipped towards the sea (to the west) within the east-west building walls, (as shown on Figure 1) and the second set dipped towards the gully (to the north), within the north-south structural walls.

Figure 1. Shear cracking the east-west building walls.

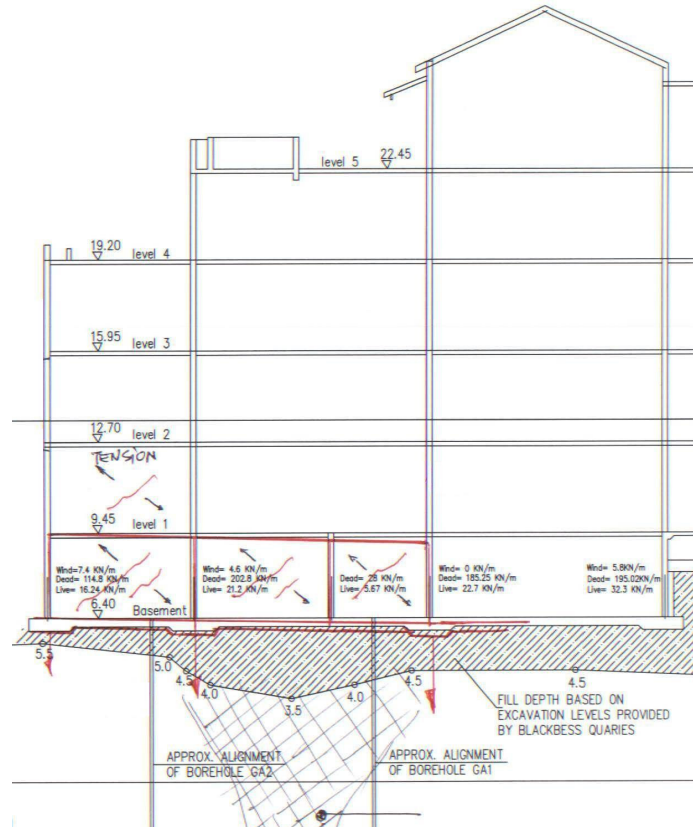
As shown on Figure 2, the fact that the northern half of the building was constructed with a lower foundation level than the southern half as a result of the basement may well have locally complicated the building response and been a key factor in the building behaviour. As described previously, the excavations undertaken for the basement level construction likely removed any of the harder and more competent coralline cap that would have originally existed on the surface of the site in this area, and this may have exacerbated the settlement response. Further, in this area, because of the basement, an additional floor level was created resulting in higher foundation loads in the northern half of building. This and the fact that because of the lower founding elevation, higher loads were transferred to the weaker, vuggy/voidy foundation conditions at depth further complicated building response. Finally, the reinforced concrete mat/floor slab foundation in the northern half of the building would have resulted in load spreading and distribution to a greater depth (into the weaker and more voided coralline strata at depth) than would have been experienced below the narrow strip

footings (perched high in the relatively more competent coralline cap) below the southern half of the building.

Figure 2. Northern half of building with basement.

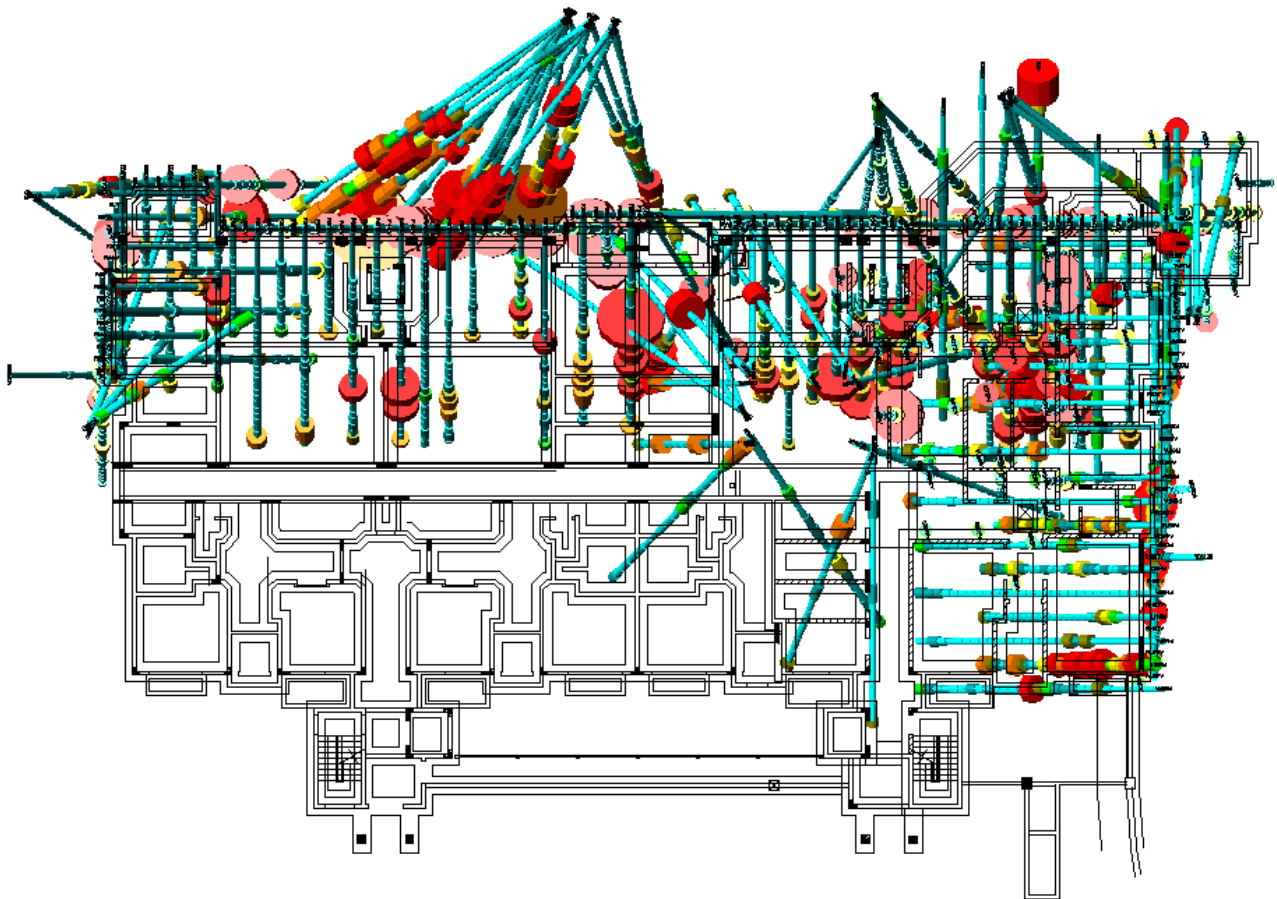
During the course of the remediation work, the conditions encountered during drilling and the volume of grout injected (or 'take') at discrete depth intervals in each hole was carefully recorded. In this manner, the geological model developed as part of the remediation design phase and formulated into the numerical modelling was adjusted and refined as construction proceeded. Refinements to design understanding and layouts were undertaken in near real-time as additional subsurface information was obtained during the remediation construction. Records were updated daily and the grout-take data was tracked using 2-D and 3-D graphical models so that the poorest conditions (i.e. most voided) in the subsurface could be readily identified. These areas were then targeted with additional grout-only holes during the course of the production work and then ultimately with a series of closure holes at key locations in the perimeter/cut-off wall. Figure 3 shows a typical key view from the 3-D grout-take model.

At the completion of the works, data had been acquired from the drilling and grouting of 174 micropiles, during which 750 m³ (1000 yd³) of low-mobility grout was injected into the voided areas of the foundation around the perimeter and below the interior of the building.

Figure 3. Plan view from 3-D grout take model.

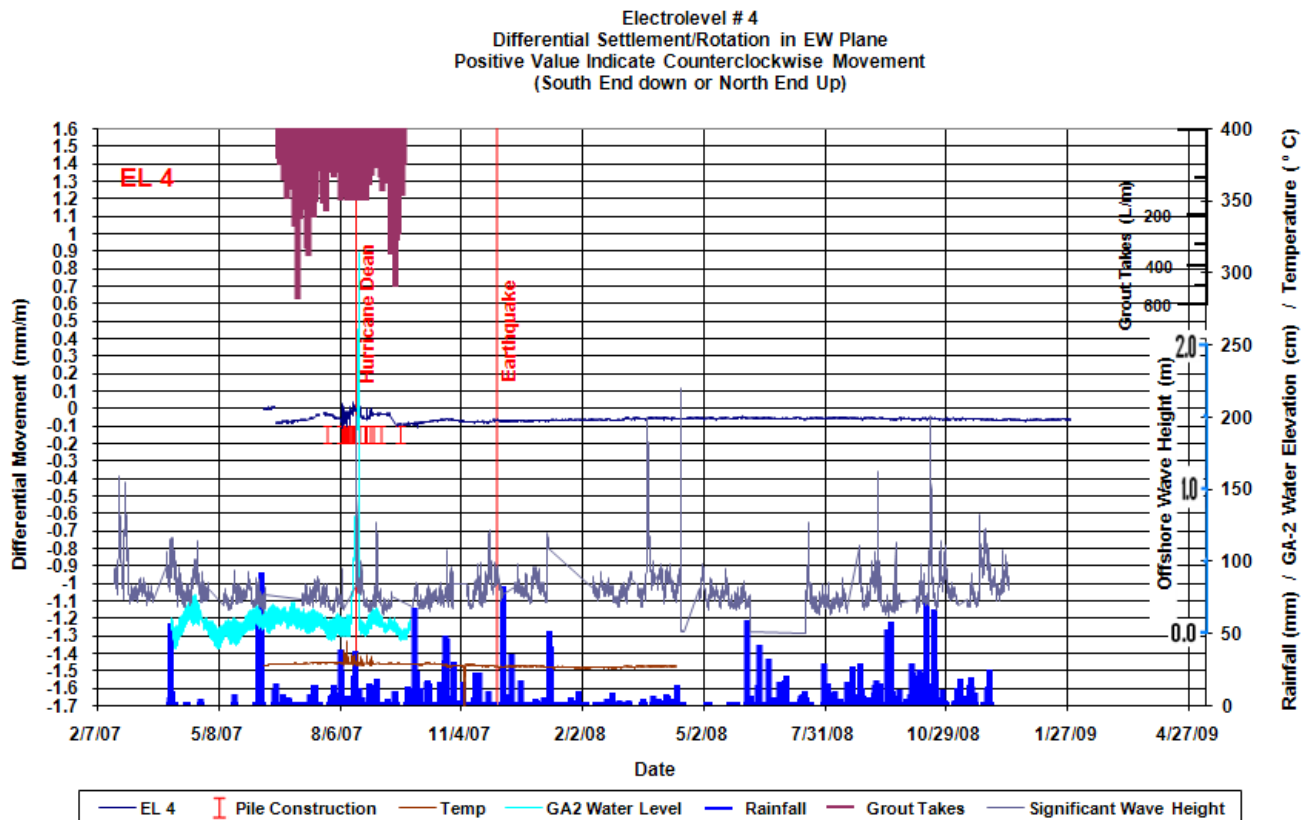
The monitoring instrumentation data (as seen in the typical electrolevel data plot on Figure 4) showed the building responding to the grouting by initial downward (i.e. settlement) movement as a result of the drilling/injection/flushing/disturbance to the poor subsoils by the micropiling operations, followed by upward (i.e. heave) movement as a result of the pressure grouting operations. In general a trend of increasing stabilization was observed in the instrumentation throughout the remediation program, as each area of the building was underpinned and grouted.

Upon completion of the foundation remediation, a selected number of the electrolevels (including Electrolevel EL#4 shown on Figure 4) and precise levelling points (including PLP-BB shown on Figure 5) were left within the structure to allow continued monitoring to assess the post-construction and long-term performance of the building.

Figure 4. Building monitoring data from electrolevel.

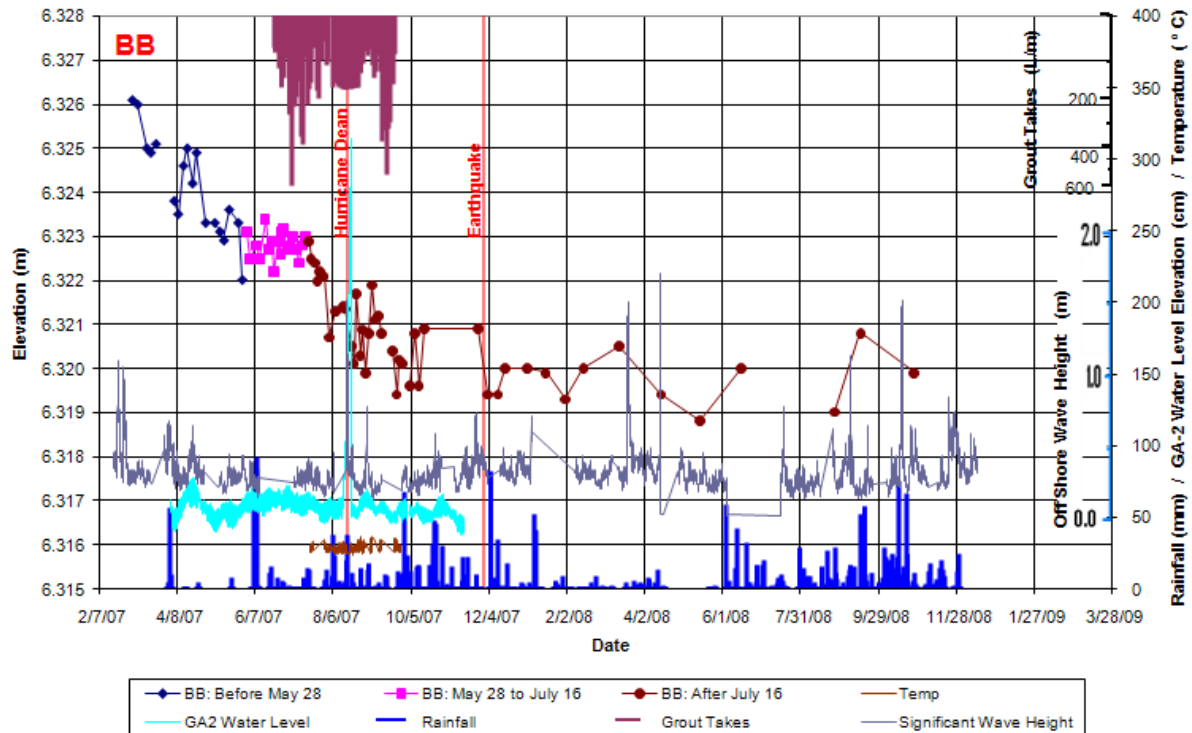
Precise Levelling Point - BB

Figure 5. Building monitoring data from precise survey.
