## Overcoming Screen Collapse in a Test Well

Kent Wiezel, M.A.Sc., P.Eng.

*Stantec Consulting Limited, Fredericton, New Brunswick, Canada*

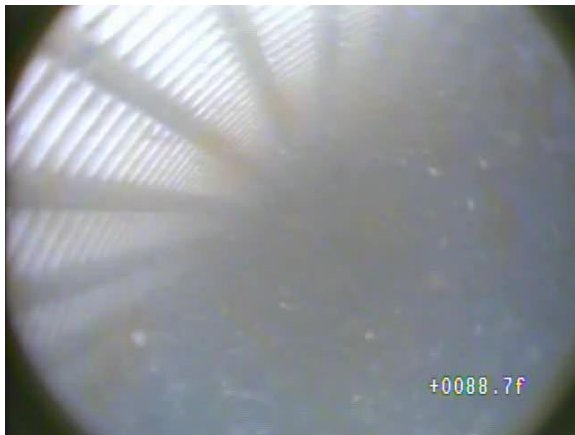
Near the top of the screen, in Figure 3A, there are no visible signs of damage. A distance of 0.4 m further down shows some evidence that lateral pinching may have occurred, and the screen begins to appear slightly deformed (Figure 3B). Figures 3C and 3D look down and sideways, respectively, at the same depth and show significant deformation and lateral buckling.

Figure 3A. 27.0 m near the top of the lower screen looking down. No visible signs of damage.

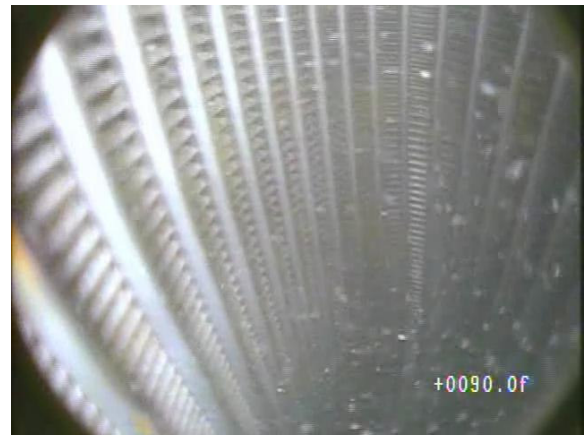
Figure 3B. 27.4 m looking sideways. Lateral pinching of the screen is becoming evident.

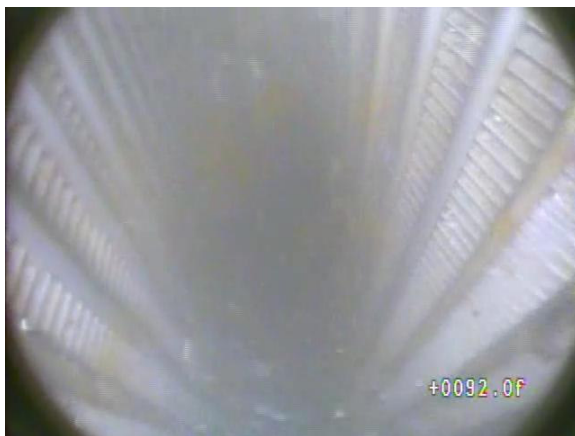
Figure 3C. 28.0 m looking down. The horizontal screen collapse can be seen with the left and right sides pinching in toward the middle.

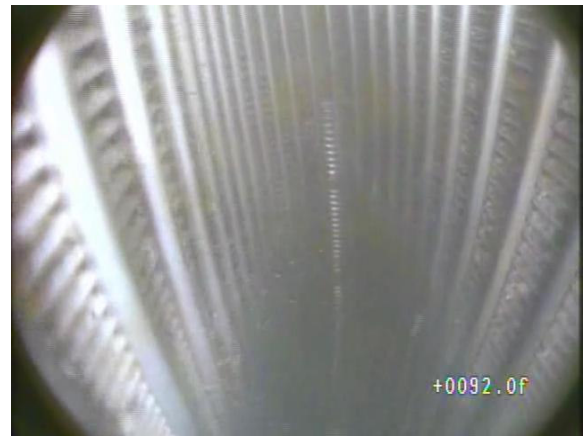
Figure 3D. 28.0 m looking sideways. More evidence of pinching, and the left and right sides of the screen appear flat.

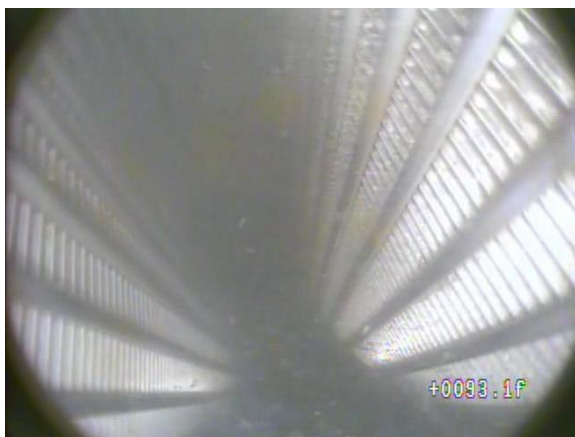
Slightly deeper in Figures 3E and 3F, effects of the collapse are clearly visible. This is near the most constricted section of screen, and the camera would not pass much beyond this depth. Only a 5 cm opening remained in the 20 cm diameter screen. This was not sufficient to allow clearance for drilling or pumping tools, and would undoubtedly affect the test well’s performance.

Figure 3E. 28.4 m looking down through the narrowest section of the collapsed screen. Only a 5 cm opening remained in the 20 cm diameter screen.

From all indications in the field and on the down hole well video, excessive lateral stress some time after installation and during development led to failure of the lower well screen material. Two sides of the screen buckled horizontally, pinching the inside of the well screen effectively reducing the diameter of the vertical passage through the screen in that interval.

Calculations of lateral earth pressures at the screen depth indicated that the screen construction should have held, and design checks by a representative from Johnson Screens confirmed this position. However, given enough viscosity the drilling mud could possibly account for lateral well screen failure – if the mud cake surrounding the well was impervious enough to prevent natural groundwater from entering the screen for an extended time, then it is possible that the difference in pressure inside the well (dry) versus outside the well (saturated) could lead to this type of failure. The exact collapse mechanism has not been determined, and our objective was not to conduct a forensic analysis on the screen; rather, it was to improve the situation, if possible.

At this point, the team devoted much consideration to how the program should proceed. It became clear that abandoning this test well location was not preferred until no other course of action was available. Ultimately a plan was formed to repair the screen, involving jetting and gently forcing a small diameter well point through the collapsed portion to open the interior of the screen.

The main repair apparatus consisted of a 13 cm threaded steel well point with jetting holes installed on the sides and bottom, connected to standard 10 cm diameter drill rods. Photos / schematics will be presented. The point was slowly pushed through the damaged screen section while air was jetted through the point against the screen. This process was repeated several times, varying the downward force and air pressure supplied by the drill rig.

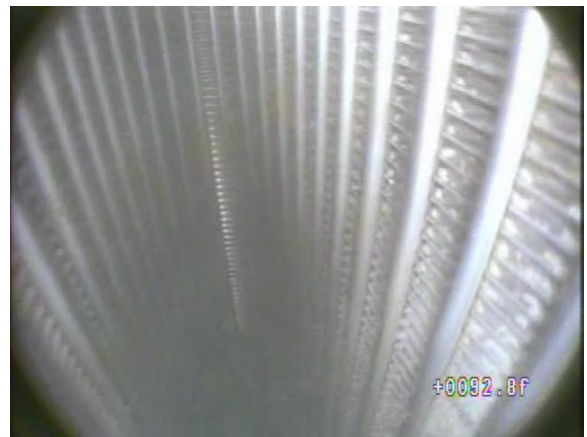
Figure 3F. 28.3 m looking sideways near the narrowest section of the collapsed screen. Distortion of the screen's shape is obvious.

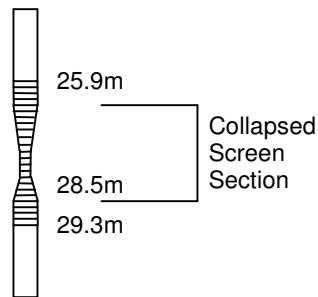
The video inspection indicated that the weld joining the top of screen to the well casing was intact, and it was assumed that the bottom weld was also intact. In this case, horizontal buckling of the well screen would have produced an hourglass shape as illustrated in Figure 4.

Figure 4. Simple illustration showing lateral well screen collapse beyond the approximate depth of 28 metres.

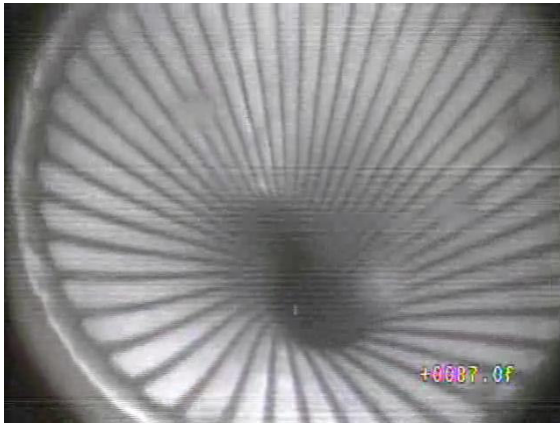
The well video on April 17, after repair and development efforts on the well screen, shows that the screen diameter was effectively increased to approximately 13 cm, or 64 percent of the original diameter.

Figure 5A. 26.5 m looking down from the top of the screen. Some distortion remains, and repair efforts have increased the diameter to 13 cm in the centre.

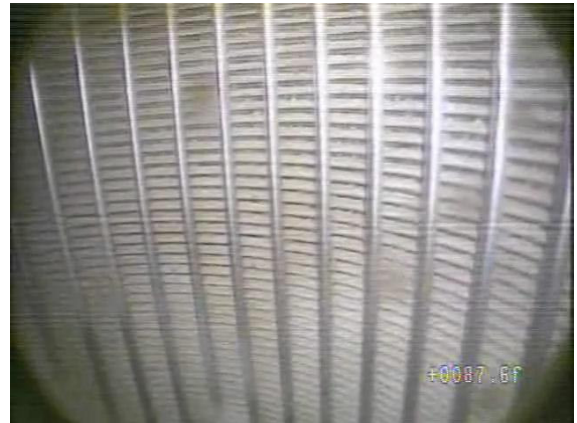
Figure 5B. 26.7 m looking sideways through the 30 slot screen. Medium sand grains are seen against the screen, forming a natural filter pack.

The well video also indicated coarse grains against the upper screen, suggesting significant mud removal and a developing filter pack, and the screen capture in Figure 5B shows a mixture of coarse and fine grains against the lower screen.

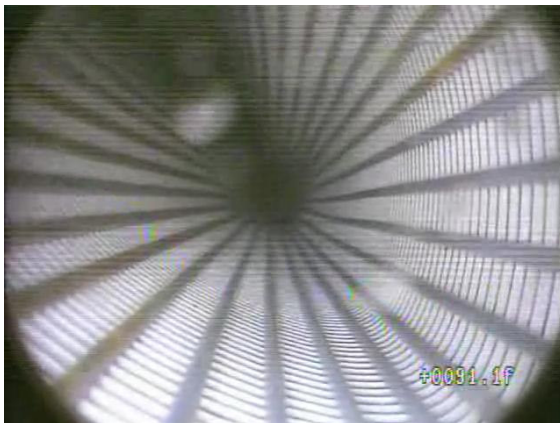
Figure 5C. 27.8 m looking down through the area that had been constricted by the horizontal collapse.

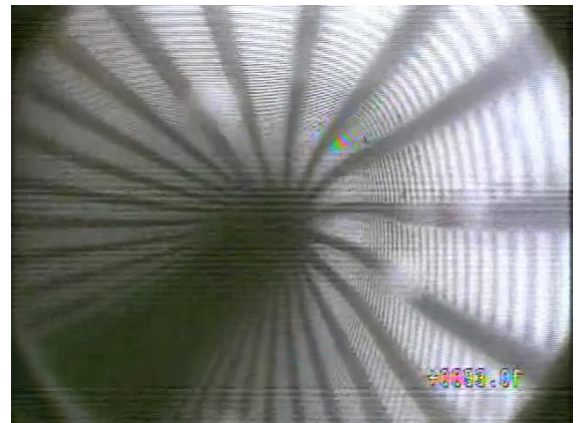
Figure 5D. 28.3 m looking down through the area that had been constricted by the horizontal collapse.

Figure 5D shows the rehabilitated screen at 28.3 m depth, compared to the collapsed screen at the same depth in Figure 3E. Some vertical support rods were slightly dislodged during the repair process, as indicated most clearly in Figure 5E (four are visible of a total 44 rods). Note that Figures 5E and 5F are at depths that could not be reached with the camera pre-treatment.

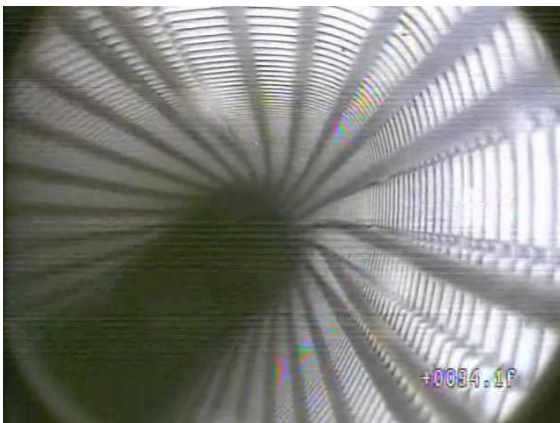
Figure 5E. 28.7 m looking down toward the bottom of the lower screen. Four vertical support rods were dislodged in places due to the aggressive repairs.

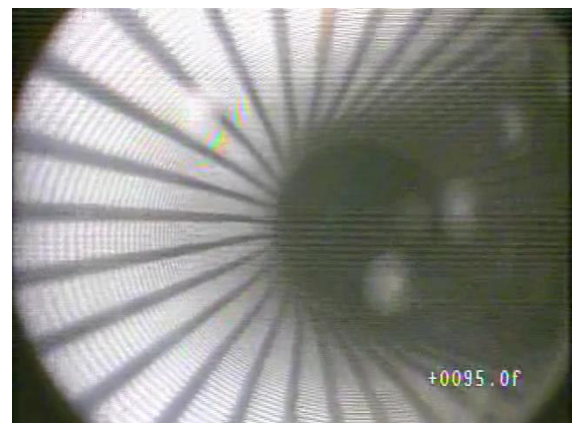
Figure 5F. 29.0 m looking down through the area that had been constricted by the horizontal collapse. The entire lower screen length was accessible.
