## Launched Soil Nail Slope Stabilization, Moosonee, Northern Ontario

Cameran Mirza, P. Eng.

### ABSTRACT

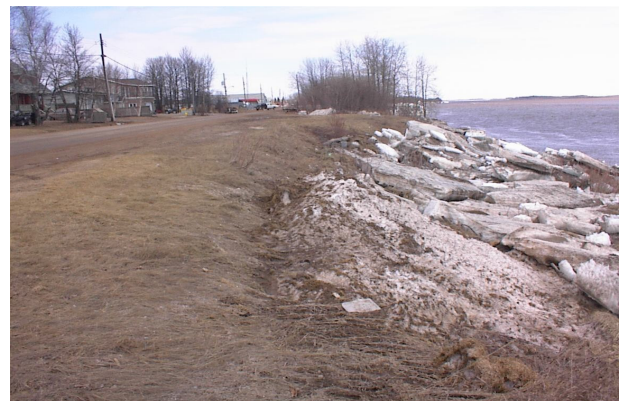
Revillon Road is oriented more or less north-south along the eastern edge of the Town of Moosonee near James Bay in northern Ontario. The road is situated 7 m above high tide level and 25-45 m away from Moose River that flows northerly. Slope failures have occurred between Revillon Road and Moose River, threatening buried utilities beneath Revillon Road. An old remnant ice floe covered slide is shown in Figure 1.

Figure 1. Old large slide adjacent to Revillon Rd. covered with remnant ice, looking north (May 2008). Note closeness of scarp to road in some locations.

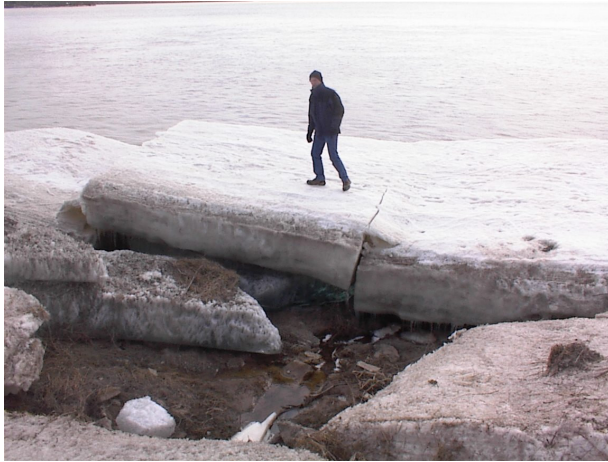
During spring break-up large ice floes tend to gouge out sparsely vegetated sections of the slope between Revillon Road and Moose River. Figure 2 illustrates one of the smaller ice floes. Diurnal tidal variations of about 2 m and rapid drawdown during spring thaw, along with toe erosion caused by the tides and boat wakes, have caused small to large slides of the river bank slope adjacent to some 800 m of Revillon Road.

Figure 2. Ice floes, May 2008.

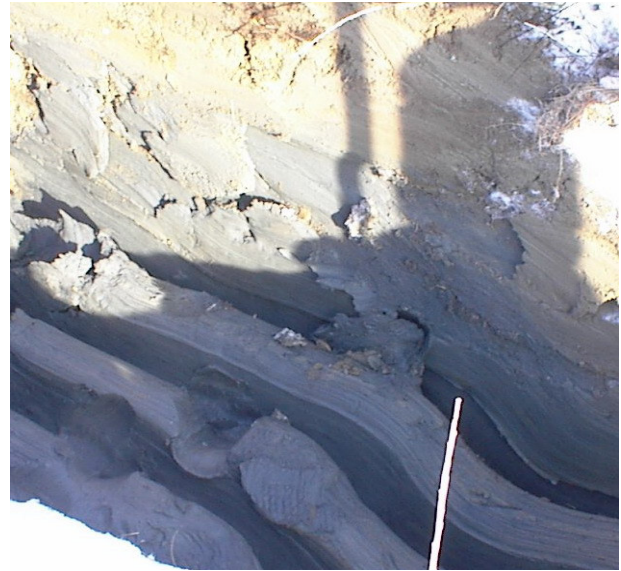
The soil profile consisted of a desiccated crust of about 2 m thickness and/or fill material underlain by blue-grey silty clay of marine origin. The exposed soil in one trench base is shown in Figure 3.

Figure 3. Grey-blue marine clay in trench base.

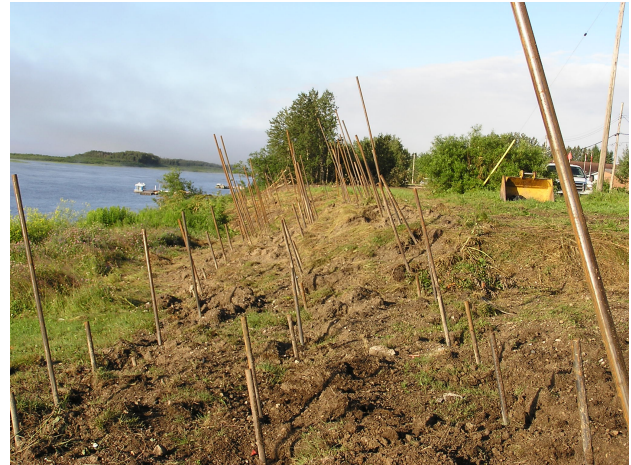
Soil nail penetration varied considerably at all locations, even when the same compressed air pressure was used. Some nails penetrated well below ground level while others hung up 1-2 m above ground surface, as shown in Figure 8.

Figure 8. Variability in launched soil nail penetration (same location as in Figure 1, looking south).

The variability in soil nail penetration can be attributed to factors such as launch air pressure fluctuations and the random presence of roots and stones in the upper 2 m of the stratigraphy. The 6 m long soil nails penetrated, on average, a depth of 5.5 m below ground surface. Nail penetration varied almost linearly with launch air pressure (Figure 10).

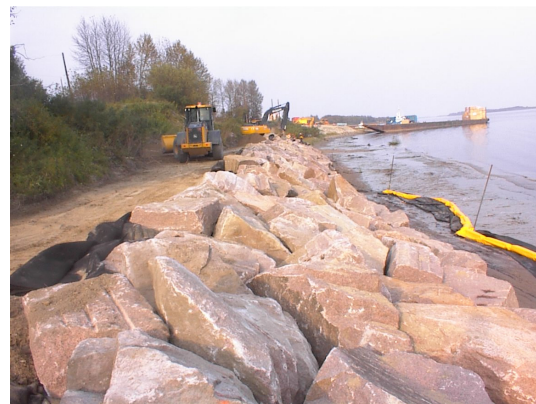
Figure 12. Shoreline stabilization (low tide, Sept. 2008).

Granite armour stone of 3-12 tonne mass was imported from a quarry near Peterborough, Ontario, by truck and rail to a municipal yard in Moosonee. Locally available free-draining granular fill was placed as a toe berm on overlapping 4.6 m wide heavy thick geotextile sheets placed directly upon and along the base of the shoreline. One course of blocky armour stone was placed as a barrier wall on the native shoreline soil. The geotextile was brought up against the inside of the barrier stone wall and wrapped around granular fill placed on the inside and along the inner base of the shoreline. More armour stone was placed above the encased granular fill. Figure 11 shows the construction of the shoreline protection scheme.

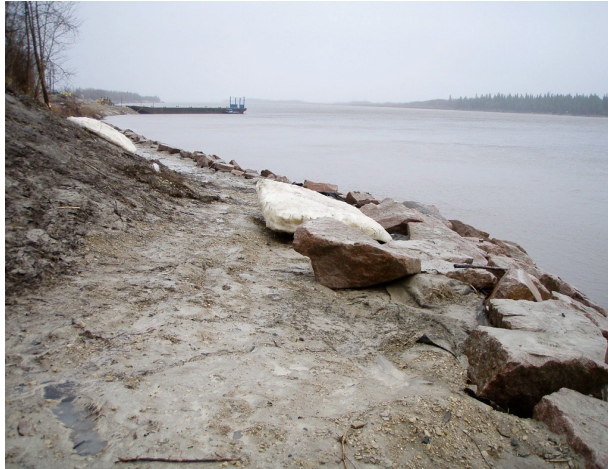
Figure 13 shows the condition of the armour stone protection after spring break up in mid-May 2009. The effectiveness of soil nailing in preventing future slope failures will not be known until thaw is completed later in June-July 2009.

Figure 13. Berm condition in mid-May 2009. Note beached remnant ice floe behind a displaced granite armour stone (view looking downstream towards the north. Photo courtesy website: [lantz.ca/](http://lantz.ca/)).

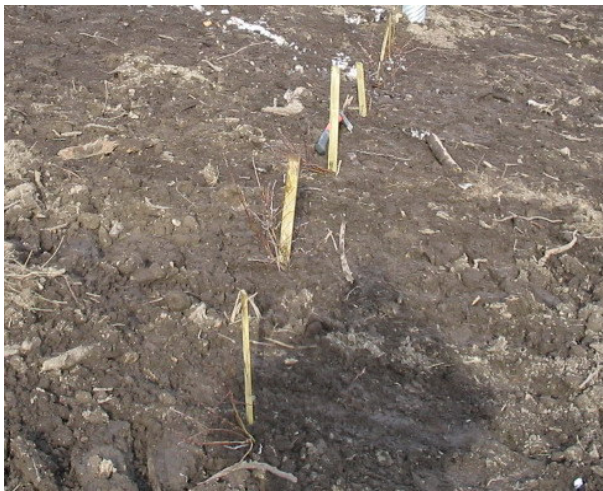
Figure 14. Willow wattling.

Shoreline stabilization work also included slope revegetation using local willow shrub wattles, Figure 14 (Grey and Leiser, 1982).
