# Mechanisms and kinematics of three translational slides along the North Saskatchewan River Valley, Edmonton

K. W. Soe Moe

## ABSTRACT

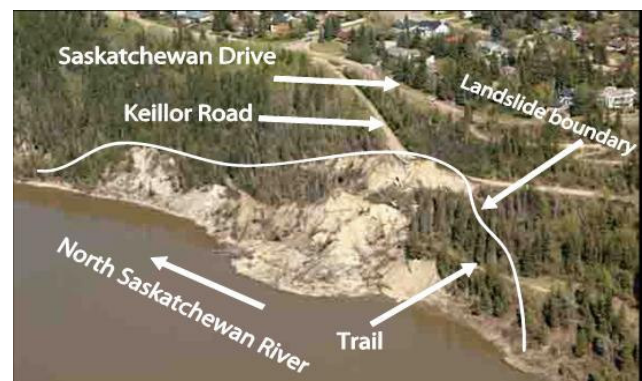
The Keillor Road Landslide occurred in the fall of 2002 on the outside bend of the North Saskatchewan River, where Keillor Road traverses down from a flat upland area to a low level terrace (Figure 1). Due to the failure, a 5 m deep graben appeared at the head of the displaced material and the toe of the slope moved 22 m into the river.

Figure 1 Keillor Road landslide (May 2005, the City of Edmonton)

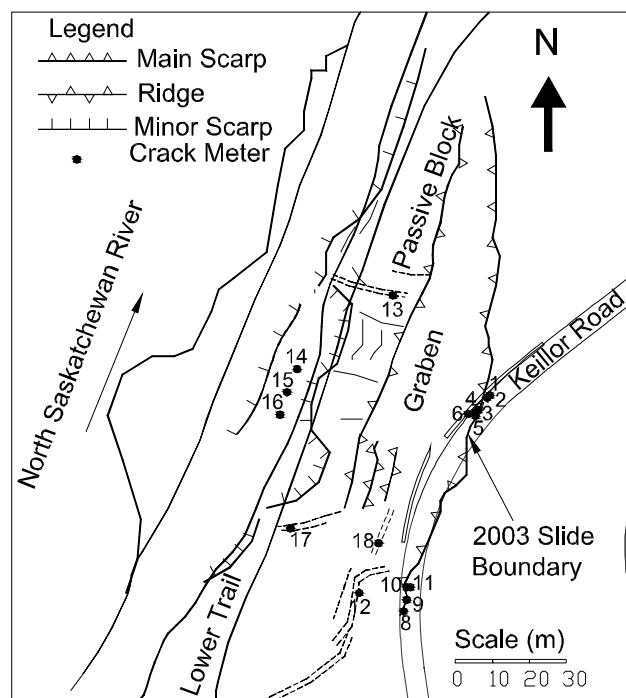
After the major failure in 2002, a field observation program was carried out to monitor the post-failure slope movement. Landslide features such as the graben, tension cracks, scarps, and ridges were mapped monthly in the spring and the summer of 2003 and 2004 (Figure 3). A total station survey was conducted in the spring of 2003 and 2004 to monitor movements of the upper pile wall and to provide a cross sectional survey of the landslide topography (SoeMoe et al. 2005).

Figure 3 Landslide map of Keillor Road (2003)

In the fall of 2002, 18 crack meters (CM) were installed in the displaced material to monitor the surface expression of the slope movements (Figure 3). Vertical and horizontal movements of the CM were monitored regularly in the spring and summer of 2003 and 2004. As the landslide progressed, significant slope movements occurred and the middle part of the main body slid into the river in July 2004. The maximum movement of the counter scarp was 3 m toward the river from May of 2003 to May of 2004. Minor scarps which formed at the lower

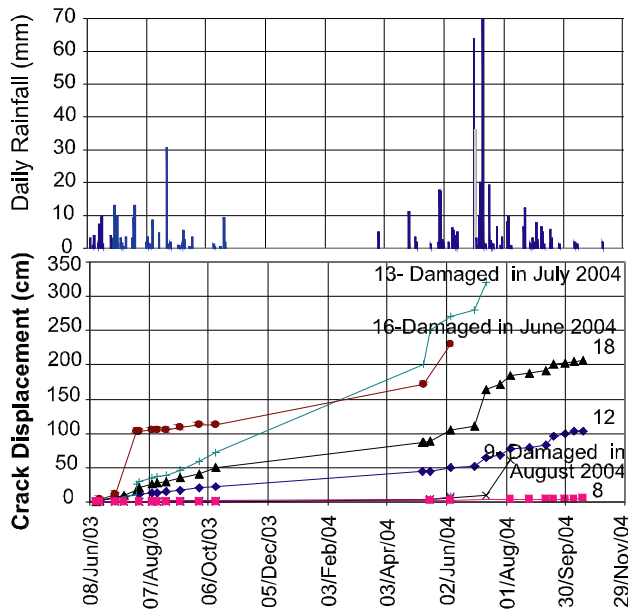
The horizontal movements of CM are presented in Figure 4. CM-13 was located in the initial toe of the slide and slid down to the river after a period of heavy rainfall in July 2004. CM-16, located at the toe of the slide, was damaged by the slide in early June of 2004. Maximum movements were observed at the centre of the slide. As shown in Figure 15, the recorded crack displacements increased significantly after periods of heavy rainfall.

Figure 4 Horizontal displacements of crack meters

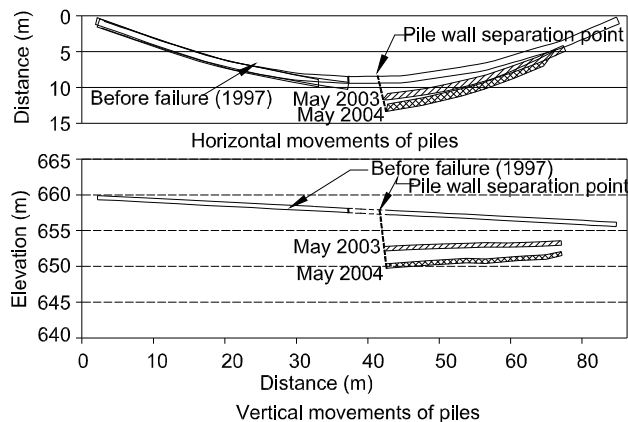
Part of the upper pile wall was located inside the graben and settled together with the displaced material. The coordinates of the top of the pile wall were surveyed in May 2003 and May 2004 (Figure 5). The maximum recorded horizontal and vertical movements in 2003 were 2.3 m and 5 m, respectively. In 2004, an additional 1.7 m and 2.3 m of movement were measured, respectively.

Figure 5 Movements of the cast-in-place piles

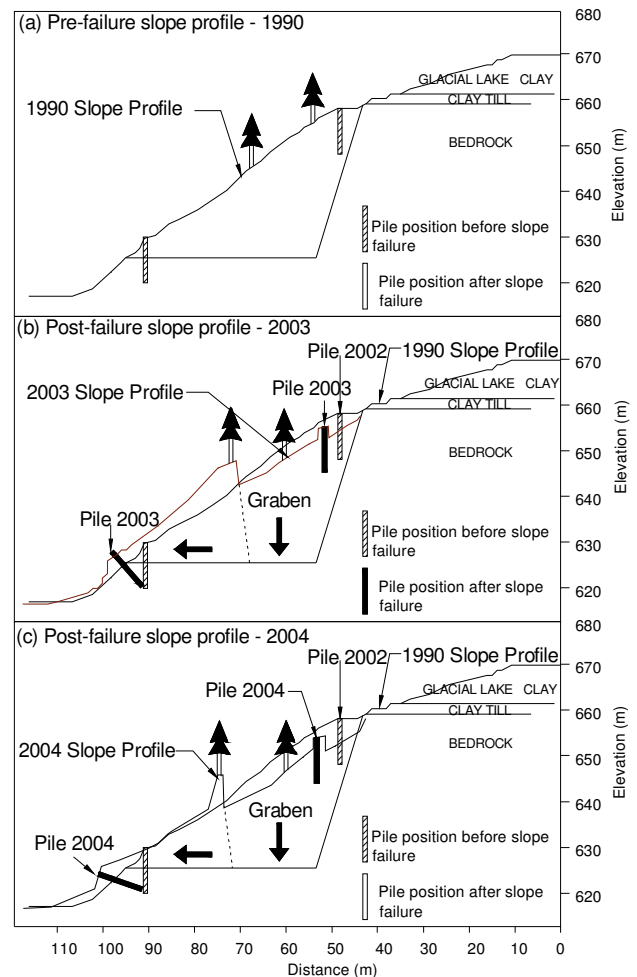
Movements observed at the Keillor Road Landslide revealed the development of landslide stages with time. At Keillor road, initial movements started as a toe failure in 1989 and a major failure occurred in the fall of 2002. Inclinoimeters installed prior to the major failure revealed the development of the main scarp. A comparison of the original slope cross-section with the surveyed post-failure cross sections from 2003 and 2004, as well as the attendant pile movements, are shown in Figure 6. As shown, the failure mechanism extended below the pile wall. Downward movement of the material inside the graben and the translational movement of the main body can be seen in Figures 6b and 6c. As the landslide progressed, more cracks appeared in the main body as a result of slope deformation. The upper pile wall at Keillor Road moved downward, and piles at the trail near the toe tilted forward as the displaced material pushed the piles toward the river.

Figure 6 Slope profile survey (Pre-failure, 2003 and 2004)

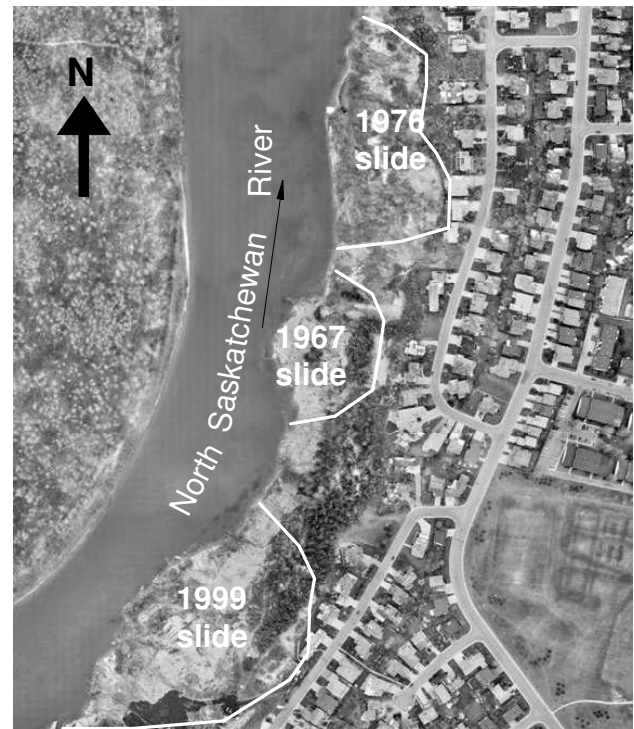
Prior to the major landslide in 1999, several movements had occurred downstream of the 1999 landslide location (Figure 8). In 1967, a failure occurred 300 m downstream of the 1999 landslide location but the failure did not affect the residential properties behind the valley wall. In 1976, a second failure occurred north of the 1967 failure involving the overlying glacial deposits and the bedrock. Significant observations before the 1999 landslide are listed below.

Figure 8 Landslides along Whitemud Road (May 2002, City of Edmonton, Line 17E, Scale 1: 5000)

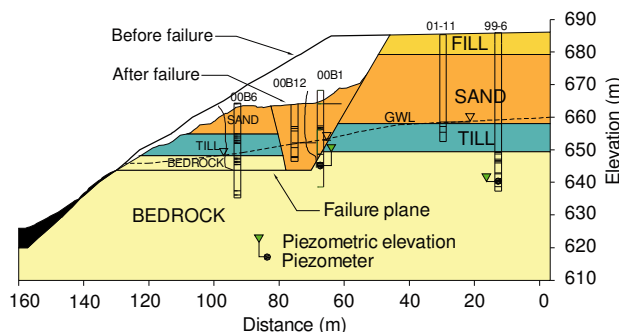
The major movements in the Whitemud Road landslide occurred within one day (Barlow and Froese 2000). A distinct graben feature formed at the head of the displaced material as the main body translated along a weak plane in the bedrock. Figure 10 presents pre-failure and post-failure cross-sections of the slide area and identifies soil and rock layers deduced from the drilling information (SoeMoe et al. 2006).

Figure 10 Pre and post-failure cross section of Whitemud Road Landslide

As shown in the figure, the failure geometry of the Whitemud Road slide consisted of a steeply dipping main scarp and a surface of rupture seated in the bedrock. Boreholes advanced inside the displaced material revealed two different profiles. The borings inside the graben encountered mostly sand, indicating most of the materials inside the graben were from the overlying sand deposit. Boreholes drilled outside of the graben boundary revealed an almost undisturbed stratigraphic profile of sand and till overlying bedrock, indicating that these materials translated along a weak plane.

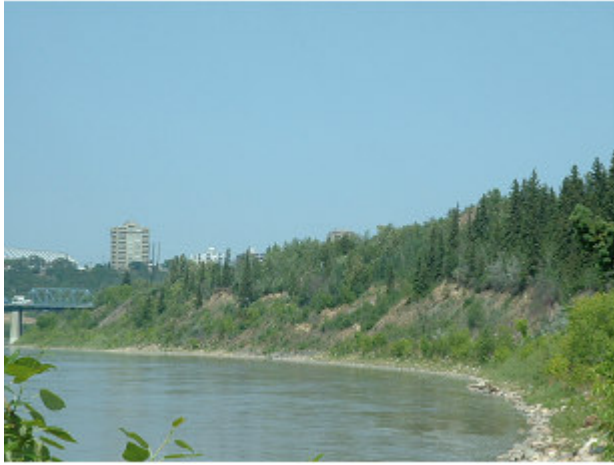
Immediately below the flat upland area, steep scarps and grabens occupy the valley wall. Transverse ridges and cracks are also found throughout the mid-slope area. A terrace is located 25 to 30 m below the valley crest, which is crossed by a lower recreational trail. The slope below this terrace is also irregular with transverse cracks and scarps. The North Saskatchewan River is located 10 to 15 m below the terrace level. Glacial till is exposed at the toe of the slope in northern part of the park, while the remaining portion of the toe is covered by the displaced bedrock. Varying degrees of slope deterioration are evident and retrogressive slumps are found in several locations.

Figure 11 River valley view of Forest Heights Park

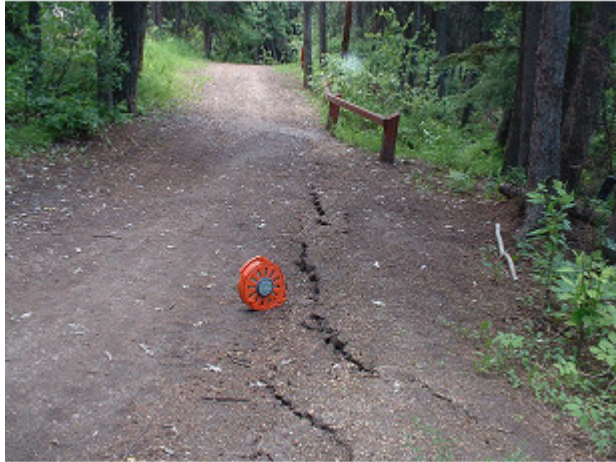
In June of 2005, the level of the North Saskatchewan River increased above the elevation of the toe berm. This flooding event caused significant toe erosion, and tension cracks soon appeared along the lower trail as shown in Figure 13.

Figure 13 Tension cracks in the lower trail

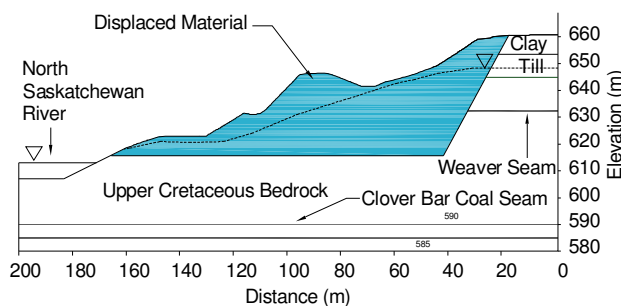
Coal mining below the area appears to have caused the weakening of overlying bedrock, accelerating the propagation of cracks deeper into the bedrock. This significant weakening of the bedrock would also have facilitated subsequent softening of the bedrock by allowing increased groundwater flow through the cracks, accelerating the softening processes in the bedrock. Finally, hydrostatic pressure may have built up within the cracks during periods of heavy rainfall, which in turn would significantly reduce the factor of safety of the valley wall. Since most of the old mine workings extracted coal from the Weaver seam, located at mid height of the valley wall, it is probable that coal extraction from the Weaver seam had the greatest impact on the stability of the valley wall. The effects of mining the Clover Bar coal seam appeared to be minimal, since this seam is located 25 m below the failure plane. The location of the coal seams together with the displaced material is shown in Figure 14.

Figure 14 Cross section of the valley wall together with coal seam elevations
