## Analysis of Field Performance of Landslide Repair Using a Pile Wall

A historically slow moving embankment fill landslide on Secondary Highway 682:02 accelerated to failure in the spring of 2007. The landslide was translational with the failure plane located between 4.5 and 6.5 m depth within native lacustrine clay. The stabilization repair method selected was a pile wall that consisted of 67 cast-in-place reinforced concrete piles spaced at 1.5 m on centre.

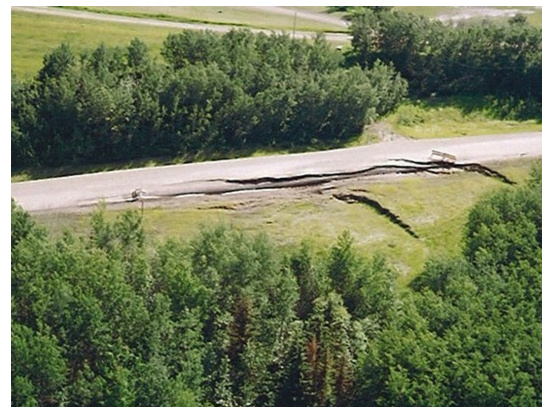
The landslide site encompassed an 11 m high embankment that spans a small ephemeral creek valley. Part of the highway grade line was constructed using cut and fill methods. The landslide was approximately 90 m wide at the head and extended to the centerline of the highway as shown in Photo 1. A pronounced toe push feature was evident near the toe of the embankment

Photo 1. Aerial view of Hines Creek (PH4) Landslide

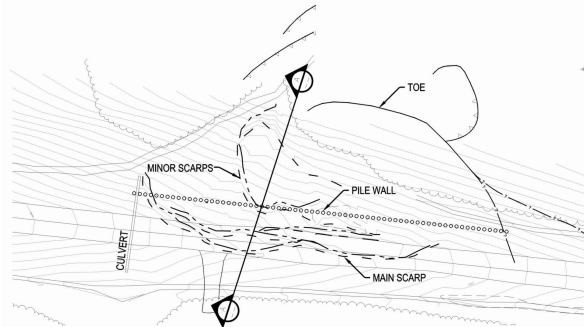
Figure 1. Site Plan

slope, which indicated day-lighting of the failure plane. The embankment fill slopes varied from 11° to 17°. A site plan showing the extent of the landslide and borehole/instrument locations is presented on Figure 1.

The final design of the pile wall included 67 cast-in-place reinforced concrete piles, 14 m in length, 1.0 m in diameter and spaced at 1.5 m on centre. The area of the steel within the piles was 2.2% of the total pile cross-sectional area. The layout of the pile wall is presented in Figure 1. A contingency plan is in place in the event that embankment fill and asphalt road surface deformations exceed AT tolerances. This contingency includes installation of tie-back anchors to further restrain the wall movements.

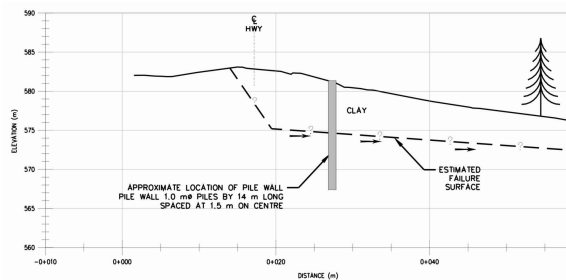
Figure 2. Landslide Cross Section

The cause of the landslide was determined to be due to the destabilizing influence of the embankment fill at the site and moderately adverse groundwater conditions. Seepage was present at various locations on the embankment slope, including approximately 2.0 m below the highway grade line. The drainage ditch immediately south of the landslide area was poorly graded with ponded water present after rainfall events. A section of the embankment slope and estimated failure plane is presented in Figure 2.

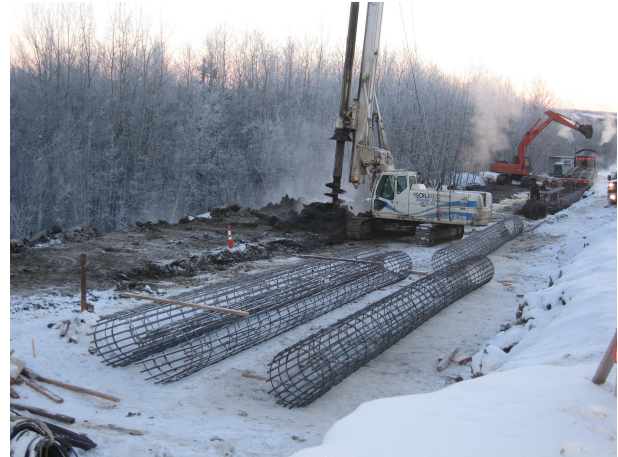
Construction started in December 2007. An access road and level pad area were built across the embankment at the pile wall location. The timing of construction was primarily dictated by the urgency associated with completing the repair work. There was some benefit to cold weather conditions as it allowed for ground freezing to improve equipment trafficability on site. Pile installation was started in mid-January and was completed in 10 days. A photograph of the pile wall construction is presented in Photo 2. The ambient air temperature varied between -25 and -40° C throughout piling construction. Pile drilling near the formerly wet area near the zone of initial movement encountered a buried drainage pipe, indicative of historic drainage efforts.

Photo 2. Pile Wall Construction (late January 2008)

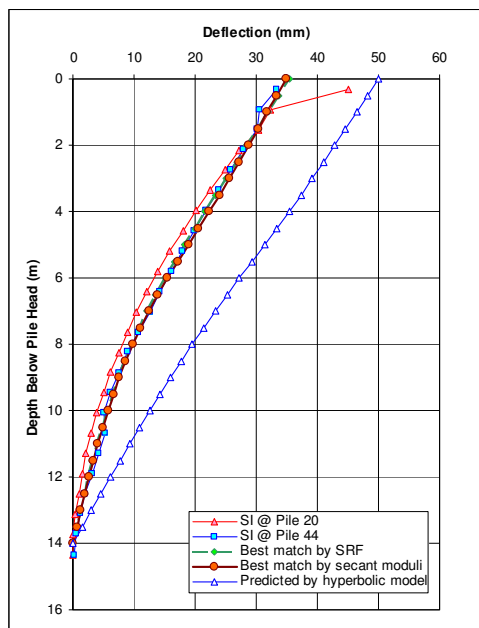
Slope inclinometer readings (on April 29, 2009) indicating the deflection observed in the pile wall since completion of construction are illustrated in Figure 3. The observed deflections were within the bracketed range of 7 to 93 mm predicted during the design phase. The majority of the deflections occurred prior to early summer 2008 when the final grading and paving was complete. There has been limited post-construction deformation or cracking of the embankment slope and repaired road surface above the pile wall.

The model parameters and results of the back analysis are presented in Table 2. Figure 3 shows a comparison between pile wall SI readings (April 29, 2009) and deformations back analyzed predicted by various methods described above.

Figure 3. Comparison between pile wall SI readings (April 29, 2009) and back analyzed deformations
