# Remediation of the Lube Land Slope Instability at Highland Valley Copper Mine

Sebastien Fortin & Carl Diederichs

Rod Kostaschuk

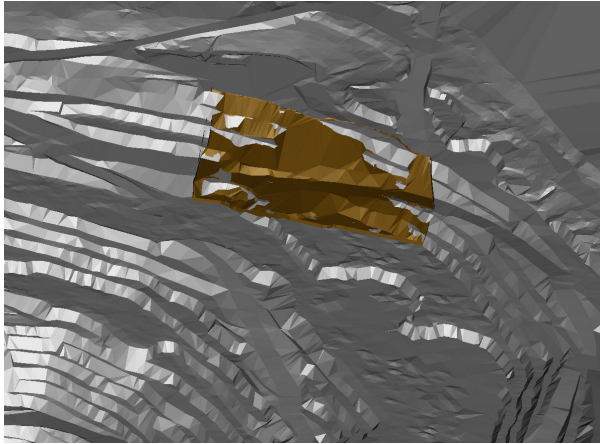
Figure 3. Area exhibiting cracking and heaving between the 1190m and 1115m benches (June 30, 2008).

By about 3PM the slope showed increased signs of strain and cracks were multiplying and widening out in the crest area. A family of sub-parallel cracks had also developed on the 1130m bench, along with the creation of a slight bulge quasi perpendicular to the crest alignment. Access to Lube Land as well as traffic on the haul road to #4-5 crusher was blocked by 4PM and light plants were mobilized in the crest area for night shift monitoring. The only SMP's available at the time were located in the northern portion of Lube Land and did not show any signs of movement acceleration at the time.

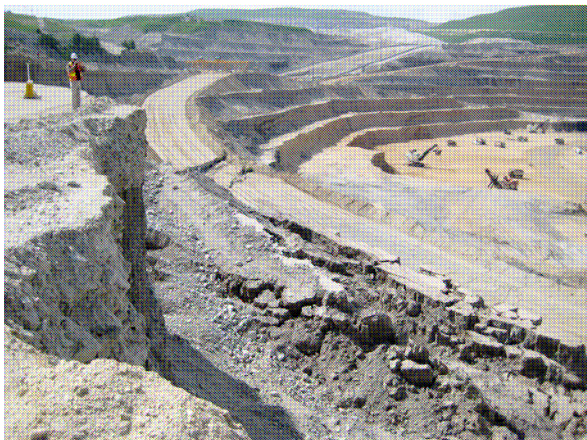
The southern portion of the Lube Land slope failed at around 3AM on July 1, 2008 (Lube Land South, Figure 4). This slope failure mobilized approximately 2.6MT of overburden soils and cut access to the Lube Land fuel station, and the height of the head scarp below the 1190m bench was approximately 10m (Figure 4). The haul road to #4-5 crusher sheared off during the event, showing vertical displacement of up to 2.5m (Figure 4). The 1130m bench below the haul road showed two sub-parallel pressure ridges bulging up to 4m above bench grade (Figure 4).

Figure 4. Looking down from the headscarp of the Lube Land failure (June 30, 2008). Note the high head scarp, smaller scarps across the haul road, and the wide 1115m bench occupied by the mining equipment.

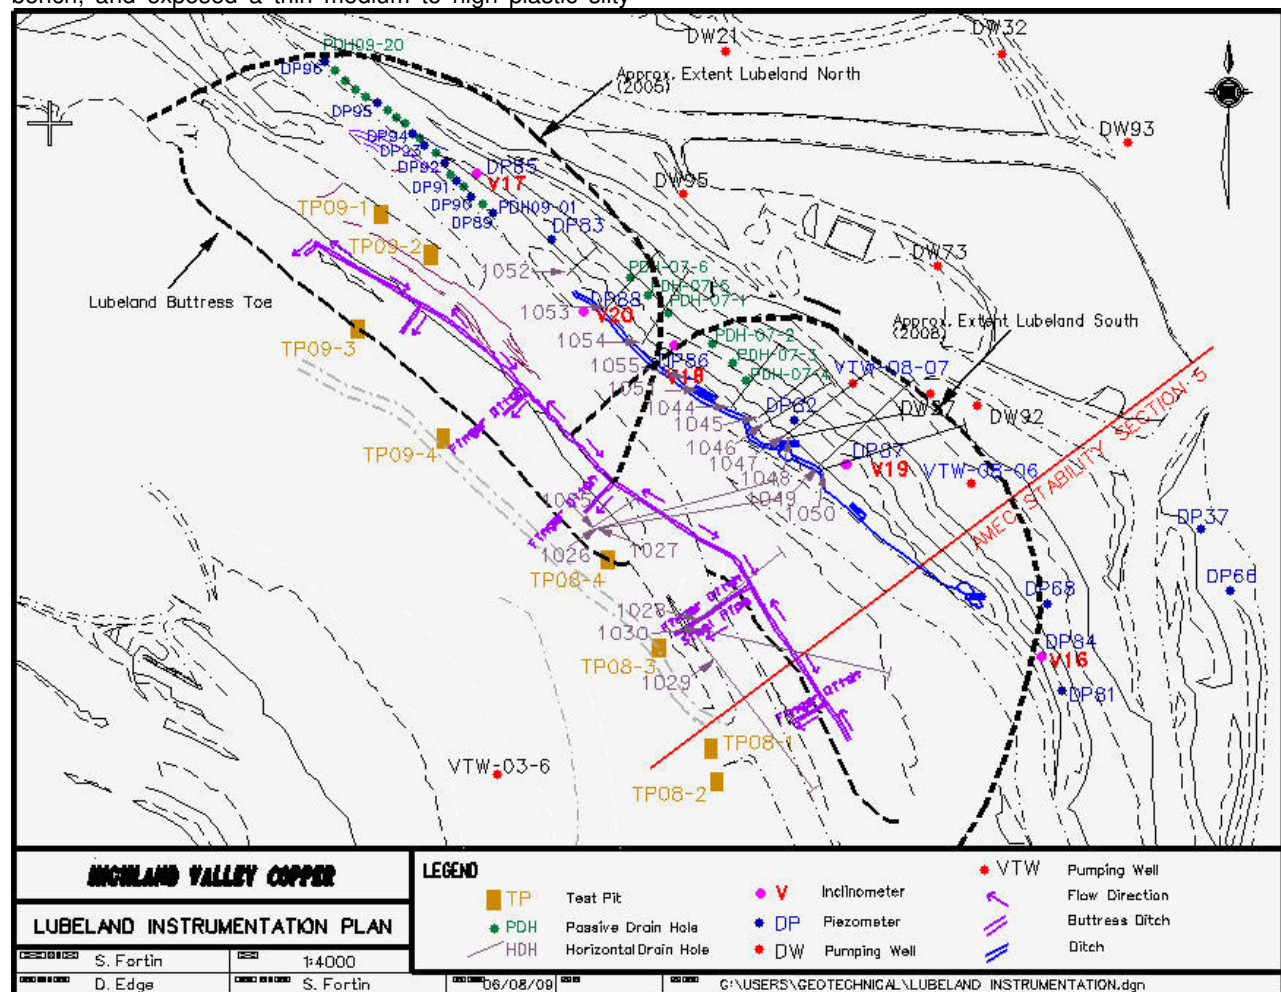
Figure 5: Plan view of the Lube Land area showing geotechnical and dewatering efforts.

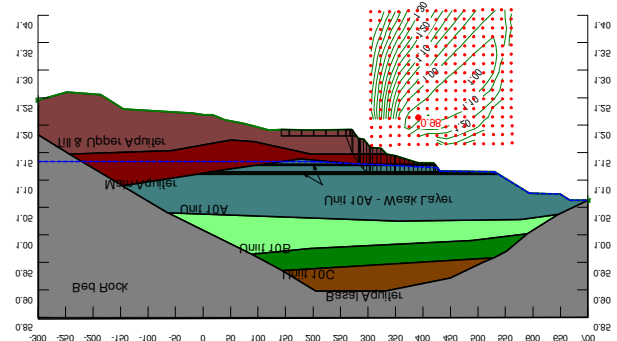
The results of the back analyses of Sections 2 and 5 are shown in Figures 6 and 7 respectively. The estimated Factor of Safety at both sections was about 0.98 for failures extending down to the hypothesized weak layer between elevations 1110m and 1114m, which concurred with the slope failure that occurred on June 30, 2008. The FoS for slip surfaces passing through the upper weak layer between elevations 1026m and 1028m is higher, at approximately 1.08. These results indicate that if the weak layers are of equal strength (12 degrees), then the lower-most one is the critical surface for stability. Therefore, it was recommended that remedial measures be designed to provide protection against instability controlled by either the shallow or deep weak layers.

Figure 6. Section 2: Stability Back Analyses (Failure through lower Unit 10A weak layer).

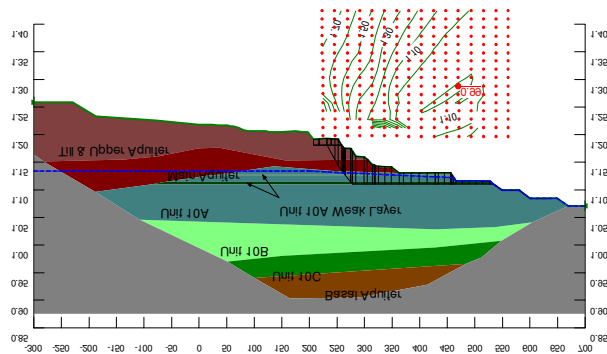
Figure 7. Section 5: Stability Back Analyses (Failure through lower Unit 10A weak layer).

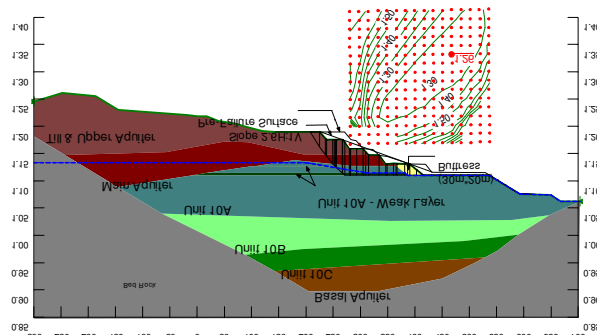
Figure 8. Remedial Option: Section 2 of the Lube Land slope, showing crest unload, rock buttress, and target groundwater depressurization. (AMEC, 2008)

4. Excavate the 1115m bench back to the ultimate pit wall location. The Factor of Safety for this condition is approx. 1.17.
5. Using slot-mining techniques with maximum slot length of 30 meters, excavate the shear key to truncate the weak layers encountered in the 1110m to 1114m elevation range, and immediately backfill the shear key and construct the buttress using clean sand and gravel, placed in 600mm lifts and compacted with truck and dozer traffic. Inspect the excavation to confirm that the shear key excavation has indeed truncated all the weak layers. Only move on to mining the next slot when the buttress for the first slot is complete. The result of this final step is to increase the long term FoS to approximately 1.25 (See Figures 8 and 9).

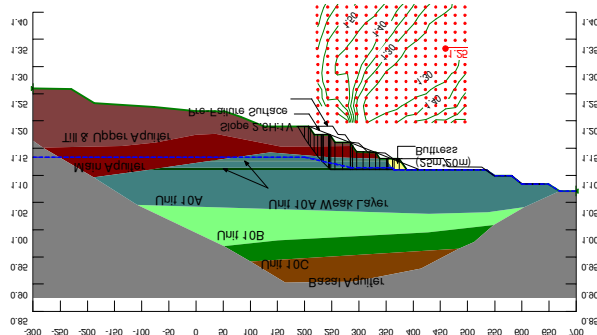
Figure 9. Remedial Option: Section 5 of the Lube Land slope, showing crest unload, rock buttress, and target groundwater depressurization. (AMEC, 2008)

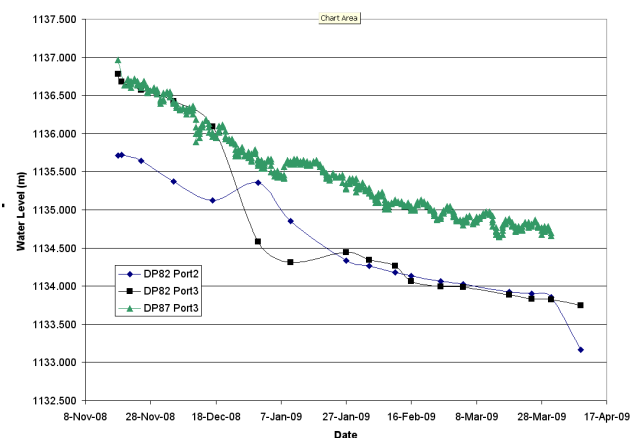
Figure 10: Time trends of selected piezometers showing positive response to horizontal drain holes.

In addition to active pumping wells, passive dewatering methods were used. Seven horizontal drain holes (HDH) were drilled from ~1130m elevation between 50 and 100 meters into the slope. One HDH was dry, while all other holes produced initial flows up to approximately 5 L/s.

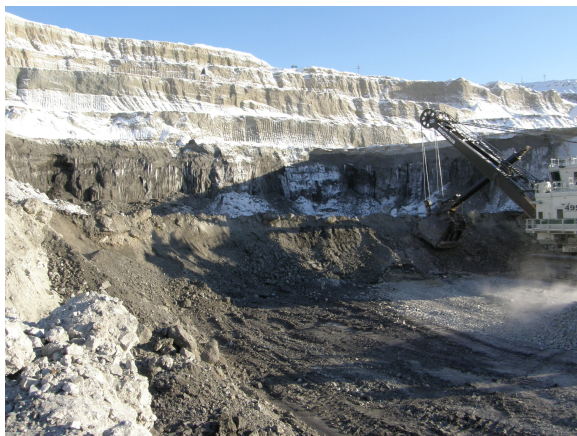
Figure 11. Bucyrus 495R Shovel excavating block 6.

1. Material from the 1115m bench to the 1130m bench was excavated flat at 1115m elevation using a Bucyrus 495HR shovel (Figures 11 and 12).
2. Once the flat pass at 1115m elevation was complete, either the shovel or a loader then completed a second pass to sink to the 1110m elevation to form the shear key under the butress footprint (Figure 13).
3. Once the shear key excavation was complete, a deeper drainage ditch was excavated and backfilled with crushed rock (Figure 13). The drainage ditch was daylighted to the pit slope to allow gravity drainage.
4. The waste rock butress was then dumped in from the 1130m bench to fill the shear key and construct the butress fill. In total, approximately 1.62 million tones of blasted run-of-mine waste rock was placed in the butress.

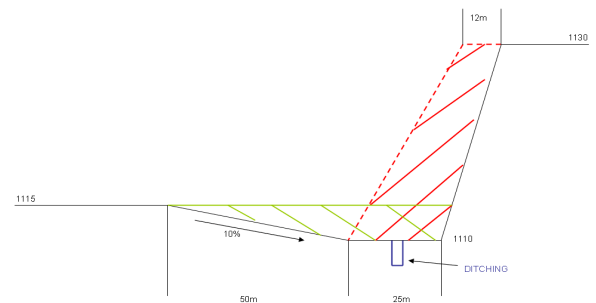
Figure 13: Schematic cross-section of conceptual Lube Land butress design. French drain acts as shear key, de-coupling lower slickensided horizon.

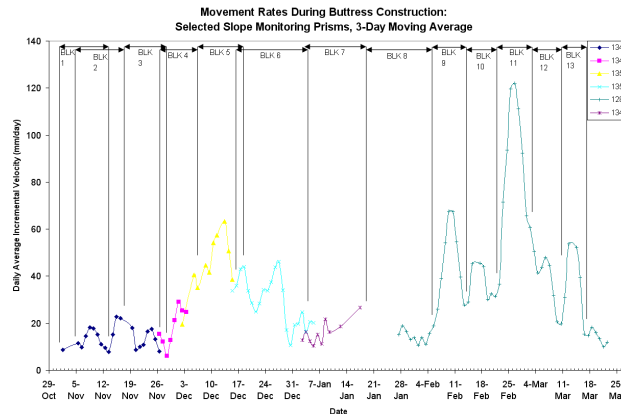
On-going surface displacements were measured by establishing a network of slope monitoring prisms (SMP's) that were monitored using automated survey equipment (Newcomen et al., 2003). Prisms were surveyed on a four-hour rotation, providing movement data six times during a 24-hour period. Displacements measured from SMP's were used to monitor slope stability during slot mining. Prism data clearly showed an acceleration of movement as each slot was excavated, with a corresponding deceleration as the rock butress was dumped in (Figure 14).

Figure 14: Slope monitoring prism velocity vs. slot mining showing acceleration and deceleration of the slope as material was excavated and the rock buttress placed.
