# Development in hilly areas induced slope stability – case history

Kamal Bahrin Jaafar, Amir Hamzah Mustapha, Suhaimi Jamaluddin & Yunus Marjan  
*Public Works Department Malaysia, Kuala Lumpur, Wilayah Persekutuan, Malaysia*

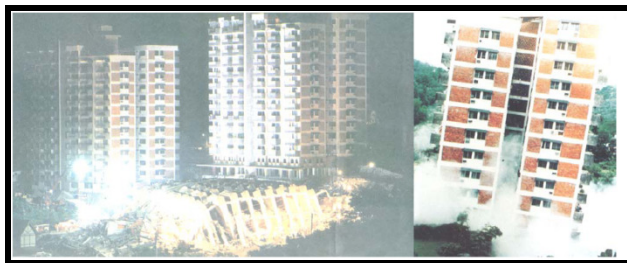
Figure 4. Block 1 Highland Tower Condominium

The investigation report explained that the most probable causes of the collapse of the Tower 1 were the buckling and shearing of the rail piles foundation induced by the movement of the soil. The movement of the soil was the consequence of retrogressive landslides behind the building of Block 1.

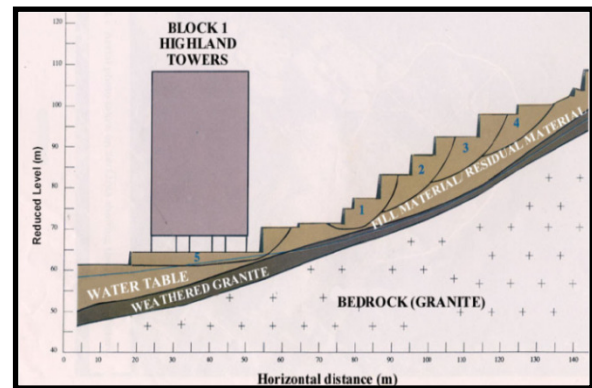
The slope and rubble walls behind and in front of Block 1 were also found to be improperly designed with an overall Factor of Safety of less than 1. Figure 5 shows the sequence of retrogressive failures that took place, causing large soil movement and increased in lateral pressure to the foundation of the building and the rubble wall in front of the Block until it collapsed and was followed by the toppling of the block 1 Highland Tower.

Investigation also found that inadequate provision of drainage system and the lack of maintenance of the drains aggravated the friable nature of the slope materials by increased surface runoff and infiltration rate that finally triggered the series of landslides.

Figure 5. Retrogressive failure behind block 1 highland tower

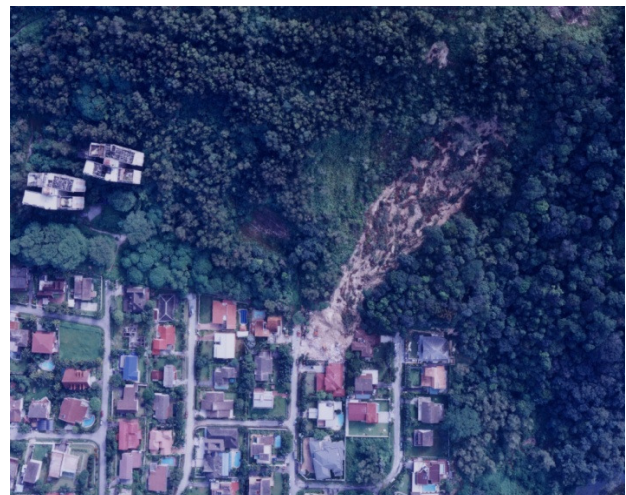
A landslide happened on a hill slope at Taman Hillview at 4.30 a.m. on 20<sup>th</sup> November 2002, destroyed a bungalow and killed 8 people as shown in Figure 6. The National Disaster Management in the Prime Minister's Department instructed the Public Works Department Malaysia (PWD Malaysia) to form a Landslide Working Group (LWG) to investigate the causes of failure and identifying areas with high landslide risks and to come up with mitigation measures.

Figure 6. Debris flow from top and hit damage the bungalow

The above factors had triggered off the failure of the slope on 20<sup>th</sup> November 2002, bringing down rubble wall. The debris would then caused scouring on the landslide scar and with an abundance of water in the soil, the debris became fluid and flowed down hill then destroyed the bungalow.

Another situation that had happened was that the horizontal thrust of the soil behind rubble wall had increased due to infiltration of the rain water, causing the inherently unstable rubble wall to fail. Debris from the collapsed rubble wall was deposited on the slope below, causing additional loading, and together with an influx of surface and seepage water, a landslide was triggered off. The resulting fluid debris comprising of fill material and boulders flowed down hill to demolish the bungalow.

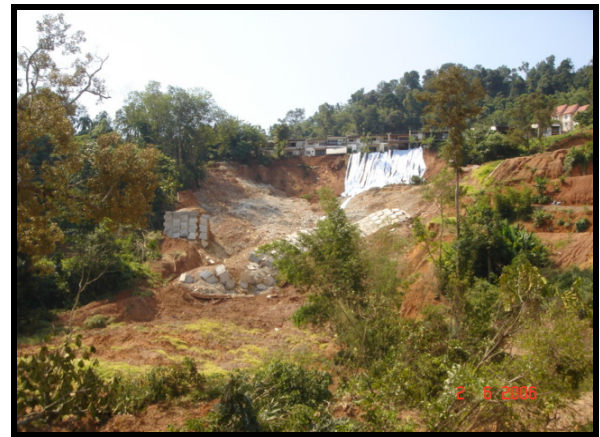
Based on the investigation it was found that the cause of landslide was due to the failure of reinforced soil wall designed by developer as shown in Figure 7. Development activities next to the failure areas without planning the drainage system also contribute to the failure as shown in Figure 8.

Figure 7. Reinforced soil wall collapsed.

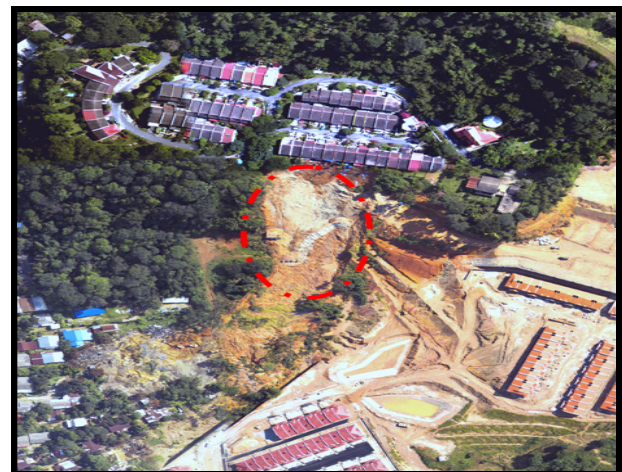
Figure 8. Development activity near landslide area.

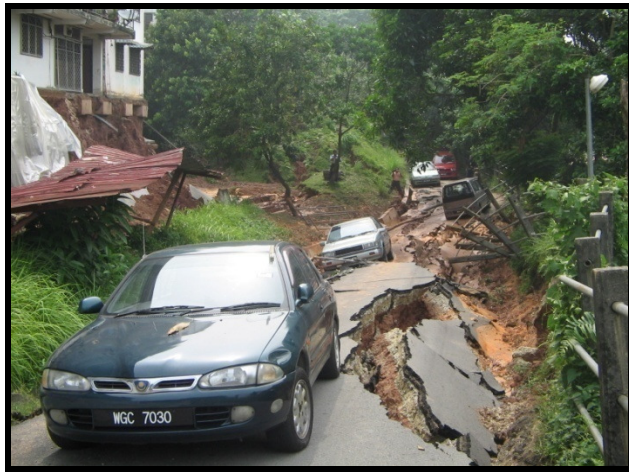
On October 9<sup>th</sup> 2006, a landslide occurred at Seksyen 10 Wangsa Maju, Kuala Lumpur. No casualty was reported but all residents in 3 blocks of 5 storey apartments were evacuated and several cars were damaged as shown in Figure 9. All resident occupied the building one year later after remedial work has been carried out.

Figure 9. Landslide at Wangsa Maju

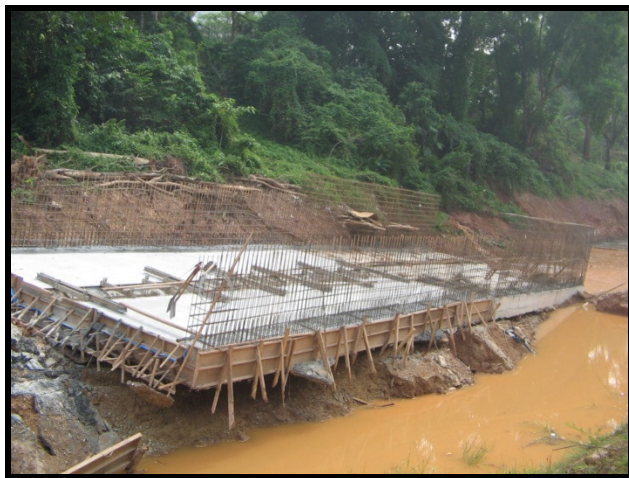
Based on landslide forensic investigation carried out by Landslide Working Committee lead by PWD Malaysia, the cause of failure was due to the disturbed at the toe of the slope in front of the apartment. The toe of the slope was excavated to construct the monsoon drain by the contractor who constructed the highway as shown in Figure 10.

Figure 10. The construction of monsoon drain.

The investigation also found that the slope were stable when the slope was in original condition. However, the analysis showed that the factor of safety ( $FoS < 1$ ) of the slope reduced significantly when the toe of slope was excavated.

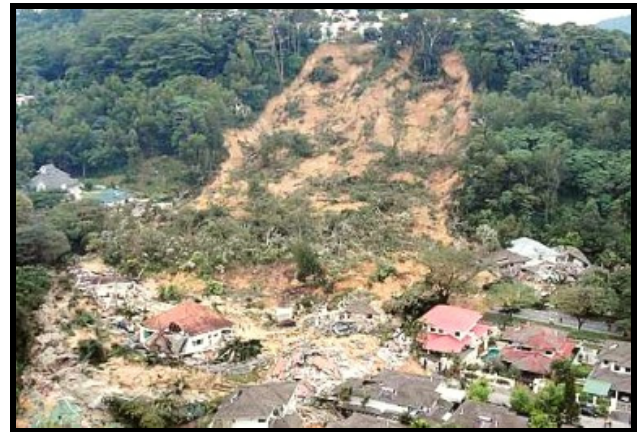
Figure 11. Landslide debris at Bkt. Antarabangsa

The landslide debris completely blocked Jalan Bkt. Antarabangsa, the only road access to some other 2000 residents. 14 bungalow houses were destroyed by the failure debris. The landslide also resulted in 4 fatalities and injury to 14 people as shown in Figure 11.

Based on the investigation carried out by Landslide Working Group lead by PWD Malaysia, the landslide can be classified as deep seated slide. It was found that the causes of the landslide had been contributed by combination of the following factors:-

- i. Loose soil from earth dumping on the slope which took place during the development of the area.
- ii. Prolonged rainfall during the months of November and December.
- iii. Unmaintained/damaged drainage system on the slope.
- iv. Damaged active water pipe along abandoned houses due to soil creep.

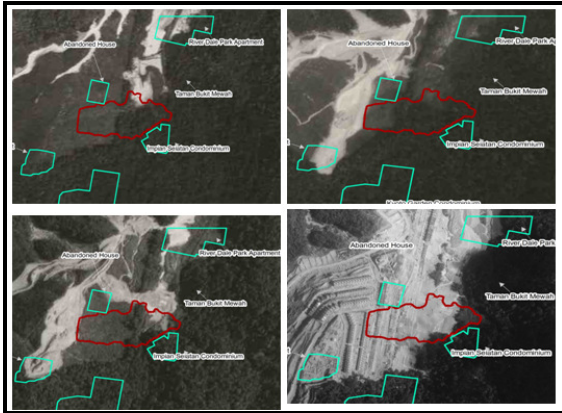
This area started to develop in year 1974. The aerial photographs were taken in 1974 and 1975, it was quite clear that there had been massive earthworks activity at the crest of the failed slope. The aerial photograph that was taken in 1975 also shown signs of earth dumping around the perimeter of the landslide. The earth dumping in general was not compacted and loose in nature.

Figure 12. The aerial photo from 1975 to 1984

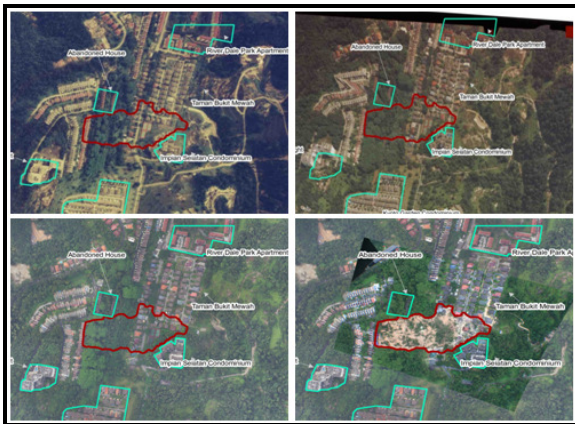
The aerial photograph of 1985 showed the progress of Wangsa Ukay development and the proposed development by developer. It can be seen in the photo that the platforms for the link house units were being prepared.

In 1992, the aerial photograph showed that three rows of abandoned houses were completed and two of the units of the link houses fall within the area of the landslide. However, the two units of the linked houses were not in the aerial photograph dated 1999.

Figure 13. The aerial photo from 1985 to 2004
