Eureka River Landslide, Hwy 726:02 Near Worsley, Alberta: Design and Construction of Remedial Measures

Barry Meays, Donald Proudfoot
Thurber Engineering Ltd., Edmonton, Alberta, Canada

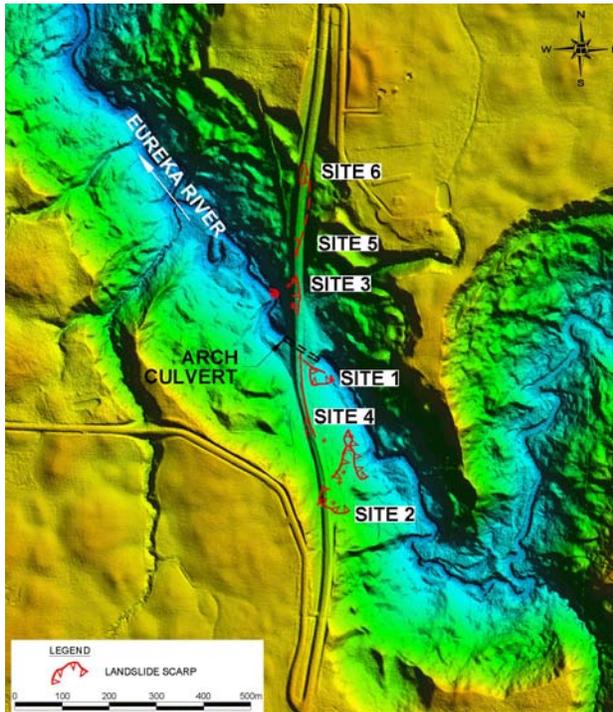
Figure 1. Shaded relief plan showing landslide locations

A shaded relief plan showing approximate locations of the landslide sites at this highway location is presented in Figure 1. Since construction in 1988, six landslides have affected the highway to varying extents along the river crossing slopes.

North of the river, slope movements were first observed in 2001 as minor pavement cracks about 100 m north of the crossing (Site 3), outside of a river meander. Conditions steadily worsened over the years, and a 110 m long scarp crack extended along the highway. Site 3 occurs where the highway is about 15 m above river level.

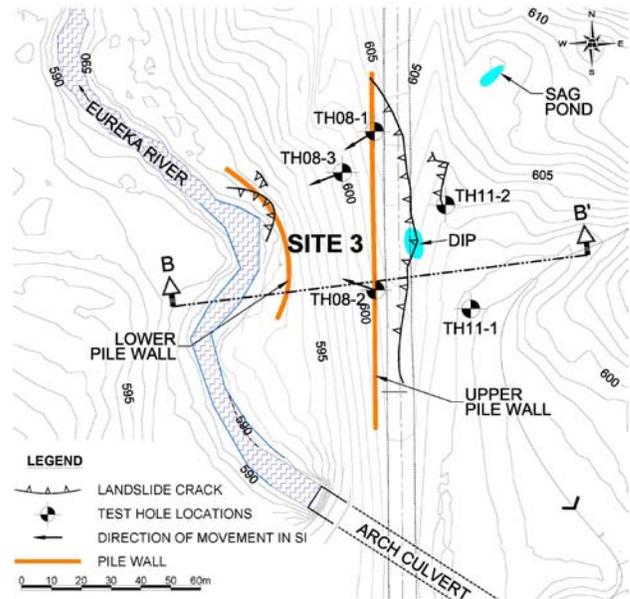
Figure 2. Slide Site 3 Layout

At Slide Site 3, the highway is about 15 m higher than the river on an embankment inclined at between 3.5H:1V to 5.5H:1V. The valley slope above the highway is 30 m high and inclined between 7H:1V to 9H:1V. Figure 2 shows the Slide Site 3 area details.

There was visual evidence to suggest that progressive erosion over time along the outside bend of the river was contributing to the instability by removing toe resistance, resulting in a loss of lateral support downslope of the highway location. It was inferred that there were likely a series of retrogressive slide block failures radiating outwards from the outward bend of the river, with the initial ones beginning nearer the river, and the furthest and most recent currently affecting the highway, (the slide scarp features observed on site are shown on Figures 2 and 3).

The design of a 120 m long tied-back cast-in-place reinforced concrete pile wall to retain the upper portion of the landslide mass was completed in late 2011. Figure 2 shows the layout of the upper pile wall. The centerline was offset a distance of about 8.5 m downslope of the existing highway centerline (or 4 m downslope of the top of paved shoulder edge). A cast-in-place concrete waler/cap beam was required along the top of the piles to provide additional restraint to the pile wall movement and to tie-off the anchors. A cast-in-place concrete retaining wall was constructed on top of the waler/cap beam to retain the highway.

A 60 m long lower cantilever pile wall was designed adjacent to the river approximately along elevation contour 592.5 (shown on Figure 2), where it would perform effectively as a cantilever wall based on the assumed failure plane elevation. The main purpose of this lower wall was to prevent soil from moving downslope and away from the upper pile wall. This was required to maintain higher resistive forces against the upper line of piles which would reduce the net resultant driving forces at the upper pile wall location). It would also reduce erosion and resulting soil loss caused by the river.

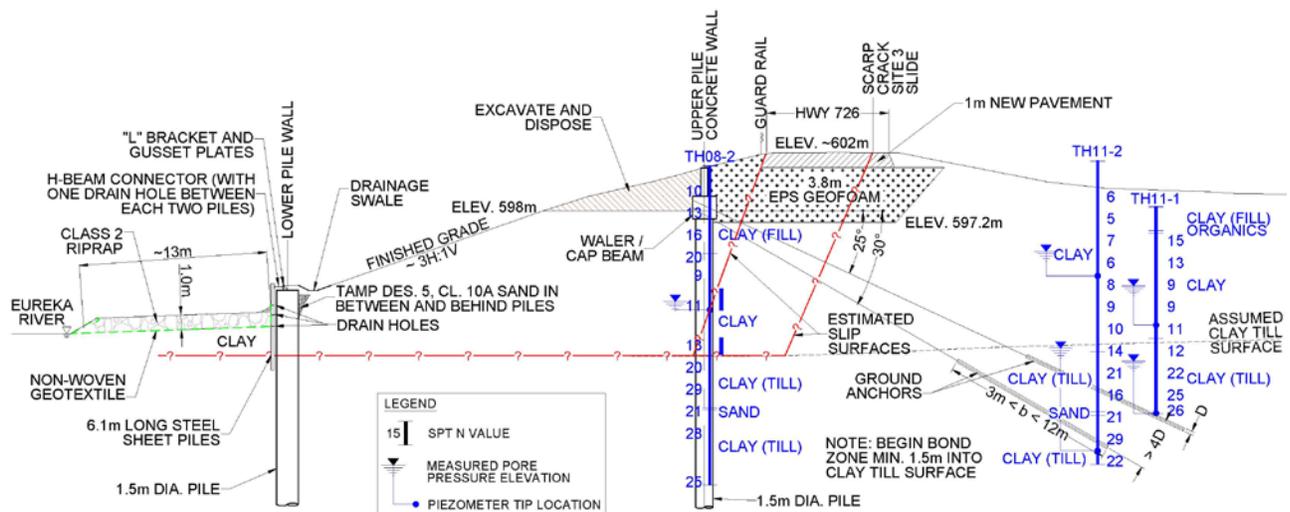
Figure 3. Stratigraphic Cross Section B-B' Perpendicular to Highway

The geotechnical investigations indicated that the subsurface conditions generally consisted of up to 6 m of highly plastic clay fill, overlying native highly plastic clay that extended to depths between 9 to 18 m below surface. The consistency of the native clay varied from firm to very stiff. Very stiff to hard clay till was encountered underlying the clay, and extended to depths of at least 20 to 25 m below surface. The interface between the lacustrine clay and glacial clay till corresponds to about elevations 586 m to 589 m. The clay till surface sloped downwards from east to west towards the river, and from south to north along the highway. The ground water levels within the landslide area were 7 to 12 m below ground surface. Figure 3 shows a simplified stratigraphic cross-section of the slope through the landslide area at cross-section B-B'.

The slope inclinometers (SI) showed that there were two distinct slip surfaces present at each SI location, with the lower one about 3 m below the upper slip surface, and located about 8 to 13 m below the highway surface (varying from elevations 589 m to 597 m). The slip surfaces were located entirely within the high plastic lacustrine clay formation, and extending as deep as, and moving along the surface of the clay till near the center of the landslide. This indicated that the clay/clay till interface appeared to form the base of the landslide slip surface, which was later considered an important design feature. The orientation of the resultant in all three inclinometers indicated that movement was directed towards the outside bend of the river, as shown in Figure 2. It was therefore assumed that the slip surface followed the surface of the clay till until it met the base of the River.

Anchor design input for pullout resistance stipulated that the anchor bond zone must be located completely within the very stiff clay till stratum beginning a minimum of 1.5 m below its surface. The recommended adhesion values for post grouted anchors in this clay till was 65 kPa ultimate, or a ULS factored value of 40 kPa (using a geotechnical resistance factor of 0.6 which assumes that every anchor is proof tested). Anchor design details are shown on Figure 3.

The piles from all three wall sections along Pile Wall 1 were completed with a reinforced cast-in-place concrete grade beam cap (waler), 2.325 m deep and 0.89 m wide. Steel tubing sleeves (trumpets) that were monolithically connected to the anchor bearing plates, were placed through the grade beam over the installed anchor threaded bars to maintain the permanent anchor free stressing length through the waler grade beam. Figure 3 shows schematic details.

During the spring of 2013, it was noticed that erosion and associated soil loss was occurring between the upper portion of the piles of the lower pile wall. Although the design was adequate based on arching theory and allowance for up to 4.5 m of slumped soil away from the downslope side of this wall, this soil loss would affect the functionality of the wall. Therefore, a design modification was implemented that basically involved two key concepts: 1) protecting the pile wall with a continuous curtain of sheet piling over the affected area, and 2) removing some of the slumped soil in front of (on the river side) of the wall and protecting it against river erosion with riprap. Details of some of these lower pile wall design modifications are shown on Figure 3.

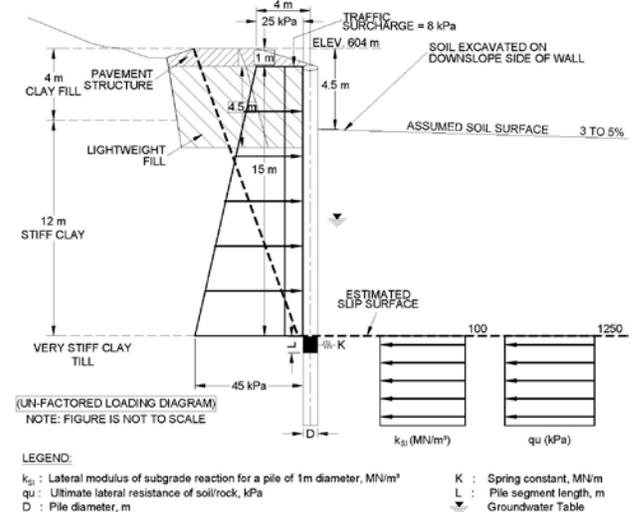
Figure 4. Lateral Soil Model for Central Section of Upper Pile Wall

The long term loading conditions were based on the construction sequence after the tie backs had been installed and locked off onto the waler/cap beam at all three design sections, and the appropriate materials (lightweight, common and pavement fills) had been backfilled against the upslope side of the waler/cap beam and retaining wall. It was also assumed that lateral resistance was provided by the slide mass in contact with the downslope side of the piles below the respective excavation depths at each design section. An additional recommendation for the long term loading conditions design was to limit pile head deflections to 50 mm. For this condition, a tied-back pile wall was required to resist a net un-factored load of 400 KN/m for all three design sections, plus the equivalent traffic load, in order to achieve a minimum long term factor of safety increase of 30%. This 400 KN/m was converted to an equivalent, design pressure distribution acting on the piles over the lengths above the slip surface at each design section. The un-factored loading pressures, resistance pressures, and design parameters for the long term loading conditions at the upper pile wall for the most critical (central) design section B+2 are shown on loading schematic Figure 4.

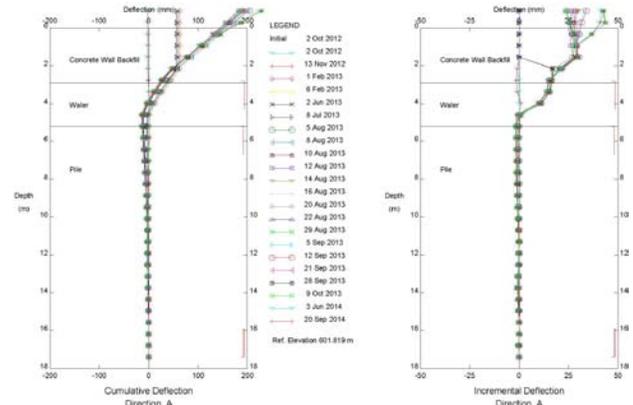
Figure 6. SI12-P17U (Cumulative and Incremental Deflections vs Depth Plots)

The readings in the upper wall SI's generally indicated that, prior to stressing the anchors, pile movements were slightly toward the river in the downslope (positive) direction. However, upon stressing, the piles and waler were initially pulled into the hillside in the negative

direction, by between 12 mm to 17 mm at the top of pile, and by up to 31 mm at the top of the waler. However the movements have since reversed and are trending downslope as the slide pushes against the pile wall, with the latest (fall) 2014 readings showing downslope movements between 0 and 11 mm/year over the length of the piles. For illustration purposes, the incremental and cumulative deflections versus depth plots in SI12-P17U (the centre inclinometer in the upper wall) are presented in Figure 6.

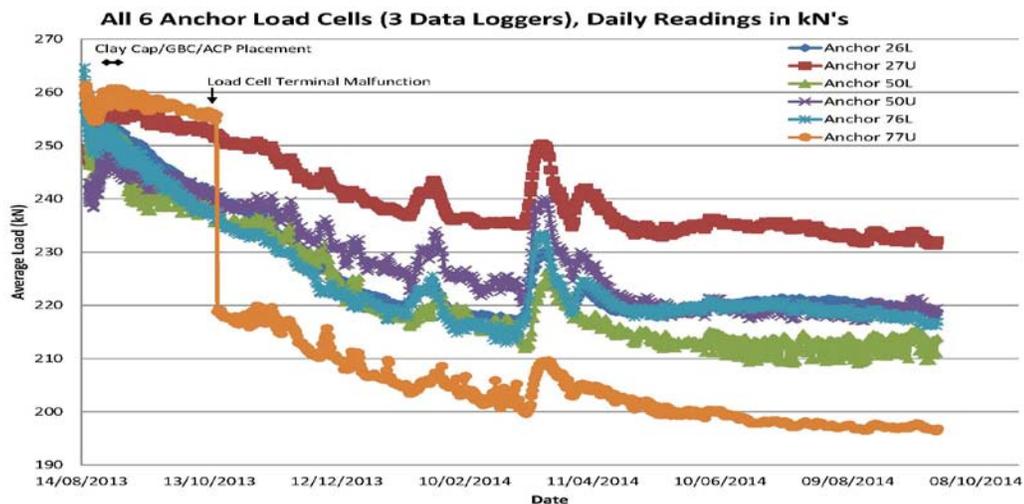
Figure 7. Variations of Anchor Loads with Time

Figure 7 shows the variation of the six anchor loads (VC1759 to VC1764 inclusive) with time for the upper pile wall. Three dataloggers were set up to record load readings every 12 hours starting in August, 2013. As mentioned previously, the anchors were targeted to be locked off about 5% higher than the design lock-off loads (ranging between 245 to 255 kN), anticipating future load dissipation. Initially the load cells for the three anchors along the lower row reflected loads in the target range, and then decreased by about 4 to 6% after 1 month. Comparatively, the load cells for the three anchors along the upper row were more variable, and initially increased by about 5 to 10 KN (~2 to 4%) in response to compaction of the highway pavement structure, and thereafter dropped off. In the fall of 2014, five of the anchor loads ranged between 213 to 220 KN, which is a drop of 10 to 15%, however anchor VC1764 read 235 KN, a drop of 6%. All six of the anchors exhibited a general trend of load fluctuations between about 3 to 5 KN (~2%) due to daytime and nighttime temperature changes.

The reduction in the anchor loads can be attributed to the non-simultaneous locking of anchors and re-distribution of loads along the wall. It is of interest to note that the decline in anchor loads was not accompanied by any significant ground movements and therefore the performance was considered acceptable as long as the current and future load losses do not reduce the anchor loads below that required for maintaining the stability of the retaining structure. So far, the pile deflections indicate that the pile walls and LWF are effective in stabilizing the landslide.
