# Evaluating the Performance of a Frozen Core Dam Founded on Ice Rich Saline Marine Silts and Clays

Maritz Rykaart, Megan Millar, John Kurylo & Lowell Wade  
SRK Consulting (Canada) Inc., Vancouver, British Columbia, Canada

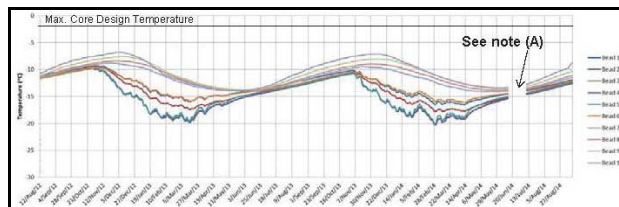
Figure 7. Time series data for ground temperature cable ND-HTS-130-28.8

Figure 7 also demonstrates how effective the thermosyphons are in cooling down the core and foundation. The lower three beads of GTC ND-HTS-130-28.8 shows markedly lower temperatures than the other beads of the same strings. These beads are in close vicinity of the thermosyphons and are therefore the lowered temperatures are recorded.

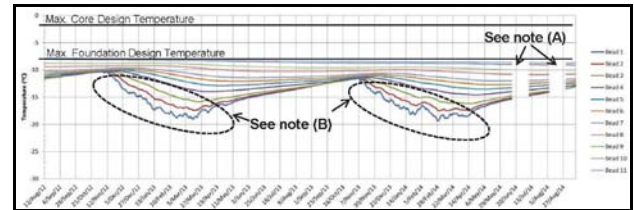
Figure 8. Time series data for ground temperature cable ND-VTS-060-KT

Note (B) on Figure 8 provides another example of how the cooling effect of the thermosyphons is confirmed through monitoring.

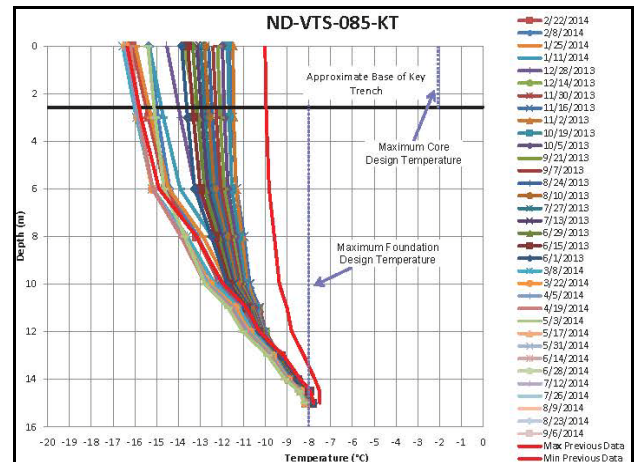
Figure 9. History of ground temperature cable data for ND-VTS-085-KT

The bottom two beads (beads 10 and 11) of ND-VTS-085-KT have a measured maximum temperature between  $-7.5^{\circ}\text{C}$  and  $-8^{\circ}\text{C}$  (Figure 9). This is sufficiently close to the required design temperature to suggest that the design target has been met.

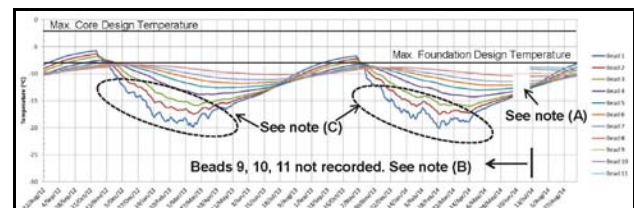
Figure 10. Time series data for ground temperature cable ND-VTS-175-KT

The measured maximum foundation temperatures directly below the frozen core for GTC ND-VTS-175-KT were approximately  $-6^{\circ}\text{C}$  from May 2013 to September 2014. However, the maximum measured temperature has decreased from the maximum measured temperature May 2012 to May 2013 (Figure 10). Should this cooling trend remain consistent, it is expected that the required design temperature would be reached within the next year.

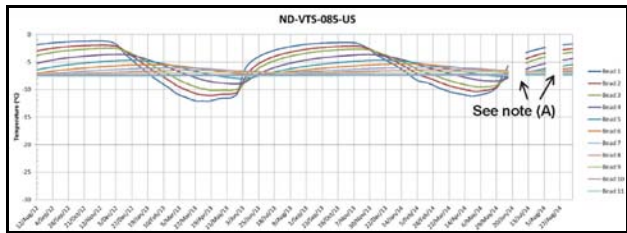
Figure 11. Time series data for ground temperature cable ND-VTS-085-US

The maximum measured temperatures of near surface beads for vertical GTCs upstream and downstream of the key trench were between  $0^{\circ}\text{C}$  and  $-1^{\circ}\text{C}$  in 2014. These maximum measured temperatures were generally colder than what was recorded in 2013 suggesting a definitive cooling trend. These warmer temperatures are however

consistent with the design thermal modeling. Figure 11 provides an example of this for GTC ND-VTS-085-US.
