# The Inuvik Airport Runway – An evaluation of 50 years of performance

Ed Hoeve

Don Hayley

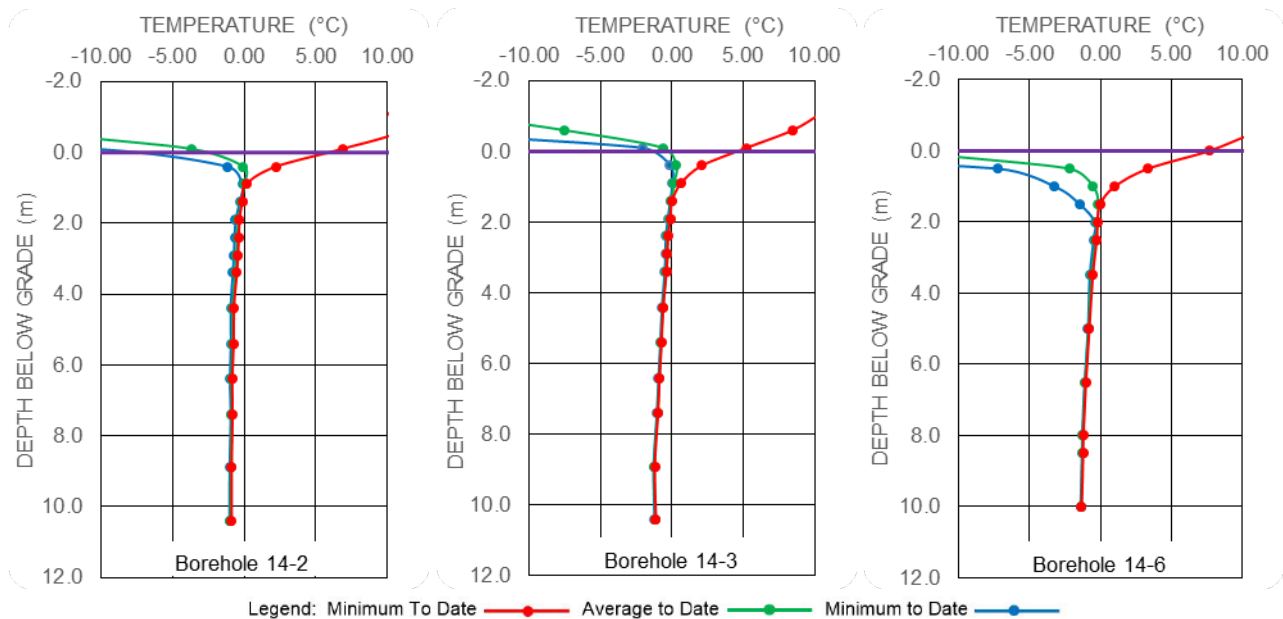
The ground temperature envelopes in Figure 5 indicate active layer thicknesses ranging from 1.4 m to about 2.0 m, and averaging about 1.6 m. These installations compare most closely with the relatively undisturbed location underlain by fine-grained soil, at which an active layer of thickness of 1.5 m was reported by Pihlainen (1962). This suggests that climate warming has not significantly impacted the active layer thickness to-date. This also supports the previously discussed conclusion that significant warming at the toe of slope, as a result of embankment construction, is not evident.

Figure 5. Recent ground temperature profiles along the edge of the runway

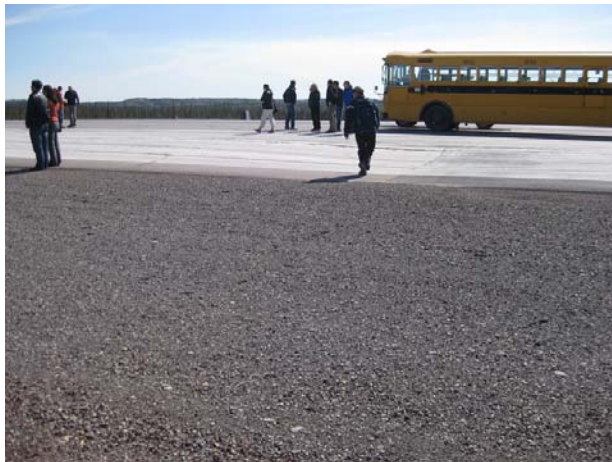
- The north side of the runway, approximately 300 m from its east end (Figure 6). This area is an infilled thermokarst pond, where permafrost likely aggraded with high ice contents, and former shallow drainage channel to the south (Tetra Tech EBA 2014a); and
- Taxiway E, near the intersection with the runway (Figure 7). The intersection formed a barrier to natural surface drainage to the southwest, following taxiway construction. A previous attempt to stabilize the area involved the installation of insulation within the fill and a concrete apron in 2008.

Figure 6. Subsidence area on north side of Runway 06-24; summer

The locations of these areas are shown in Figure 2. Both areas exhibited water at the toe of the embankment, indicating interrupted surface drainage; and longitudinal tension cracks in the gravel shoulders, indicating permafrost degradation. Both areas were given particular attention during a geophysical investigation at the airport (Tunnicliffe et al. 2011).

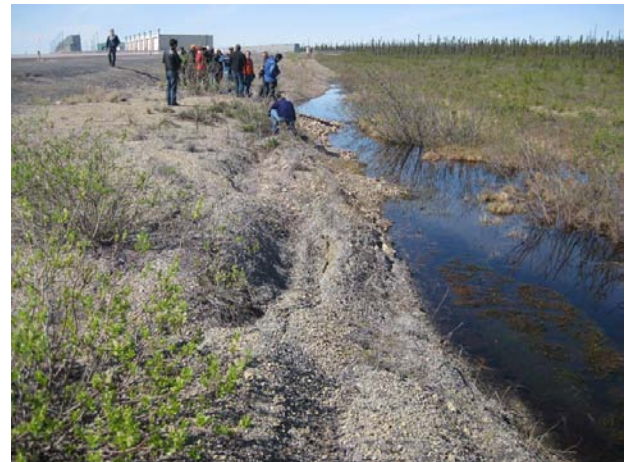
Figure 7. Runoff collecting along east side of Taxiway E, and associated subsidence; summer 2011

- An insulated drainage structure was installed across the settlement area in Taxiway E in 2011, in connection with relevelling and embankment slope regrading. The area continues to undergo settlement. It is considered to be too soon to know if this ongoing settlement is the result of further permafrost degradation, or consolidation of previously thawed soil.
- Ditch clearing and regrading was undertaken in 2014, to limit the collection of water along the east side of Taxiway E and the north side of the runway.

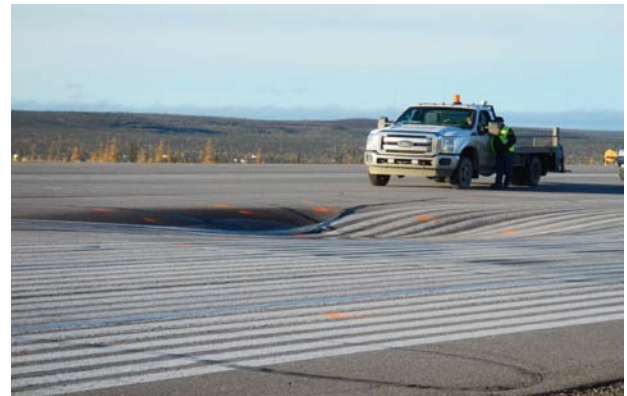
In the late summer of 2013 a sinkhole developed rapidly in the north side of the runway, at the previously identified subsidence area, about 300 m from the east end. Within about 5 days, the sinkhole reached a maximum depth of about 0.5 m, was about 10 m long and several metres wide (Figure 8).

Figure 8. Settlement location looking southwest along historic drainage path; fall 2013 (Neil Parry)

The area was repaired by filling and casting a reinforced concrete apron, at least as a temporary measure. A geophysical investigation was undertaken to evaluate the extent of the impacted area and the risk of further sinkhole development (EBA 2013). The area continues to be monitored, and subsidence is ongoing, but not at the rate exhibited in 2013.

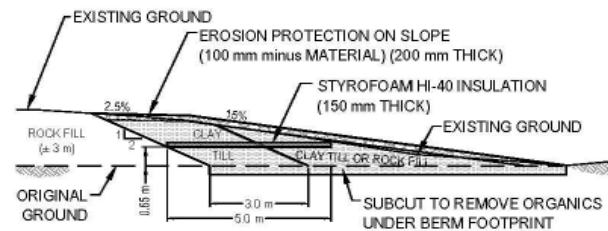
Figure 9. Cross-section of insulated seepage control berm

A seepage barrier has been designed for the north side of the runway, adjacent to the settlement area, but construction has not yet occurred. In concept the seepage barrier involves excavating down through the organic soil to the native fine-grained till, then constructing an insulated berm with fine-grained fill. The configuration is shown in Figure 9. This structure has three purposes:

- Impede the flow of water under the runway, with a low-permeability, physical barrier;
- Thermally stabilize the ground, by placement of insulation; and
- Redirect flow towards existing drainage, through improved surface grading.
