Geophysical imaging of permafrost conditions along the northern Yukon Alaska Highway

Greg A. Oldenborger & Anne-Marie LeBlanc
Geological Survey of Canada, Ottawa, ON, Canada
Chris W. Stevens
SRK Consulting Inc., Anchorage, AK, USA
Jason Chartrand
Geological Survey of Canada, Ottawa, ON, Canada
Benoit Loranger
Université Laval, Québec, QC, Canada

Challenges from North to South
Des défis du Nord au Sud

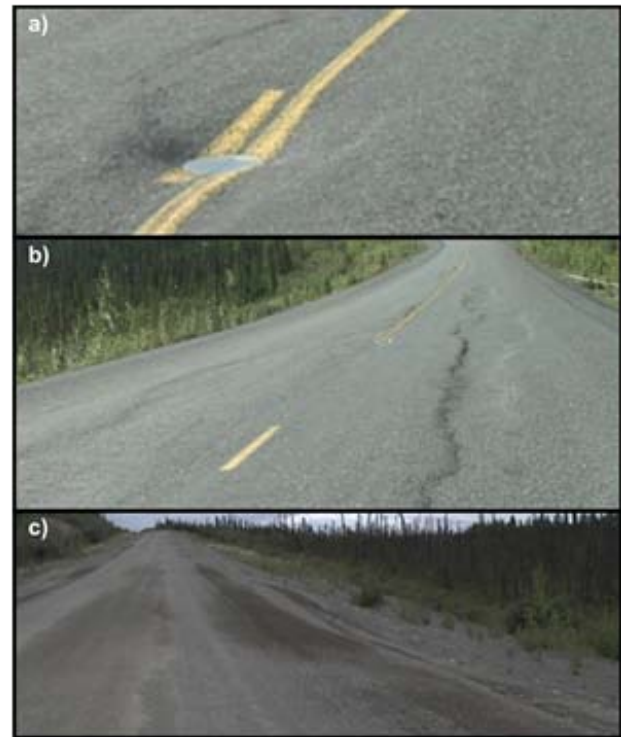
large areas and affecting significant portions of the road surface and/or embankment. Local settlement includes damage such as sinking guardrails, isolated sinkholes and small depressions (Figure 2a). Linear settlement includes damage such as elongated depressions, cracking of the road surface or embankment and culvert failure (Figure 2b). General settlement includes large sections of differential settlement over the road and/or embankment (Figure 2c). In addition, the severity of the observed damage was classified in a purely relative sense as light, medium or severe.

Figure 2. a) Localized damage: punctual thaw settlement, km 1896.2, 2011. b) Linear damage: longitudinal settlement, km 1896.4–1896.2, 2011. c) General damage: differential settlement, km 1894.4–1894.3, 2012.

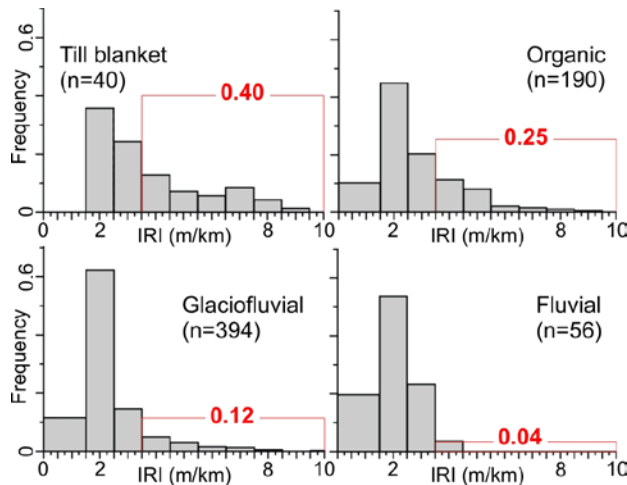
We analysed the International Roughness Index (IRI) measurements (provided by YHPW) from Kluane Lake to the Canada-US border for the year 2010 (Figure 3). IRI represents cumulative vertical displacement of a sprung mass relative to a vehicle axle over a 100 m distance. Very poor highway conditions most frequently occur within Till and Organic surficial units for which ICE is encountered at a range of depths; poor IRI regions are also encountered for units with no observed ICE, although other types of ground ice may be present (Oldenborger et al., 2015). Surficial geology units with better IRI distributions are glaciofluvial, fluvial, colluvial and eolian. Causes of surface roughness may reside below the depth of the mapped surficial geology. Furthermore, repair history, which is unaccounted for in this analysis, may bias the observed distribution of IRI values in that

Figure 3. IRI measurements for km 1684.0–1902.5 classified as good: 0.0–1.5 m/km, ok: 1.5–2.5 m/km, poor: 2.5–3.5 m/km and very poor: 3.5–10 m/km. The portion of very poor conditions is indicated in red.

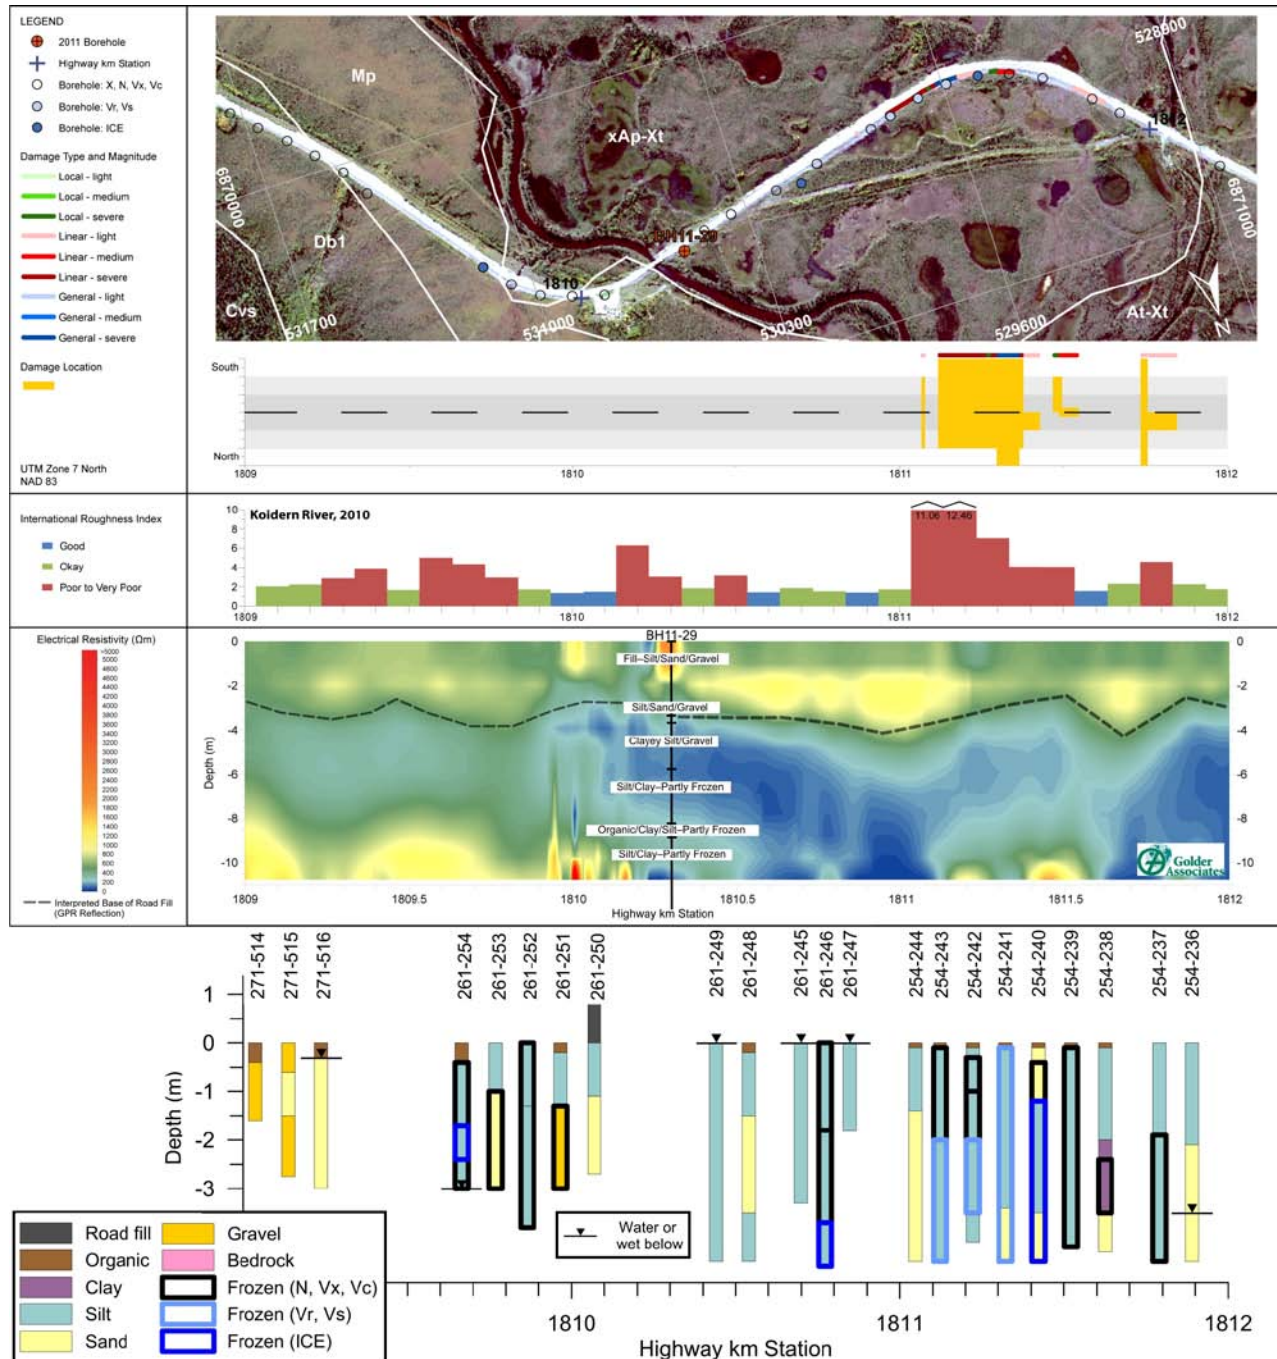
The Koidern River highway section extends from km 1811.1–1814.0 (Figure 1) and crosses a fluvial plain consisting of silt with organic surface cover (Figure 4). Geotechnical boreholes indicate that the sediment texture transitions from mostly silt with sand to sand and gravel across nearby fluvial terraces. The highway section extends across thermokarst terrain which closely follows the limit of the silt-rich fluvial plain. Boreholes confirm that ground ice is a major component of the cryostratigraphy (boreholes 261-254 to 254-237).

Highway damage along the Koidern River section was identified in 2010 mostly as light-to-severe linear settlement coincident with poor to very poor IRI measurements. Conversely, poor and very poor IRI measurements are not necessarily accompanied by observable surface damage as classified here using vehicle-level photographs. Observable damage appears to be confined to the thermokarst terrain and related to observations of ground ice, whereas poor to very poor IRI measurements extend across thermokarst terrain into morainal tills with no observed ground ice (boreholes 271-514 to 271-516).

Despite the multiple borehole observations of ground ice, recovered electrical resistivity is generally low along the Koidern River section. The transition from the more resistive morainal tills (300–800 Ωm) to silt-rich ground (<400 Ωm) is apparent near 1809.9 km. From there, a conductive anomaly extends below the interpreted depth of road fill from 1810–1812 km which corresponds to the extent of the thermokarst terrain and may result from appreciable unfrozen water in the silty sediments.

Observed damage does not seem to be related to the conductive anomaly over its entire length. In fact, the observed damage and the historical ground ice observations occur within a region of increased resistivity (1811.1–1811.6 km). This zone of increased resistivity is interpreted to represent ice-rich frozen ground that is undergoing degradation in the midst of relatively unfrozen and wet, but more stable ground. After repairs in 2010, the IRI measurements over the interpreted frozen ground

Figure 4. Koidern River section: surficial geology (Lipovsky and Bond, 2014), damage observations, IRI measurements, geophysical survey results (Hammond, 2013), geotechnical borehole record (Lister, 2011) and sediment texture and ground ice data from 1993 (Lipovsky, 2009).

continued to increase whereas the remaining IRI values, although poor, remained the same (Oldenborger et al., 2015).

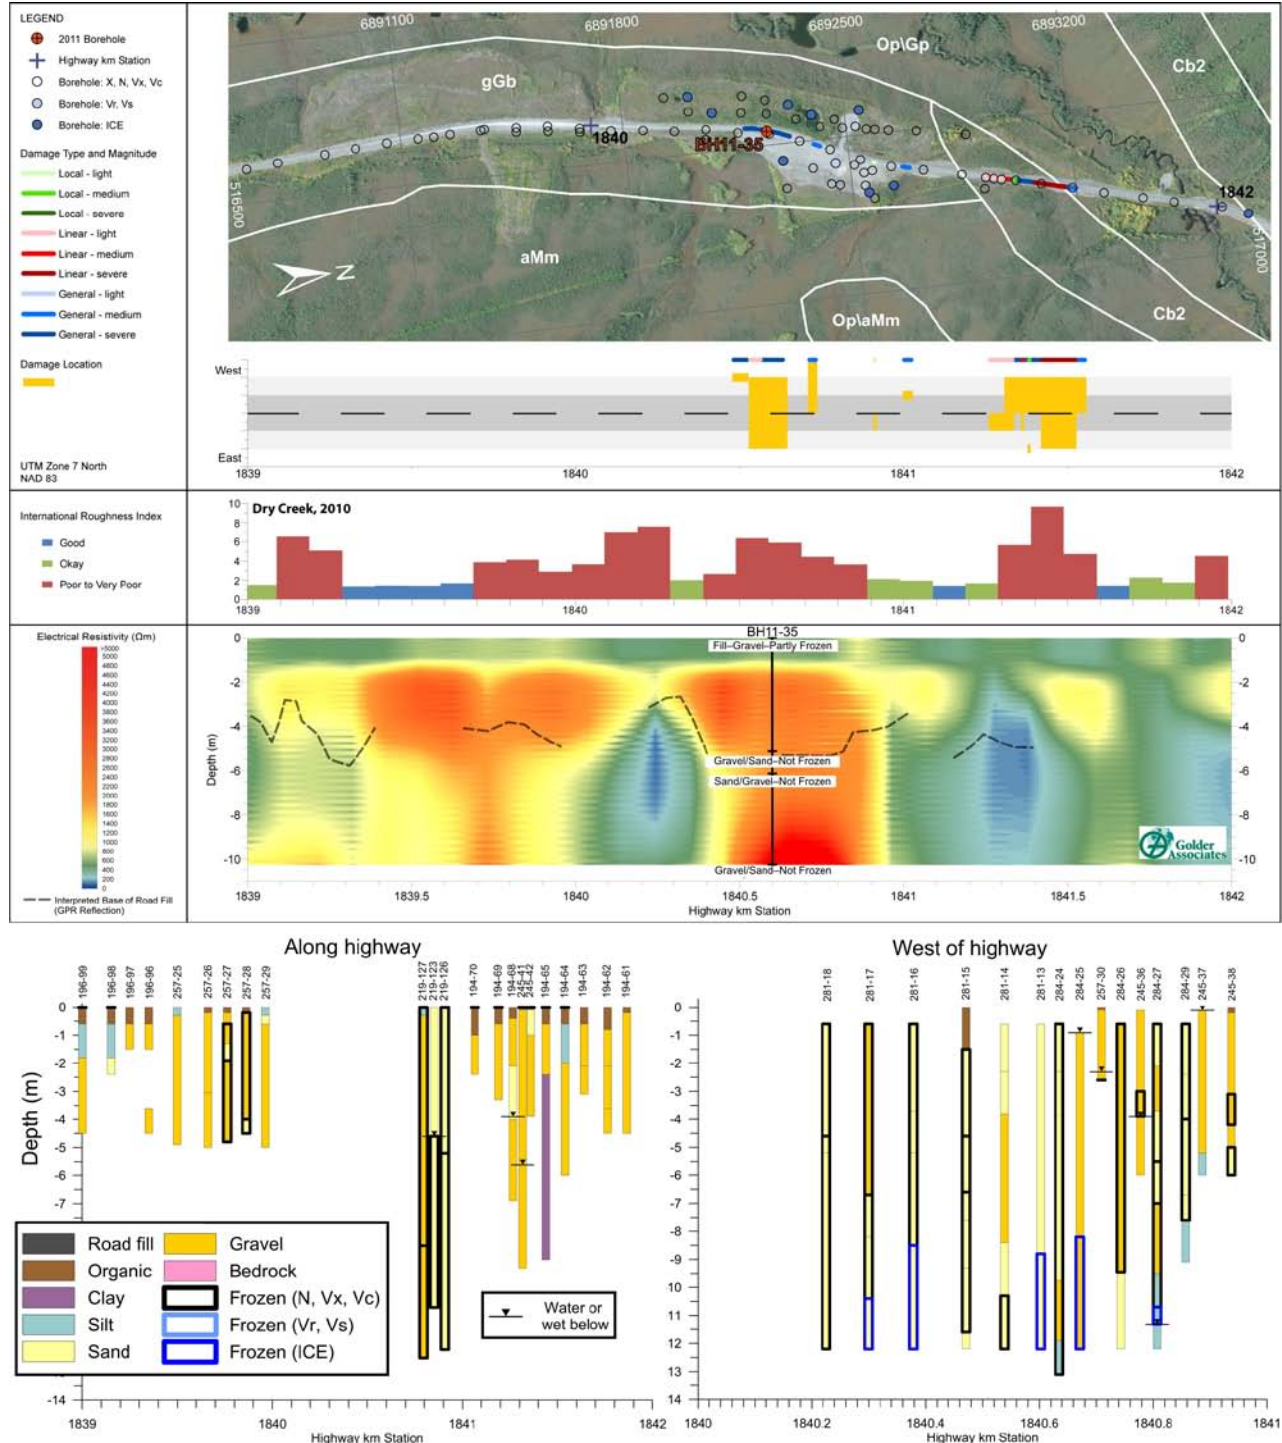
Figure 5. Dry Creek section: surficial geology (Lipovsky and Bond, 2014), damage observations, IRI measurements, geophysical survey results (Hammond, 2013), geotechnical borehole record (Lister, 2011) and sediment texture and ground ice data from 1992-1994 (Lipovsky, 2009).

The Dry Creek section extends from km 1837.5–1842.0 (Figure 1) and crosses glaciofluvial and organic terrain underlain by glaciofluvial sediments of McConnell age (Figure 5). The general cryostratigraphy for the glaciofluvial deposit is characterized by relatively ice-poor sands and gravels underlain by deep-seated ground ice below about 6–7 m (boreholes 281-17 to 284-25). Given the low potential for ice segregation in sand and gravel, it is postulated that the ground ice described in the geotechnical boreholes for the Dry Creek section represents relic massive ice buried under glaciofluvial deposits.

Observed highway damage includes all forms of settlement characterized mostly as moderate to severe. Local and linear settlements predominately occur west of the highway, extending from the embankment to the adjacent highway lanes. Again, observed damage coincides with poor and very poor IRI measurements, but there are many poor IRI measurements that have no apparent associated damage.

Observed road damage near 1840.6 and 1841.4 km is associated largely with unfrozen sand and gravel (glaciofluvial) with limited potential for segregation ice. However, there is a distinct cluster of ICE and other ground-ice observations located near the road. There is apparent correspondence between ice occurrence, observed damage and poor IRI measurements near 1840.6 km. Degradation of deep ice may explain the observed highway damage and the absence of thermokarst directly adjacent to the road.

Borehole observations of ICE are perhaps deeper than the reliable depth of investigation of the CR survey. However, there is a clear resistive anomaly ($>4000 \Omega\text{m}$) at 1840.5 km starting around 8 m depth underneath the already resistive sands and gravels ($2000\text{--}4000 \Omega\text{m}$). This is likely the signature of massive ice, but it does not appear to be encountered by BH11-35.

In contrast, there are no observations of ICE along the road near the damage location of 1841.4 km. This zone is associated with a conductive anomaly ($<400 \Omega\text{m}$) that occurs near borehole observations of unfrozen clay. The anomaly appears to continue into the highway embankment. Such an observation would be consistent with increased moisture content or active groundwater within the embankment and natural ground. Heat advection, thaw settlement of any partially frozen clay, mechanical erosion and seasonal freeze/thaw would all contribute to damage of the highway surface for this zone.

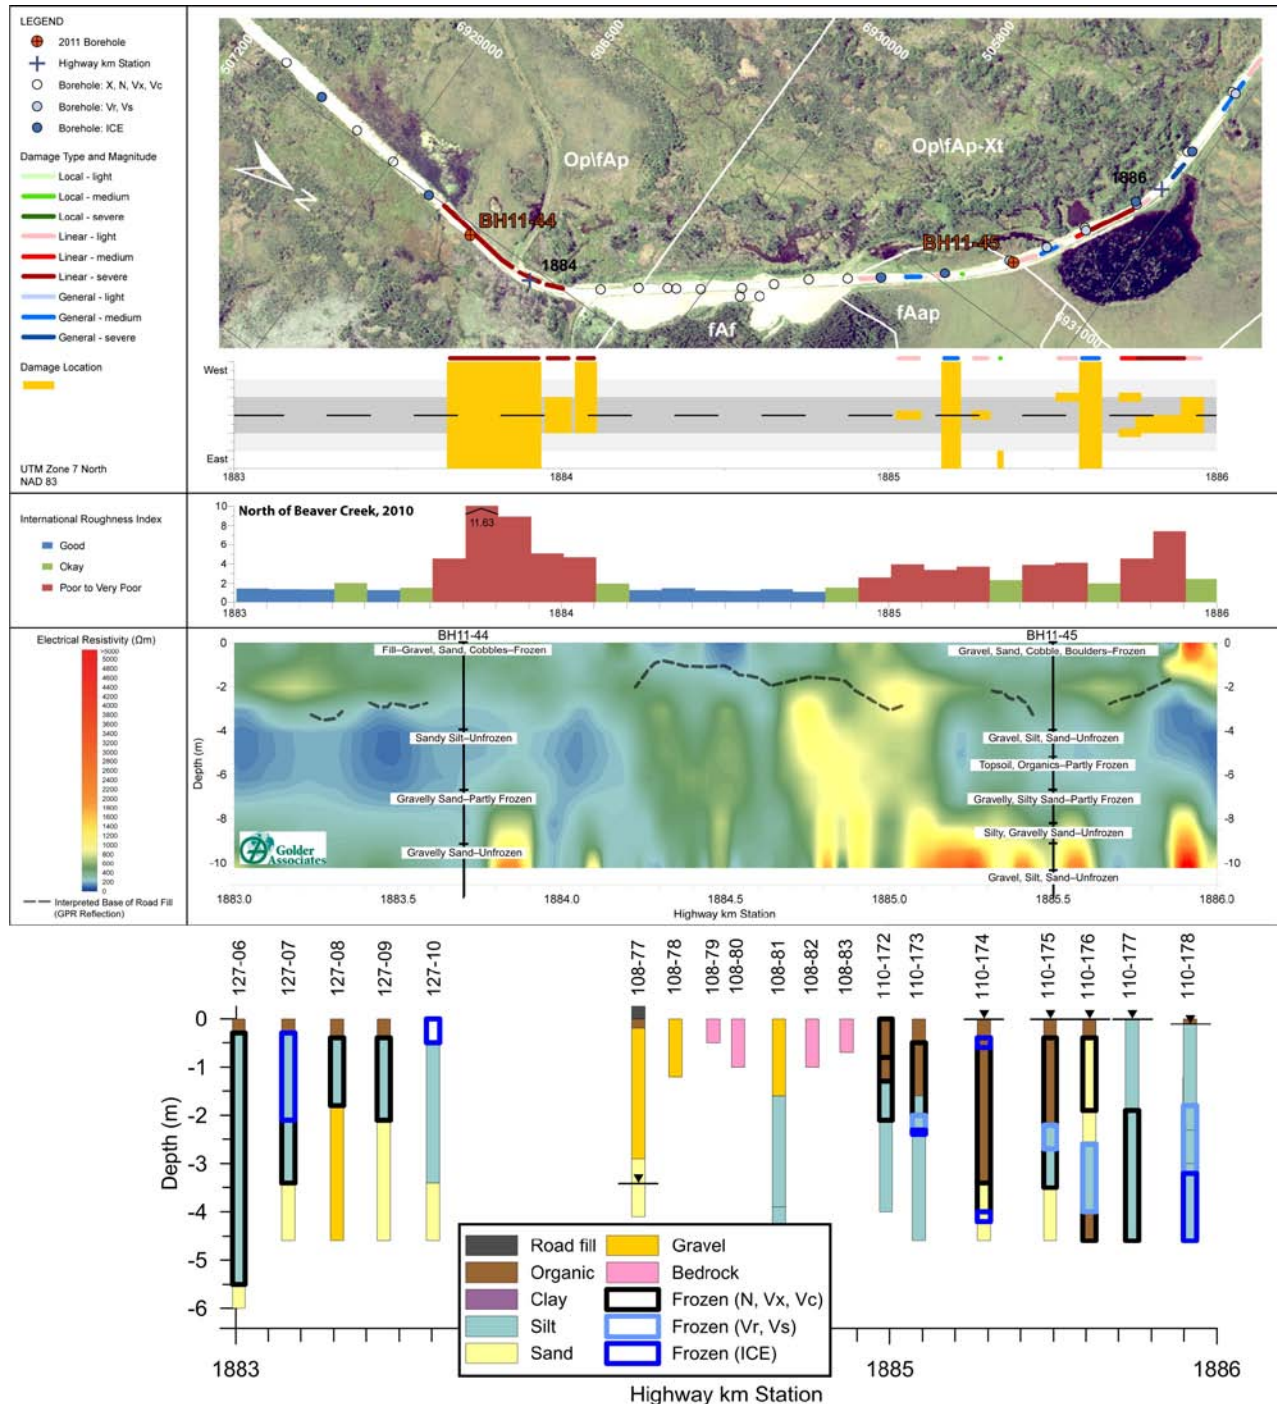
The Beaver Creek section extends from km 1882.6–1898.1 (Figure 1). From km 1883–1886, organic surficial material overlies fluvial sediments and thermokarst features appear across portions of the organic units (Figure 6). Sediment texture is variable; observations of ground ice are prevalent and confined largely to silt. There

are some observations of thick frozen organic material that will be highly susceptible to thaw settlement. This section of highway is oriented perpendicular to the direction of surface hydrological flow. Poorly-drained terrain surrounds the highway from 1884–1886 km and surface hydrology or shallow groundwater may play an important role in highway performance.

This part of the Beaver Creek section appears to have a strong relationship between observed damage, poor IRI measurements, and the occurrence of ground ice (boreholes 110-172 to 110-178). However, there is no obvious consistent electrical resistivity anomaly that coincides with the zones of damage. Both sections of elevated IRI measurements near BH11-44 and BH11-45 seem to exhibit reduced resistivity of the embankment material, and high attenuation of the GPR signal is observed near BH11-45 (Hammond, 2013) consistent with increased unfrozen water content or shallow groundwater. These conductive embankment sections occur over silt and organics with ground ice as observed in BH11-44 and BH11-45. It is inferred that the combination of a conductive embankment over conductive frozen silts represents a resistivity anomaly indicative of shallow groundwater-related settlement.

In contrast, the highest observed embankment conductivity is from 1884.1–1884.8 km, but is over borehole observations of bedrock and gravel and coincides with stable good IRI measurements. The resistivity signature of bedrock is not readily apparent, but is interpreted as the moderately resistive anomaly ($1200 \Omega\text{m}$) from 1884.7–1885.1 km below 1–2 m depth. The weakly resistive anomaly ($800 \Omega\text{m}$) from 1884.2–1884.6 km below 2 m depth is interpreted as predominantly gravel. Therefore, a conductive embankment signature alone is not necessarily indicative of settlement.

Figure 6. North of Beaver Creek section: surficial geology (Lipovsky and Bond, 2014), damage observations, IRI measurements, geophysical survey results (Hammond, 2013), geotechnical borehole records (Lister, 2011) and sediment texture and ground ice data from 1990–1991 (Lipovsky, 2009).
