# Temporary Slope Stabilization at the Airport Trail Tunnel Excavation, City of Calgary

Paul Xu, Ognian Gubev, Bronwen Kelley  
Laura Normore, Tara Rihn, Lee Nichols  
*Terracon Geotechnique Ltd., Calgary, Alberta, Canada*  
Kelly Illerbrun  
*PCL, Calgary, Alberta, Canada*

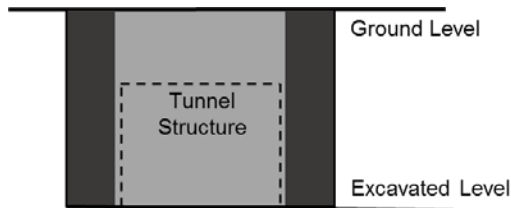
Figure 1B - Near vertical slopes require engineered shoring

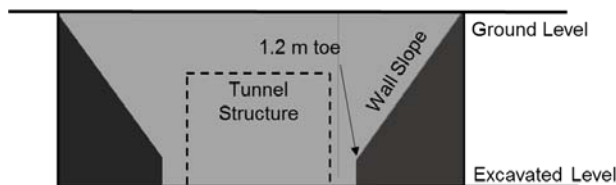
Figure 1D - 0.5H:1V globally stable slopes offer reduced excavated volumes relative to Figure 1A with modest slope protection

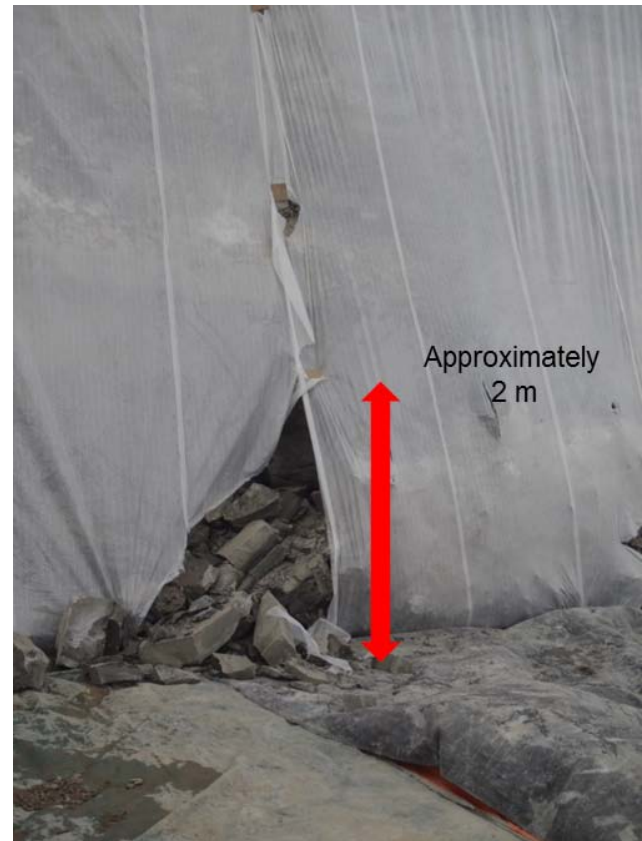
Figure 2: Rockfall Incident Photograph

By late November of 2011, the excavation of the initial portion of the tunnel had been completed and some concrete work had started when an uncontrolled rockfall incident near the toe of the open cut rock slope occurred. Given its safety implication, this rockfall incident shut down all construction activity below the excavation slopes.

The delay and the slope protection scope had the potential to have significant impacts to the overall project plan (cost and schedule). The rock fall occurred as a wedge failure where the bottom 1.2 m was excavated vertical to allow more working room to complete form work and concrete work. The PVC tarps that were draped on the slopes partially guided the rockfall. It was also observed that the PVC tarps were holding ravelled rock pieces in various locations potentially leading to additional safety concerns if the tarps failed. They were not designed to retain broken rock.

Observation of the uncontrolled rockfall incident sites suggests that the root cause is the alternating layers of the weak, rapidly weathered claystone/shale and hard, more competent siltstone and sandstone. Based on the observation and analysis, Terracon engineers interpreted the rockfall to be attributed primarily to the following processes:

- As the side slope is cut and subject to various elements, the poorly indurated shale/claystone becomes fissured under active weathering and gravity transport, and eventually constitutes a progressive mass wasting (ravelling) process and contributes to small talus pile formation at the toe when the highly fissured shale/claystone, usually in beds of 1 cm or so, disintegrates;

- B. When the shale/claystone ravel, the overlying rock is undercut or develops an overhang condition. Eventually, as the raveling reaches a critical point or joint surface, the overlying rock cannot support its own weight as well as those above it and breaks away, causing a rockfall event.

In mid-December of 2011, Terracon Geotechnique Ltd. was retained to investigate this incident, the construction safety of the slopes and to recommend mitigating measures that would allow the construction activities at the site to resume and continue in a safe manner. Terracon conducted a review of the initial rockfall site, original design considerations, geotechnical site investigation findings, construction plan, local geology, construction issues and analyses to develop recommendations for mitigation strategies. In addition, Terracon conducted immediate and regular slope monitoring to proactively observe the slopes to ensure the site was safe for work to proceed while further mitigation measures were evaluated.

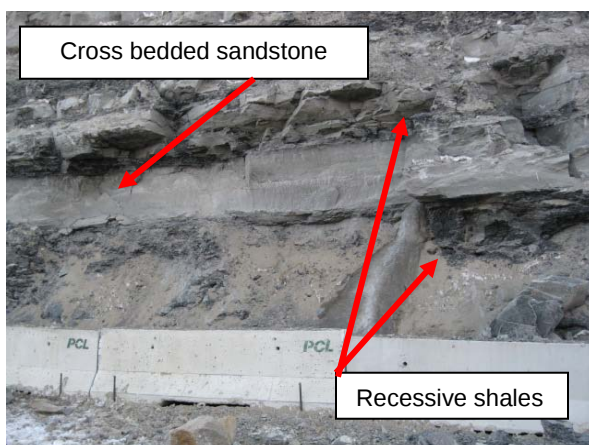
Figure 4: Typical Bedrock Vertical Composition at ATT Excavation (December 16, 2011)

Consistent with the regional bedrock geology, the Tertiary sediments at the tunnel construction site are essentially flat lying and the beds are interpreted to have negligible deformation by tectonic forces. The observed fracture network overprinting the bedded sediments at the ATT site showed no sign of displacement. Bedding orientation relative to the fracture array can be seen in Figure 4.

\*Note fracture orientation and spacing

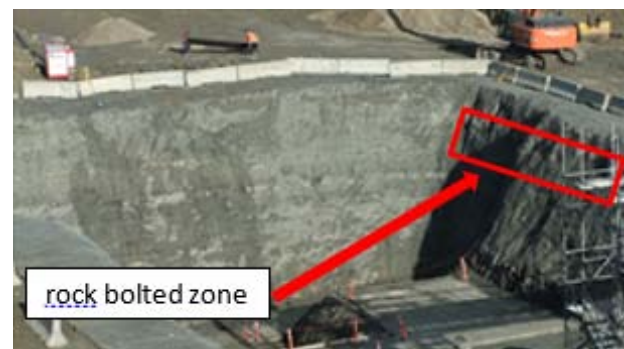
Figure 5: Example of Rock Bolted Zone

However a tension zone defined by a crack 15 m long set back 1.5- 2 m from the wall crest developed shortly after the excavation was completed. A stability analysis was completed and it was decided to bolt this tension zone.

In light of the tension zone which developed in the sandstones at the top of the West face of the excavation. Terracon completed a rock bolt design to stabilize this incipient failure zone. This mitigation measure was completed with the installation of approximately 25 bolts of 19 mm #6 Dywidag threadbase (CSA G30.18) cut to 5 m lengths, complete with flat face plates 250 mm square. This tension zone was stabilized and monitored as part of the monitoring effort of the storm water tank excavation. The bolts were placed in two horizontal rows on a 1 m by 1 m spacing, with the top row being 1 m below the crest.
