Grierson Hill Slide and Stabilization Strategies for Developments in the Area

Xiaobo Wang, Robin Tweedie *Thurber Engineering Ltd., Edmonton, Alberta, Canada* Paul R. Lach *City of Edmonton, Edmonton, Alberta, Canada*

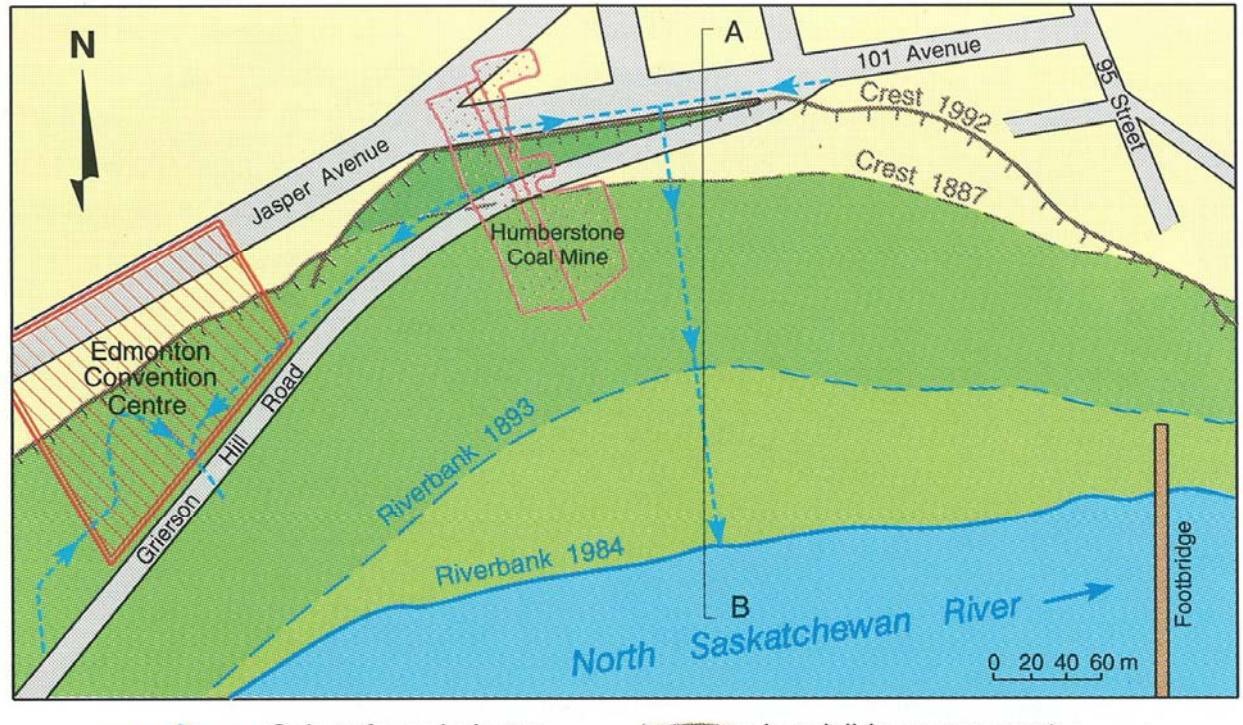
The Grierson Hill Slide still remains active after more than a century. Since the initial slope failure, the Grierson Hill slope crest has retrogressed 30 m to 40 m and the riverbank has moved out more than 100 m into the river channel from its 1883 pre-slide location (Figure 1).

Figure 1. Site plan of the Grierson Hill Slide showing change of slide toe and crest (from Godfrey 1993)

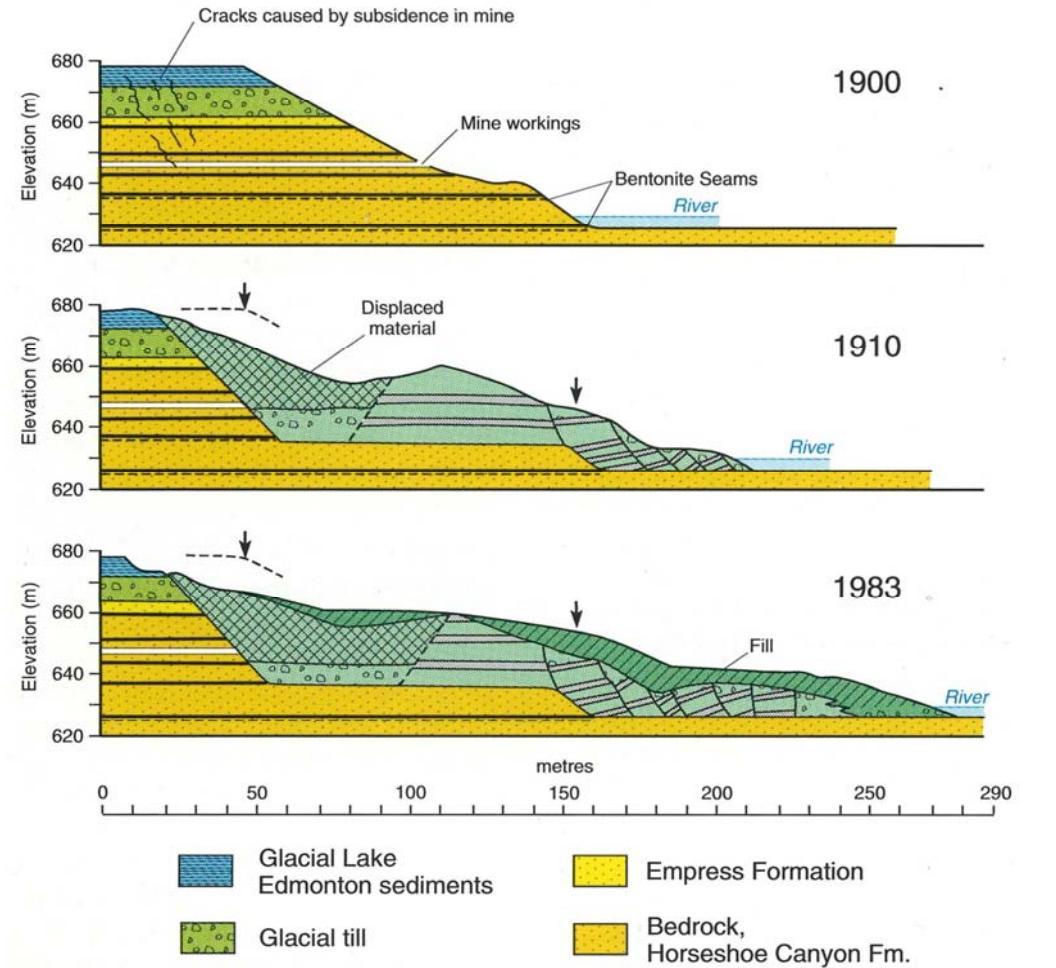
Figure 2. Stratigraphic sequence of the Grierson Hill Slide and changes of the slope configuration from 1900 to 1983 (modified from Godfrey 1993)

As illustrated in Figures 2 and 3, placement of a large amount of the fill in the graben area promoted instability of the slide and pushed out the Lower Slide debris further into the North Saskatchewan River.

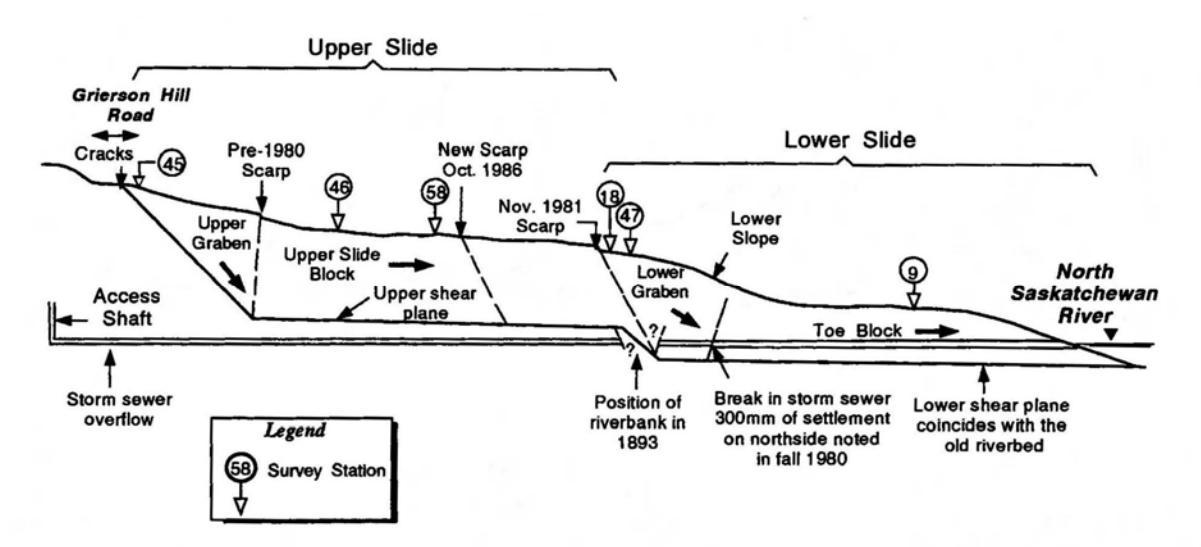
The findings from the geotechnical investigations and slope movement monitoring indicated that the Grierson Hill Slide was a deep-seated translational slope failure (Martin et al. 1998). The slide moved southwards into the North Saskatchewan River along planar near-horizontal shear surfaces that developed along distinct bentonite seams within the bedrock. The initial slide eventually broke up into two separate slides of smaller scale, designated as the Upper Slide and Lower Slide, which have moved independently, at different rates along two distinct slip surfaces, as illustrated in Figure 3.

Figure 3. Schematic diagram of the Grierson Hill Slide failure mechanisms (from Martin et al. 1998)

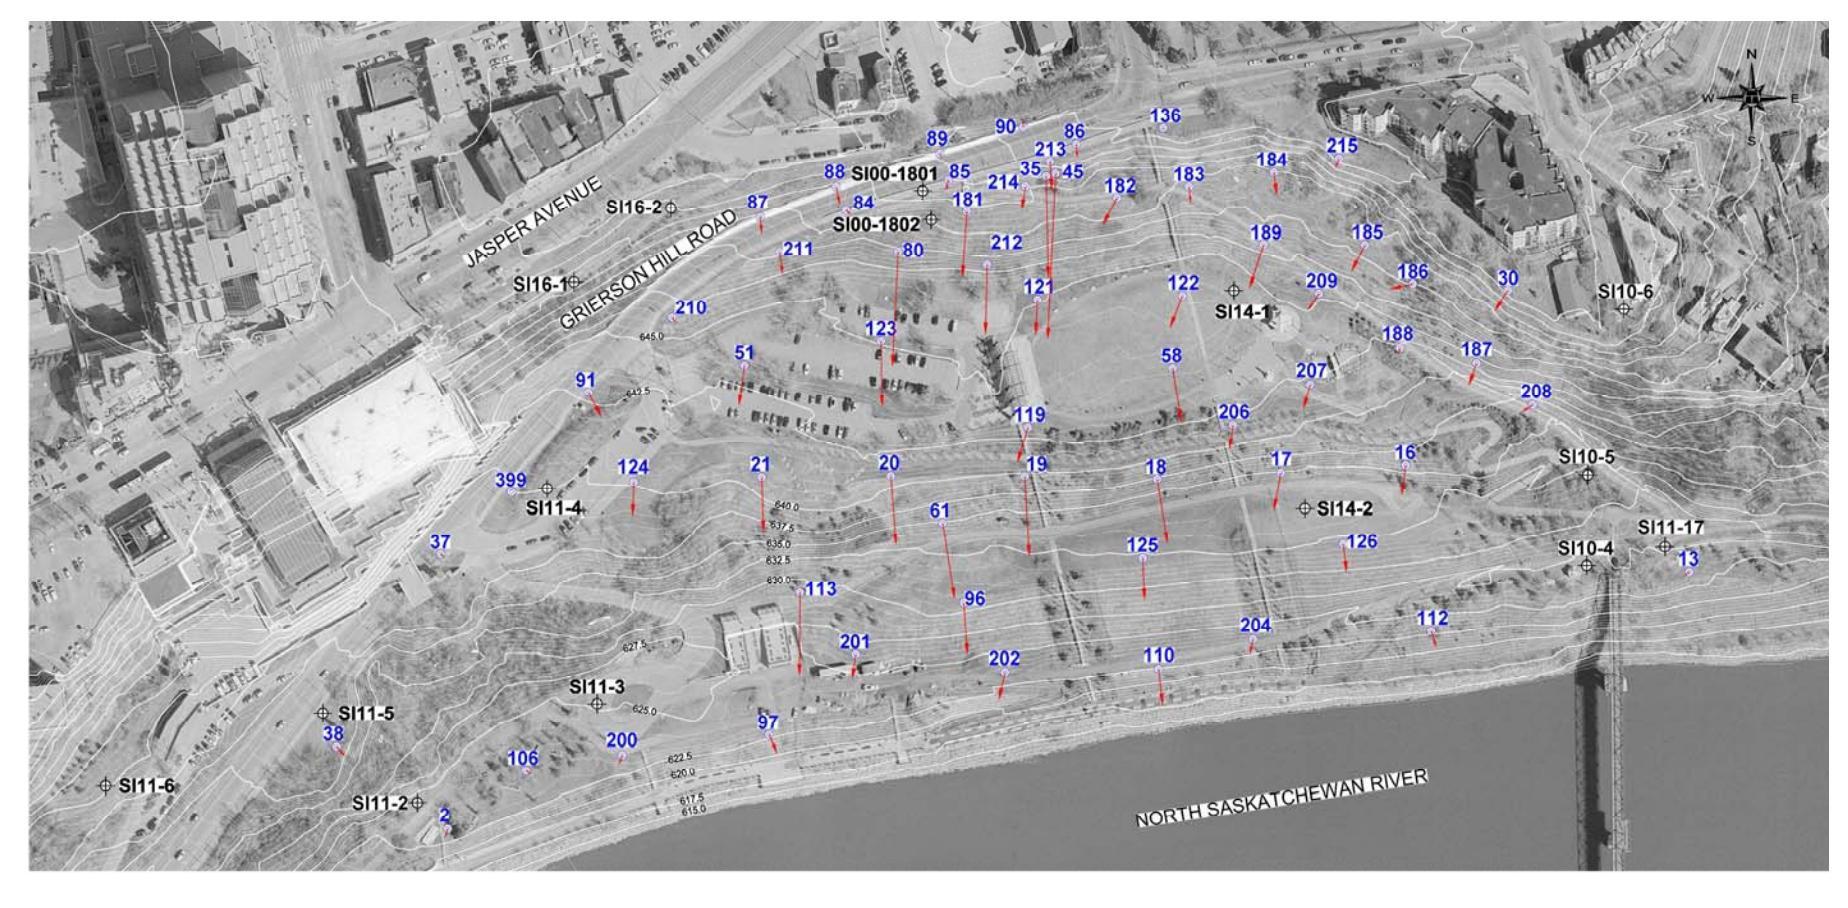
The results of the ground surface survey programs undertaken between 1950 and 1996 were reported by Martin et al. (1998). Figure 4 shows the locations of the survey stations and associated movement vectors based on the survey data in 2016. Table 1 provides a summary of the recorded ground movement from 1901 to 2016.

Slope monitoring over the last 15 years has indicated relatively small on-going movements along the deepseated pre-sheared sliding surface, indicating that the deep-seated movements are relatively dormant at present. However, noticeable surficial slope movements have been detected within the overburden soils from several slope inclinometers. The monitoring results are consistent with the findings of the ground survey of the Grierson Hill slope, which have shown that most noticeable slope movements have taken place throughout the central part of the Grierson Hill Slide with lesser movements on the east and west flanks of the lower slopes.

Figure 4. Site Plan showing locations of slope inclinometers, ground surface survey stations, as well as movement vectors based on survey data from 2001 to 2016

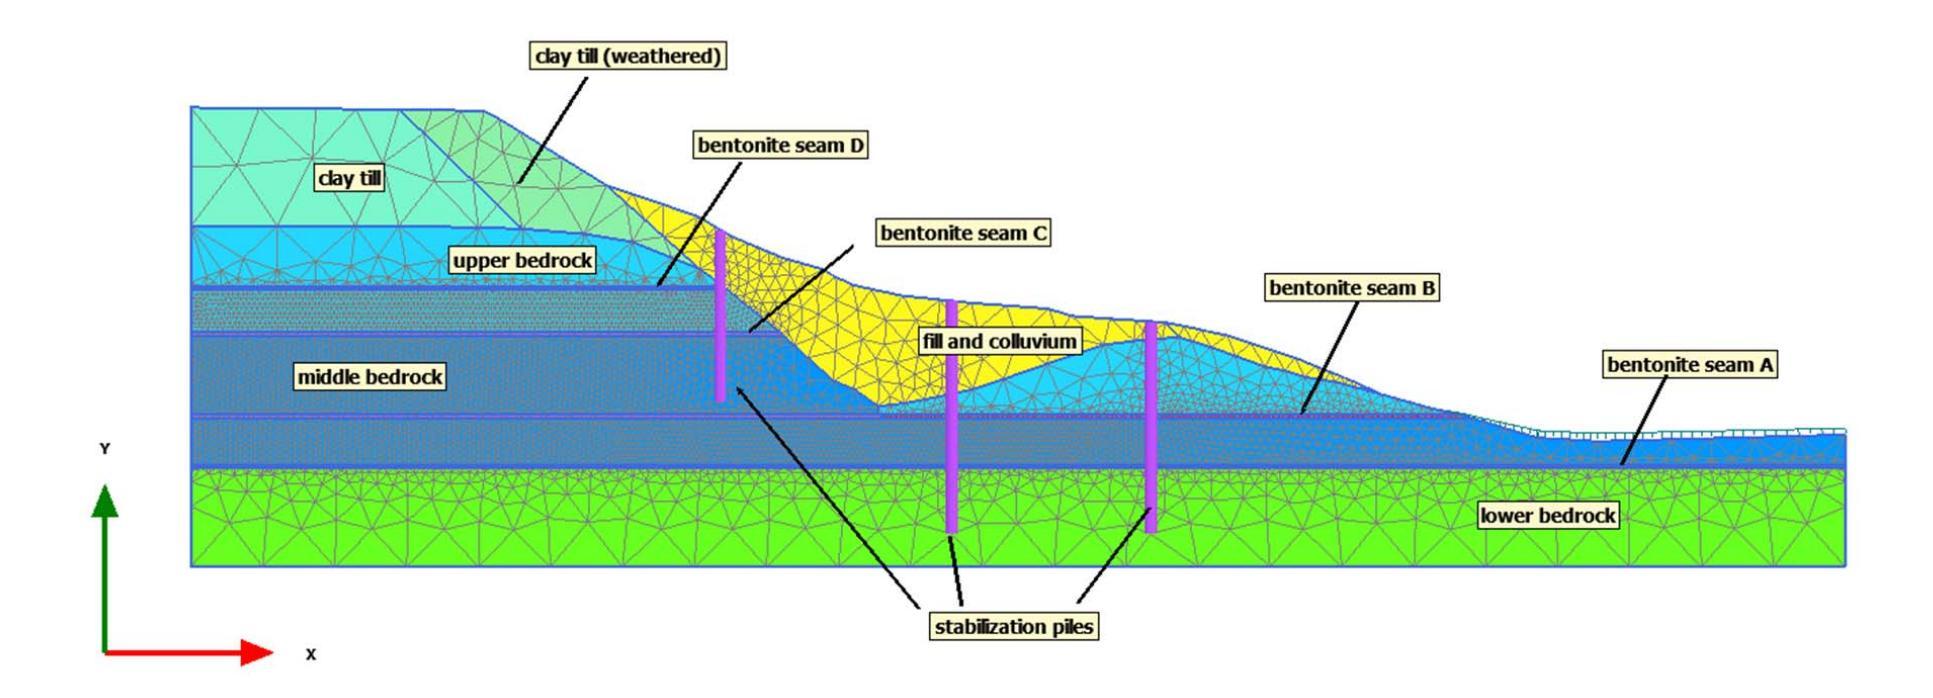
Figure 5 Conceptual design of slope stabilization piles for the Edmonton Valley Line LRT in the Grierson Hill Slide Area

Slope stability analyses were performed to evaluate the long-term stability of the LRT works and the need for slope reinforcement measures (Wang and El-Ramly 2012). Even though discernable deep-seated movements were not detected in the short term, the stability analyses indicated that the slope had a relatively low factor of safety, in the range of 1.1 to 1.3.

Based on the potential failure modes identified from the slope stability analyses, multiple rows of vertical pile walls were required to improve the local and global stability of the natural slope. An upper row of piles was required near the tunnel portal to maintain positive support to the upper slopes. Additional rows of piles were required below the tunnel level on the flat portion of the riverbank to anchor the slope toe and enhance the stability of the lower slope (Figure 5).

The final slope reinforcement design consisted of 34 cast-in-place concrete piles in four rows. The bottom two rows consisted of 15 cast in place concrete piles, 2.1 to 2.4 m diameter, and extending 30 m deep. The upper two rows consisted of 19 piles of 1.5 m diameter with pile length varying from 35 to 47 m. All the slope stabilization piles extended about 8.5 m below the deepest potential sliding surface. The slope stabilization piles were installed between July 2017 and March 2018. Construction of the LRT tunnel portal and bridge abutment on the slope commenced after the bottom two rows of stabilization piles were in place.
