Catastrophic piping failure of Saskatchewan Provincial Highway No. 16: A geohazard case study

P. Jorge Antunes MDH Engineered Solutions Corp, Regina, SK, Canada Moir D. Haug Department of Civil and Geological Engineering, University of Saskatchewan, Saskatoon, SK, Canada D. Chad LePoudre MDH Engineered Solutions Corp, Saskatoon, SK, Canada Brent L. Marjerison Saskatchewan Ministry of Highways and Infrastructure, Saskatoon, SK, Canada

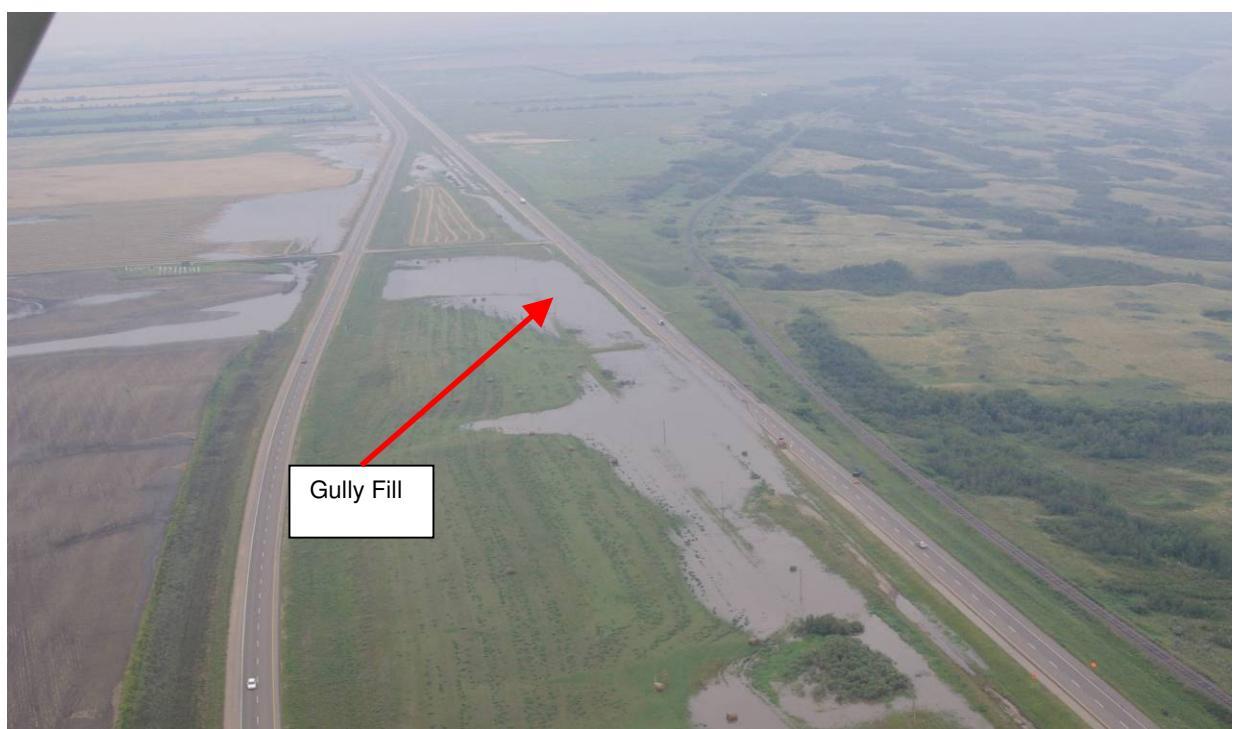
On 17 - 19 August 2007 a severe (1:50 year) rain event occurred (approximately 200 mm in 48 hours) in the Langham area. Water backed up behind the eastbound lanes of PH No. 16 and flowed into the gully between the eastbound and westbound lanes (Figure 2 and Figure 3). The water began to build up due to the inability for the long through grade culvert to pass the water flows. The water began to run towards the east and flow through the highway at that point. This culvert was unable to handle all of the flow and at approximately noon on 19 August 2007, the water began to overtop the highway surface of the westbound lanes approximately 150 m east of the Gully Fill. At this location, a sideslope failure occurred on

Figure 2: Aerial view of site looking west

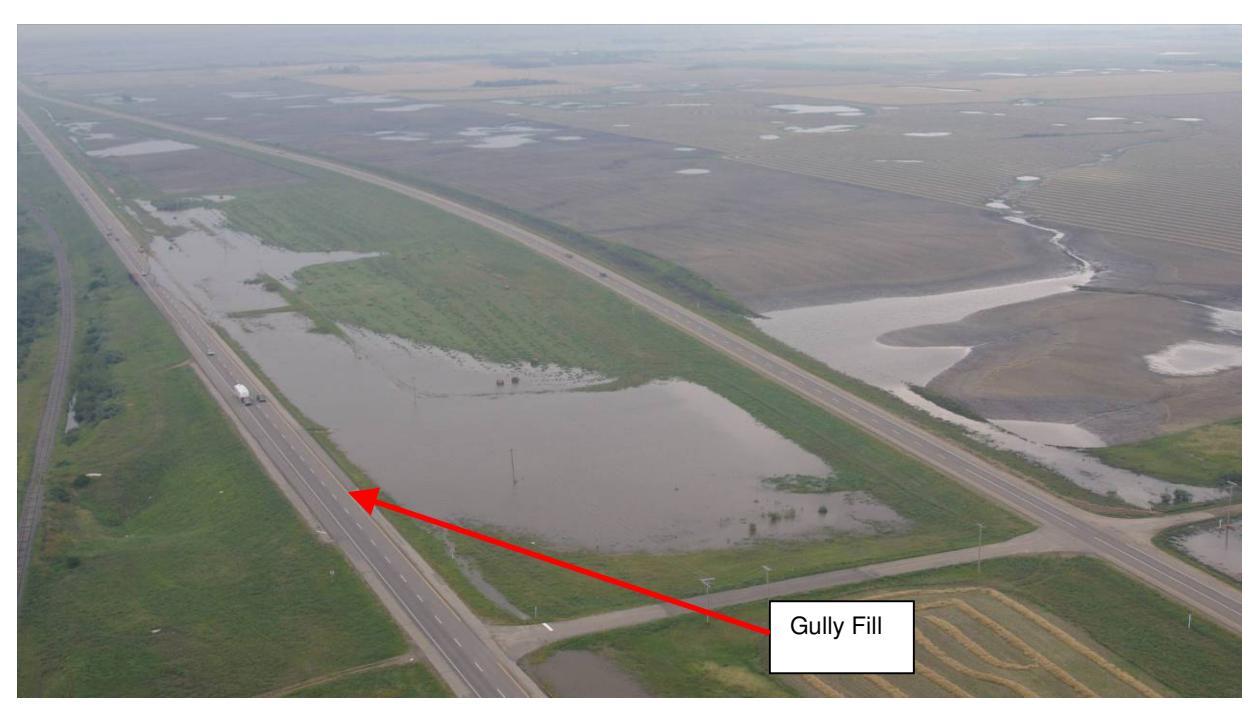
Figure 3: Aerial view of site looking southeast

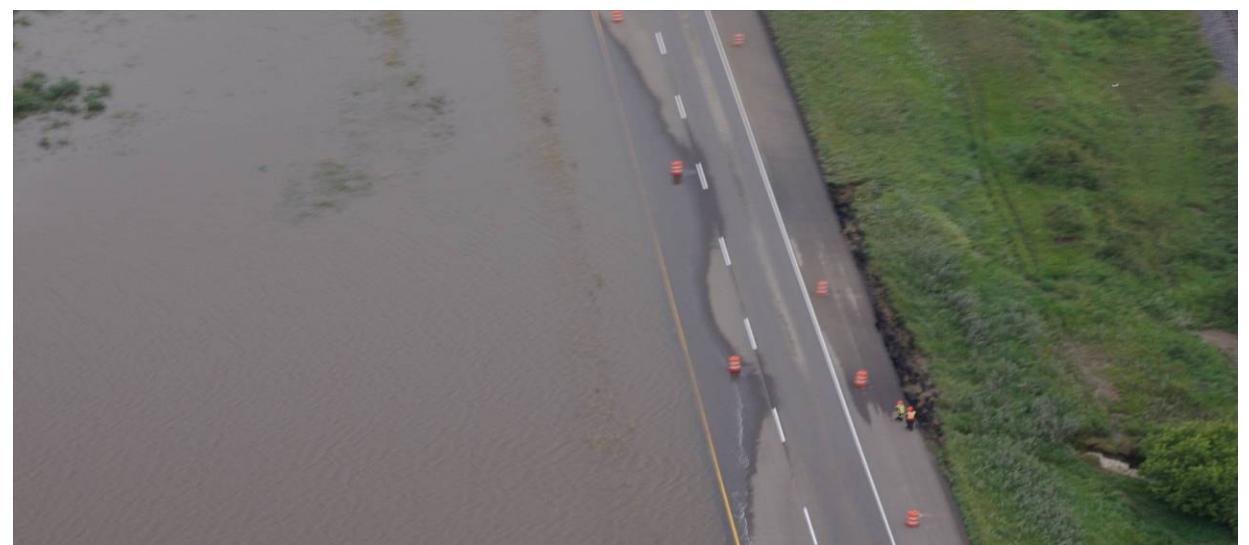
the north slope of the westbound lanes due to the overtopping event. The vertical headscarp drop at the north pavement edge was in excess of 2 m for a length of approximately 70 m (Figure 4). The location of this failure is the same location as the repairs to the embankment conducted in 1993.

Figure 4: Aerial view showing water overtopping highway and small slide

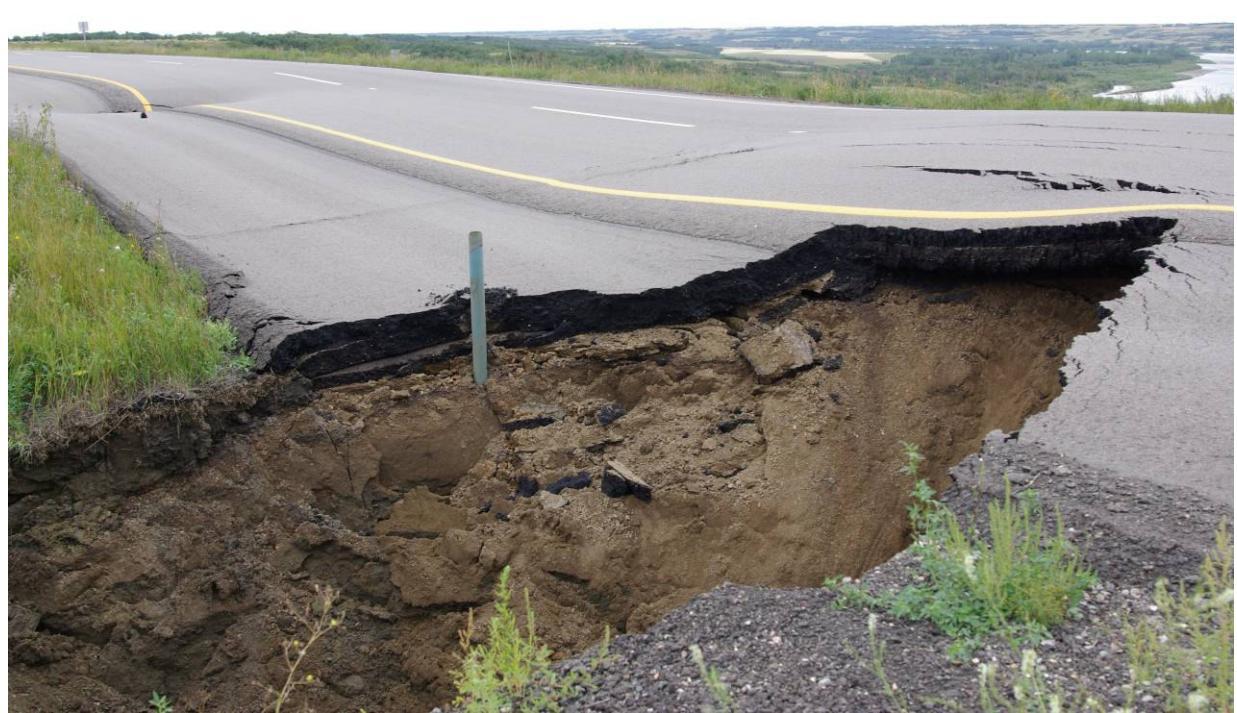
During the site investigation on 21 August 2007, a major failure occurred at the Gully Fill. A large body of water accumulated south of the embankment of the westbound lanes. This area was of concern because of the historical problems at the site and the possibility that a rapid drop in the water level could initiate a "rapid draw down" failure. It was surprising to find that most of the water had disappeared overnight. This presented a concern about a possible slope failure and loss of stability. While investigating the reasons for the rapid water loss a hole appeared adjacent to the south shoulder on the west lanes. The sinkholes and deformation (Figure 5) occurred very rapidly resulting in the closure of the westbound lanes of PH No. 16 and the rerouting of traffic to the eastbound lanes at approximately 3:15 PM on 21 August 2007.

Excavation and examination of the gully culvert through the embankment found that it was in poor condition (eroded with holes), contained boulders and rocks, as well as a tire with wheel rim (Figure 6). Restrictions on water flow through the embankment caused water to back-up" into the gully. This caused the overtopping of the highway to the east and created large seepage pressures around the culvert. These seepage pressures caused a form of piping around the culvert to occur. While this piping likely started some time ago (the gully was previously filled with water and had to be pumped in 2005), piping type failures can accelerate with time and the recent large rain fall event triggered the eventual failure of the embankment. During this event, a large quantity of soil was washed out of the embankment. This was evidenced by the dark colored discharge of water in the North Saskatchewan River observed and photographed from the air (Figure 7) as well as from the downstream culvert. The large cavity created by the piping undermined the highway and lead to the failure on 21 August 21 2007.

Figure 5: Catastrophic sinkhole failure of 'Gully Fill' Embankment

It was decided, based on the Geohazard and Corporate Risk Assessment techniques, that the immediate relocation of the westbound lanes (Alternative 3) provided the best solution for this catastrophic failure.

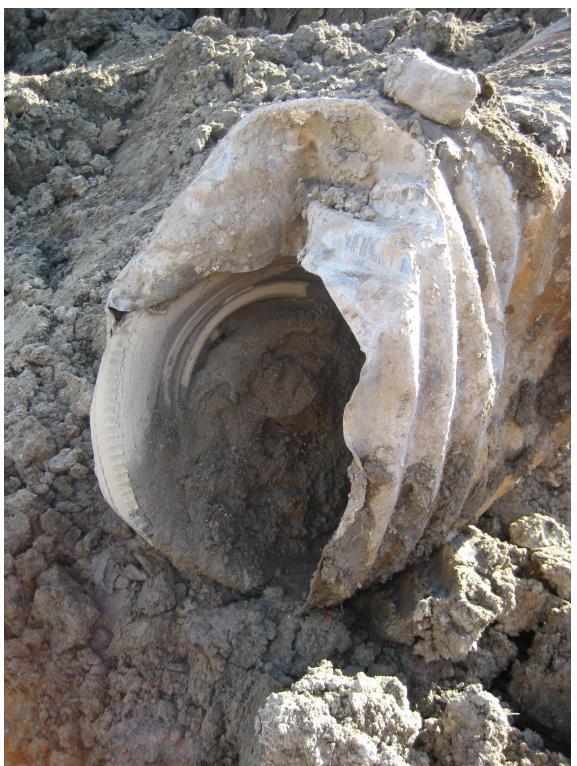
Figure 6: Photo of tire and rim in culvert

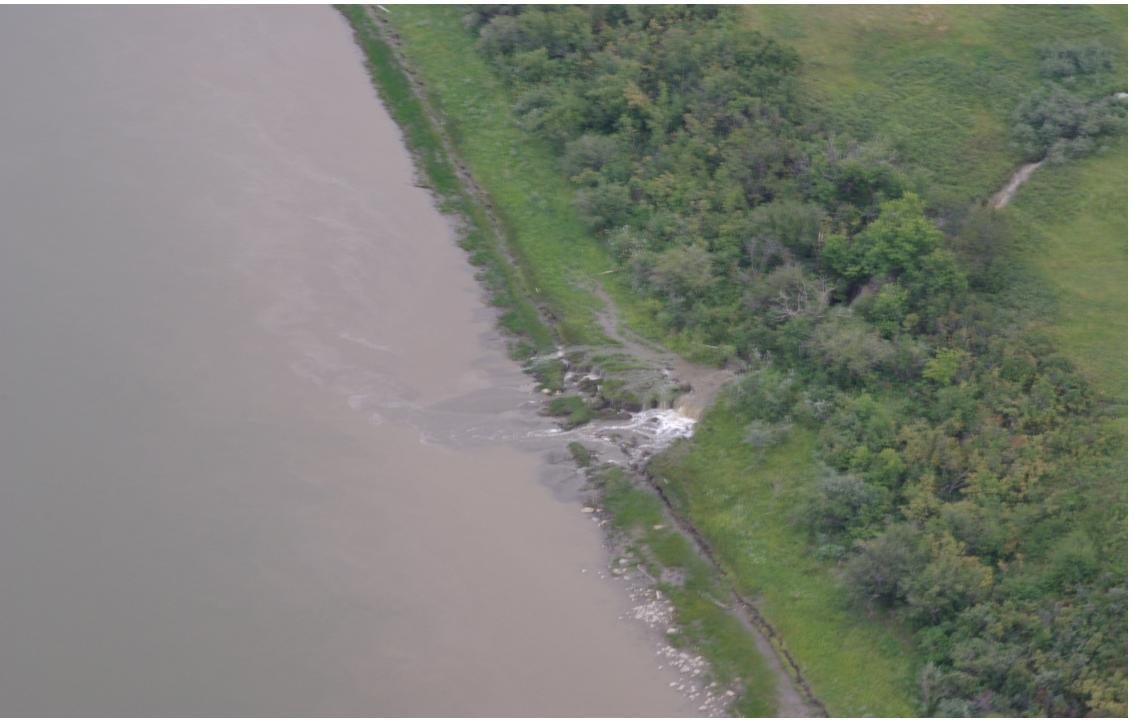
Figure 7: Photo of sediment flowing into river.

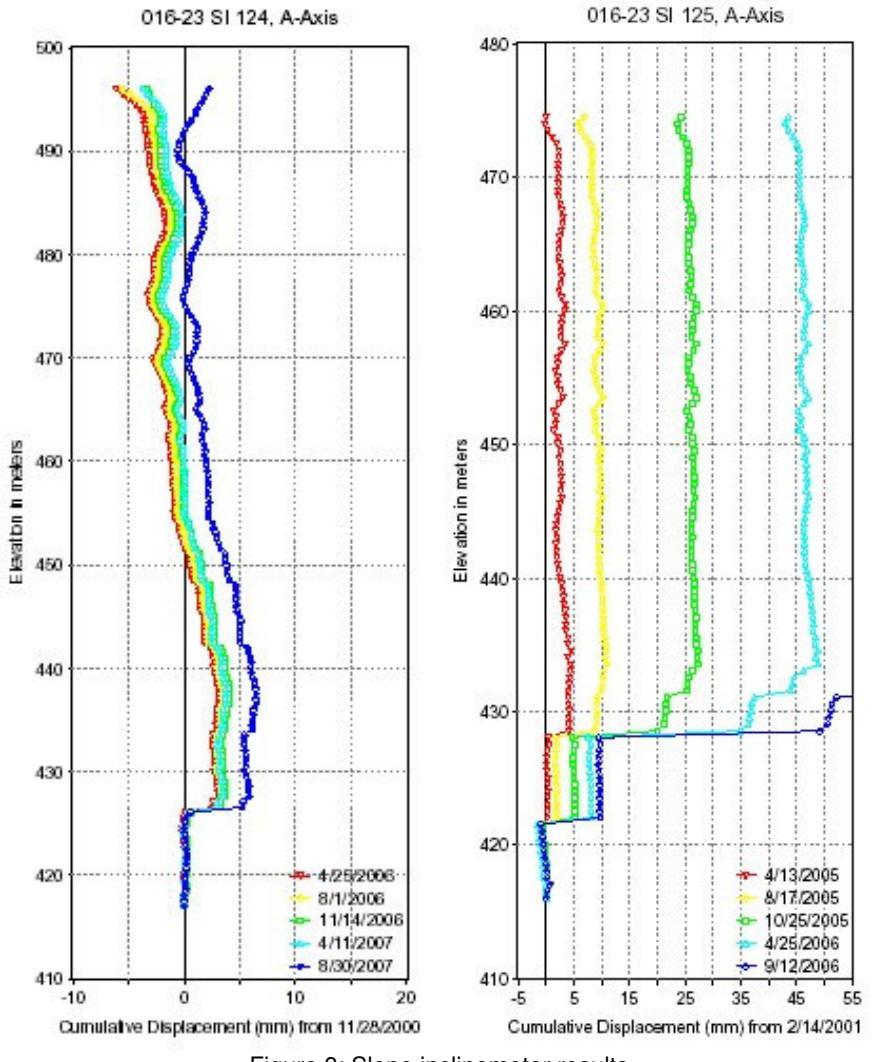
The highway in this location is also on an active landslide. A slope inclinometer (SI 124) to the east near the site of the overtopping showed movement. Another slope inclinometer (SI 125) down slope of the gully has shown considerable movement and at different depths. This SI is now inoperable. The readings from these slope inclinometers are shown in Figure 8. Two slope inclinometers installed in the gully embankment have both sheared off near the base of the embankment. Figure 9 contains a conceptual model of slope movement along the valley slope. The landslides slowly work their way up the slope (retrogress) when activated. The present westbound lanes appear to be just inside the last slide block, with only 5 mm of horizontal movement in the past 7 years. In contrast, SI 125 down slope has had over 50 mm of movement the past 6 years with multiple slip surfaces (at least 3 evident at SI 125 location). GeoEdmonton'08/GéoEdmonton2008

Figure 8: Slope inclinometer results.
