Landslide dams, Peace River lowlands, Alberta

B.G.N. Miller BC Ministry of Agriculture and Lands, Fort St John, BC, Canada D.M. Cruden Civil and Environmental Engineering, University of Alberta, Edmonton, Alberta, Canada

ABSTRACT

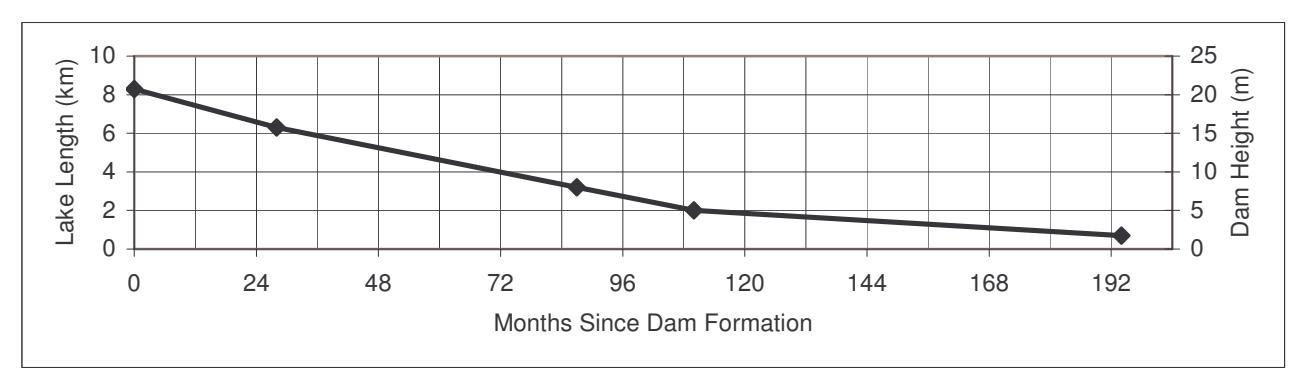
At its maximum, the landslide lake exceeded 8 km in length (river km 11.5 to 19.8) (Figure 2). The lake's high stand was recorded by flood debris in the branches of trees. By 6 October 1992, the lakeshore had regressed almost 2km to river km 17.8 (Alberta aerial photographs

Figure 2. Change in the length of the Eureka River landslide lake since the dam formation. The dam height was determined by comparing the extent of flooding to topographic data. This value does not consider deltaic deposition at the head of the lake and therefore underestimates actual dam height.

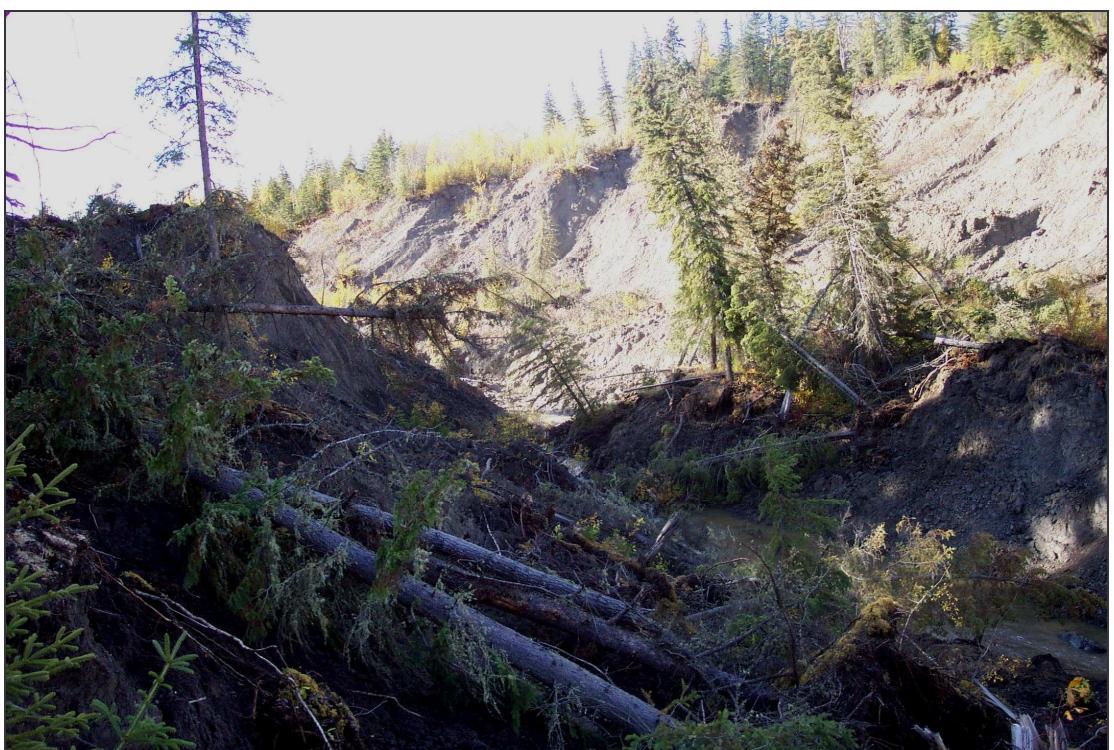
By August 1999 the new channel had incised by up to 20m. This rapid incision has promoted extensive instability from both banks (Figure 3). Between river km 11.0 and 11.1, and between 11.4 and 11.5, instability has caused coarse alluvium (cobbles and boulders) from the pre-landslide channel to be introduced into the new channel. However, this coarse material was not stable within the new channel and was subsequently transported downstream, leaving the channel unprotected.

Figure 3. Extensive instability at the toe of the Eureka River landslide has caused coarse alluvium from the pre-landslide channel to be introduced into the new channel. This coarse alluvium has subsequently been transported downstream. Photo captured on September 28, 2007 looking northwest towards the 1990 landslide.

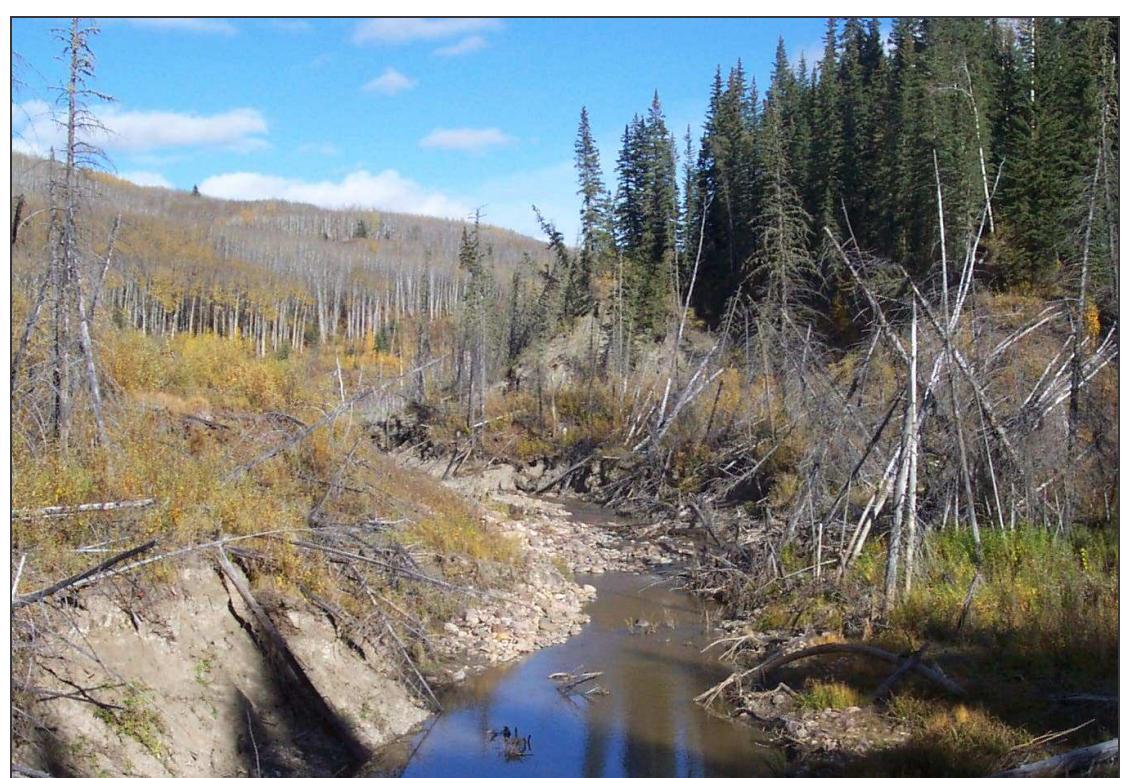
Figure 4. Eureka River dam on September 28, 2007. Photo captured looking upstream towards the large lake (not visible). Coarse alluvium from the pre-landslide stream (centre) protects the dam from erosion.

A field survey in August 1999 found the large lake extended to km 13.5, which represents a regression of 1.2 km and a water surface lowering of about 3m. A beaver dam exaggerated flooding by about 20cm. Between the small and large lakes, the Eureka River flowed along the edge of the pre-landslide channel. The bed of the former channel was tilted towards the new channel (Figure 4). Coarse alluvium, from the pre-landslide channel, was forming armour in the bed of the new channel.

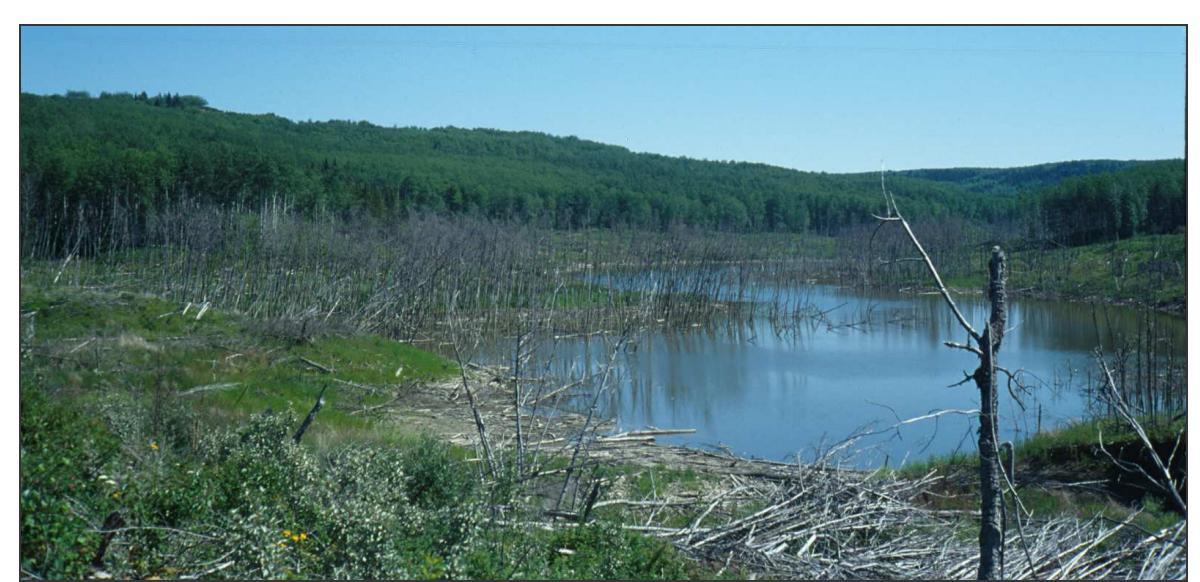
Figure 5. The Saddle River landslide lake in July 1999. A logjam, at the outlet of the lake, is in the foreground.

A logjam occurred at the Saddle River dam (log jams did not occur at the Eureka or Spirit River dams; there is no information on log jams for the Hines Creek or Montagneuse River dams) (Figure 6). The logjam at Saddle River may be due to the extensive forest flooding that occurred because of the gentle topography at the foot of the valley slope. The effects of logjams on landslide dams largely depend on the nature and arrangement of the logs; logjams that are more effective at retarding flow have a greater effect. The effectiveness of logjams to retard flow may also decrease with decreased stream flow. The logjam on the Saddle River is expected to have a similar effect to a beaver dam.

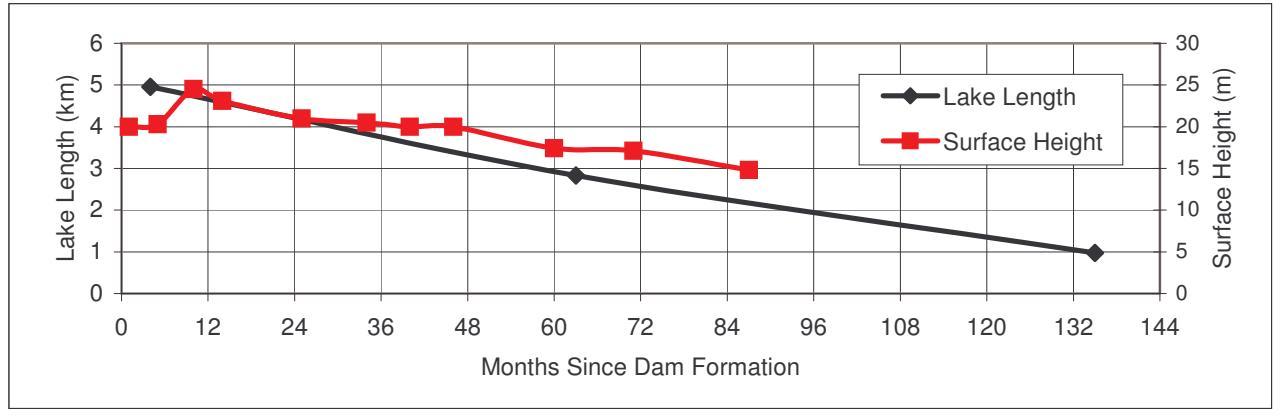
The landslide dam was first inspected on July 24, 1990 by Alberta Environment (Hanson 1994). At that time the lake level was approximately 20m above the prelandslide river level. There was approximately 4m of freeboard (Figure 6).

Figure 6. Change in length of the Saddle River landslide lake (from aerial photographs) and change in water surface height (Water Resources Administration 1997) since dam formation in June 1990.

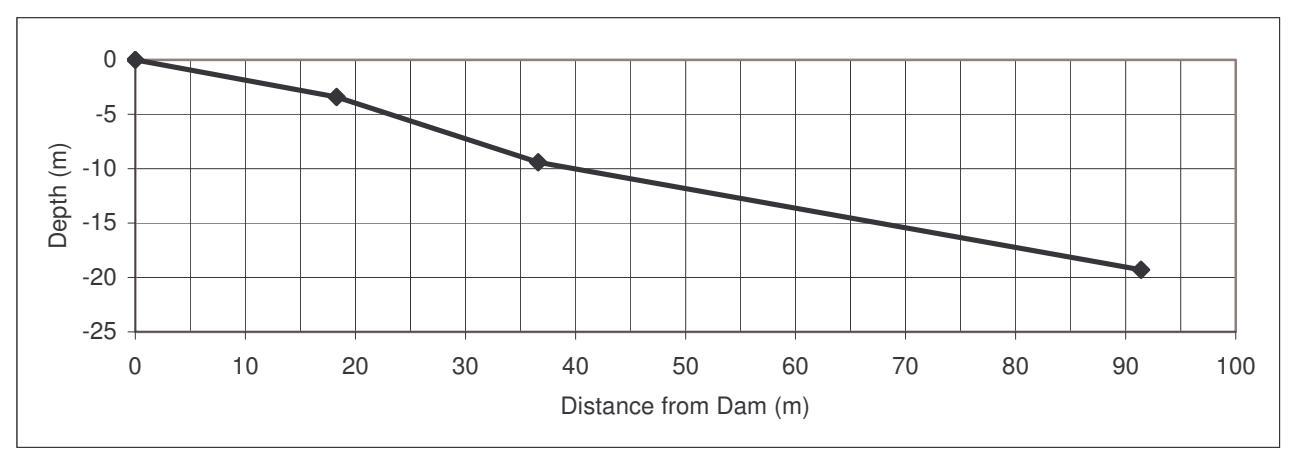
Figure 7. The submerged extent of the Saddle River landslide dam on June 30, 1991 (Hanson 1994). As the stream incises into the landslide dam, the width of the landslide dam becomes progressively larger.

Deriving slope values is not straightforward, as ponding along the dam's length and the submerged extent of the landslide debris must be accounted for - as the lake level is lowered, the width of the landslide dams become progressively larger (Figure 7). The maximum dam height is also not obvious as the dams obstruct the river over a considerable distance and affect a range of bed elevations (for example, the Eureka dam is a maximum of 25m above the pre-landslide channel, but the landslide lake was 20m deep).

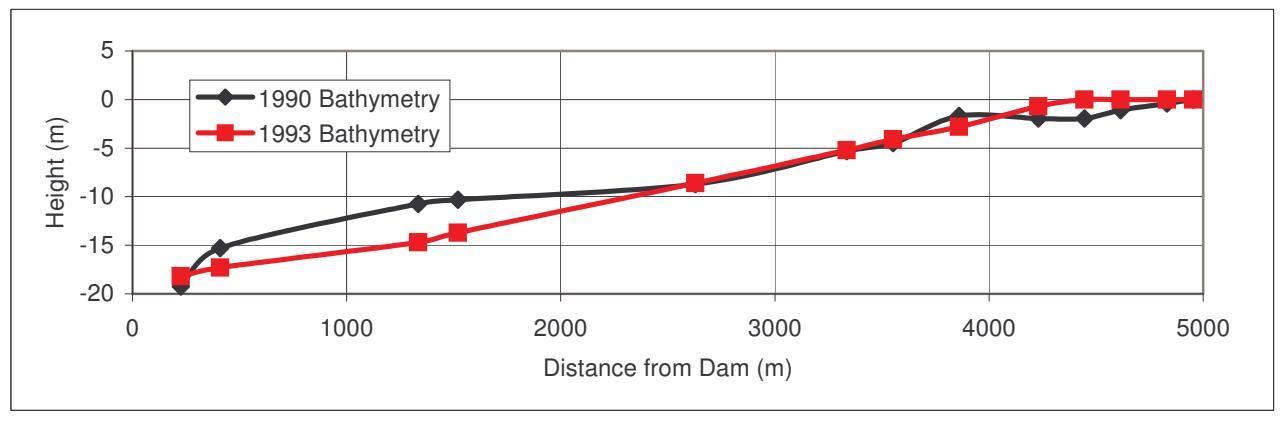
Figure 8. Depth sounding of the Saddle River landslide lake on October 3, 1990 and October 26, 1993, derived using a lead-line (Hanson 1994). Lake levels had decreased by 0.10m in 1993, from 1990 levels. Challenges with identifying the drowned thalweg explain transposed data. Noteworthy is the extensive deltaic accumulation at the head of the lake.

The landslide lakes are eventually drained by basin infilling and incision into the dam (Figure 8). The Montagneuse River and Hines Creek (pre 1952) landslide dams provide insight into the long-lasting effects of the landslides on the tributary streams. These examples suggest that the Saddle and Eureka River watersheds could take several decades to fully recover from the landslide events.
