# Slope stabilization efforts along Highway 744:04, Judah Hill Road, Peace River, Alberta

Neil H. Kjelland, Roger K. Skirrow Alberta Transportation, Edmonton, AB, Canada A. James Morgan Alberta Geological Survey, Edmonton, AB, Canada Edward J. Szmata Alberta Transportation, Peace River, AB, Canada

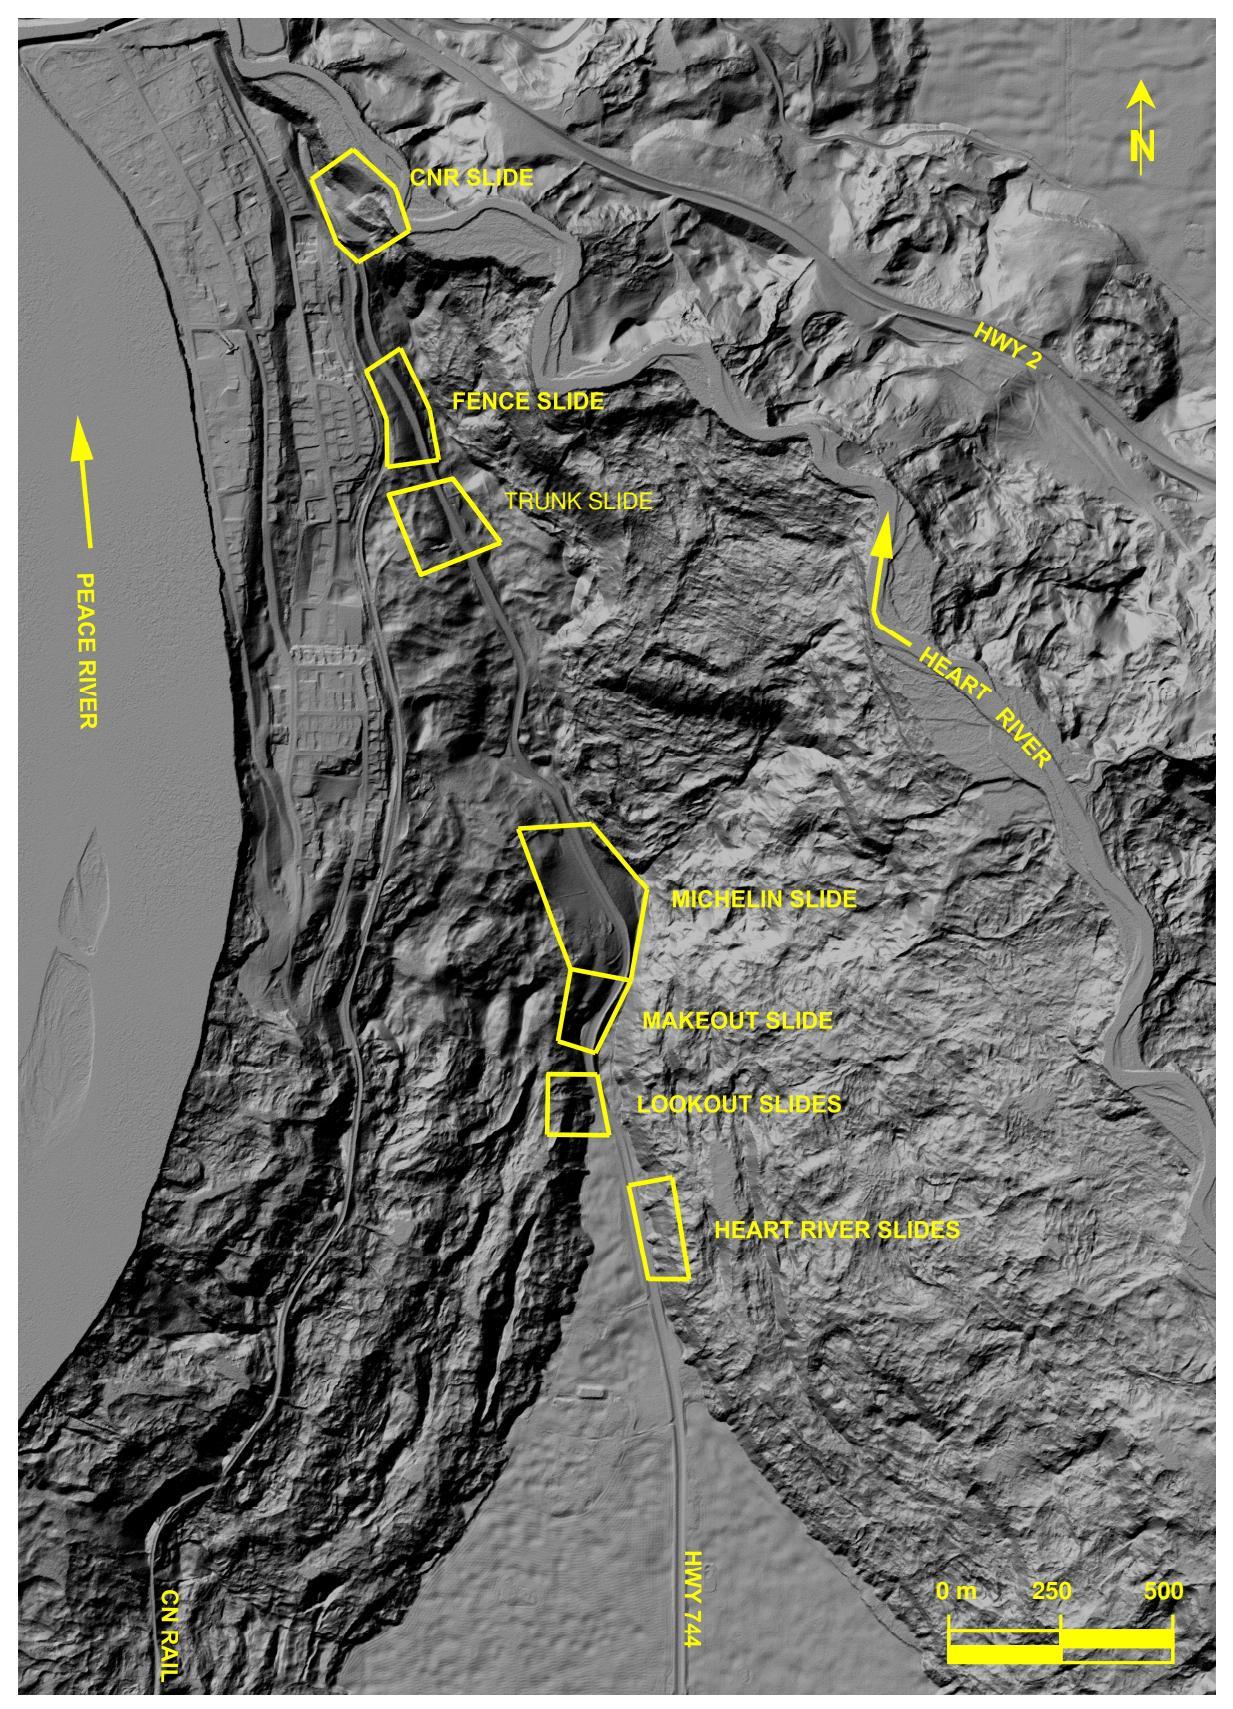
Figure 2. LiDAR image of Hwy 744:04 showing locations of slide areas (courtesy of the Alberta Geological Survey).

Figure 2 shows LiDAR imaging of Highway 744:04 with the 7 slide group locations superimposed over top, and Figure 3 shows an oblique photograph of the road. The LiDAR image clearly indicates that the topography along the east valley wall of the Peace River valley is a remnant of landslide activity, as are all Heart River valley slopes. Judah Hill Road can be seen to intersect many old slide features along its descent into the town of Peace River. Table 1 outlines the geotechnical history of each slide area over the life of the roadway.
