Slope Stabilization at Mt. Alberta View SE, Calgary, Alberta

Luis A. Martinez, Dennis E. Becker Golder Associates Ltd., Calgary, Alberta, Canada Victor Cui City of Calgary, Calgary, Alberta, Canada

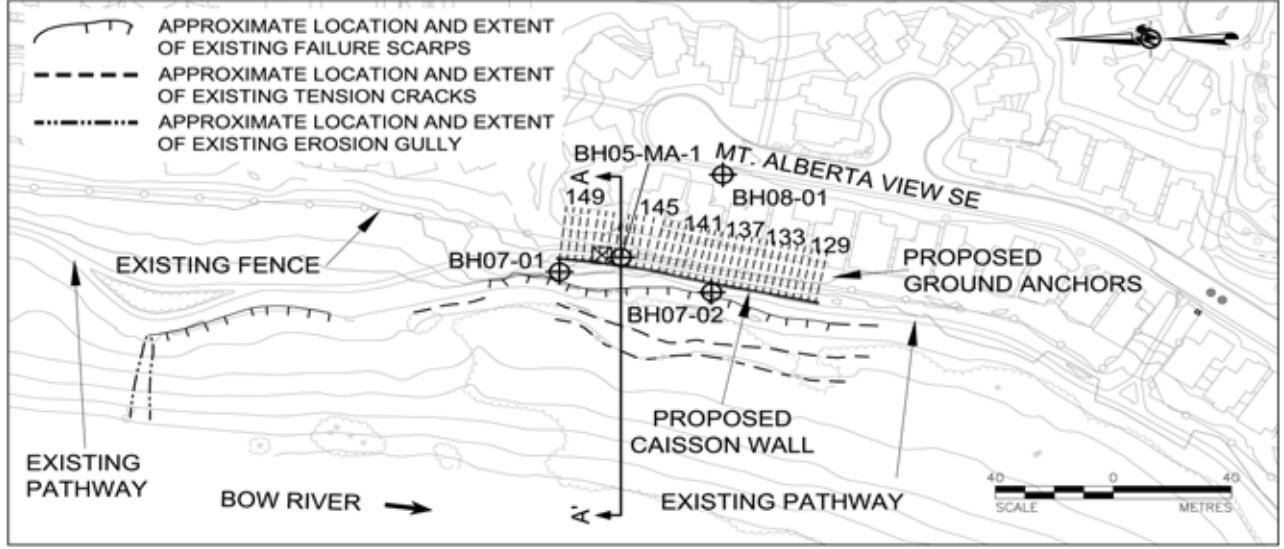
Figure 1. Area of study

The main backscarps in the vicinity of the study area as a result of the 2005 and 2007 slope movements are indicated in Figure 1. The backscarps are approximately 100 m wide with heights of about 1 m to 2.5 m.

Slope inclinometer readings indicate that no shear zones had developed behind the 2007 backscarps (upslope) at the study area. The tip of the slope inclinometer was installed about 38 m below ground surface and top of bedrock was estimated to be about 17 m below ground surface.

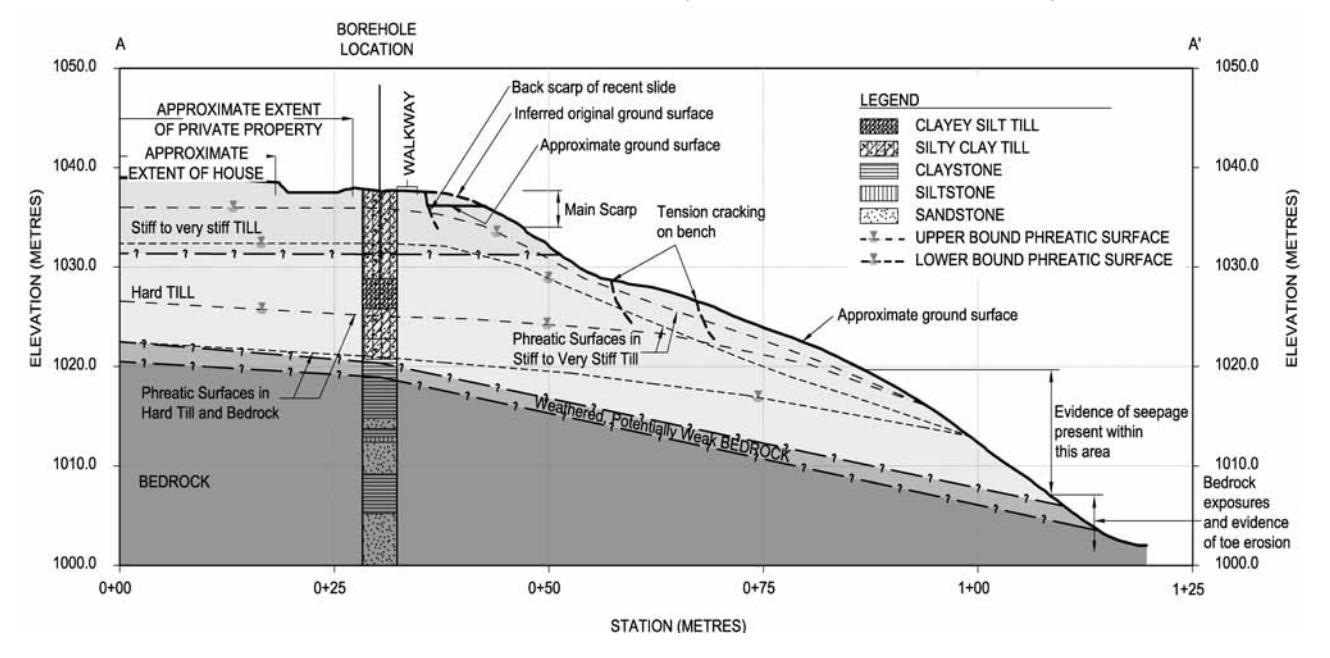
Figure 2. Cross-section used in slope stability analysis

The geological cross-section used in the slope stability analysis is shown on Figure 2. The slope model comprises a layer of stiff to very stiff clayey till 6.6 m thick, overlying a layer of hard clayey till, which in turn overlies bedrock to the bottom of the slope.

Upper and lower bounds of piezometric levels were used in the stability analyses as shown on Figure 2. The lower bound piezometric level is based on piezometric measurements taken during winter 2005 and evidence of seepage on the face of the slope. This piezometric level is likely not the highest that the slope has experienced in the past or will experience in the future.

raised with respect to the lower bound piezometric levels until a calculated Factor of Safety of 1.0 was achieved. This corresponds to an increase in piezometric levels within the stiff to very stiff till and within the hard till of approximately 3.5 m and 4 m, respectively, from the levels measured in December 2005. This would represent a limiting condition of a failure.

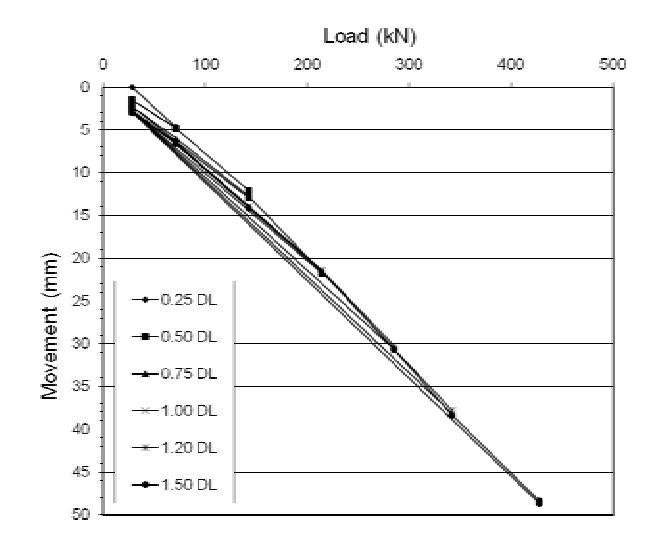
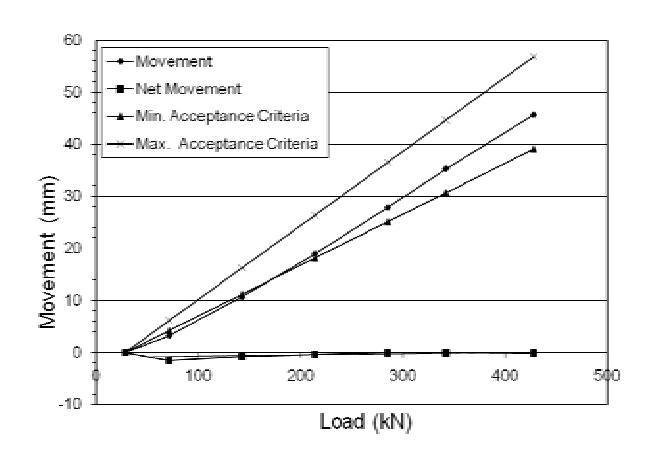
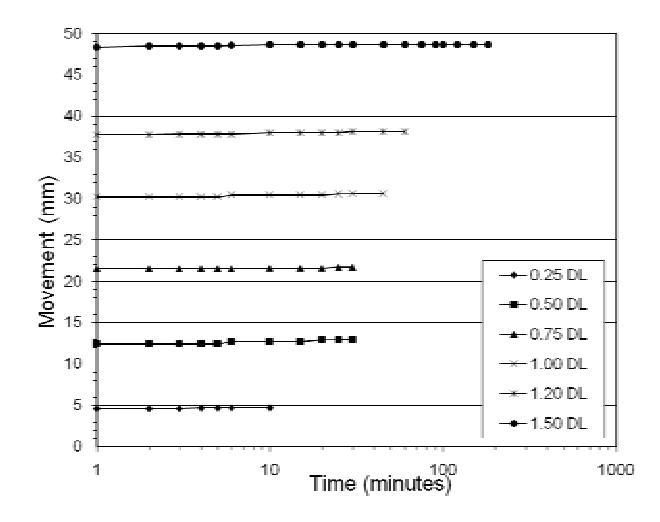
The results of one of the two performance tests carried out during the construction stage of the project are shown on Figure 8. The other test yielded similar results. Figure 8a shows a plot of load versus corresponding movement reading for each cycle. Figure 8b indicates that the movement is within the minimum and maximum limits of the acceptance criterion. The observed net movement, as a result of inelastic behaviour, is in all cases less than 2 mm. Figure 8c shows that the creep movement is less than 2 mm over the testing period for all loading cycles.
