Recent Experience with Landslide Assessments, Cariboo Region, Interior of British Columbia.

Robert G. Wilson, FEC, M.Eng., P.Eng., P.Geo. Evergreen Geotechnical Inc., 150 Mile House, BC, Canada

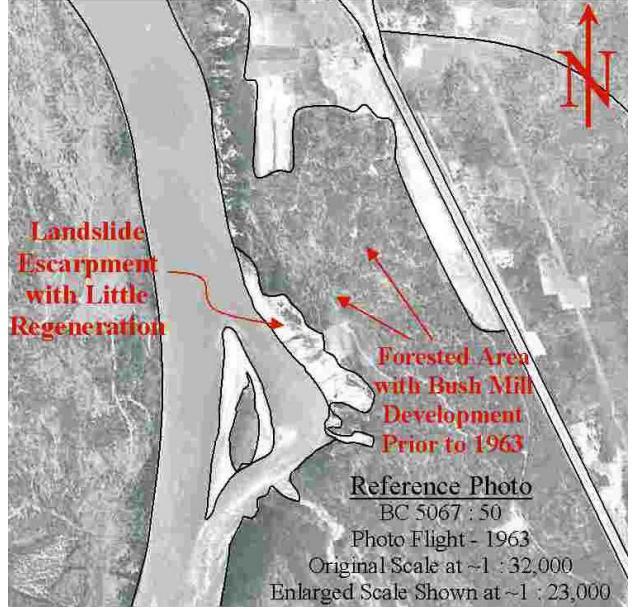
Figure 2. 1963 Air Photo with the Landslide Extents

The historical landslide is shown on Figure 2, a 1963 air photo, which is the earliest obtained for this site.

The landslide clearly occurred prior to the 1963 air photos being taken. Figure 3 shows the surveyor's subdivision plan with the outline of the northern end of the landslide. The subdivision plan indicates that the existing present natural boundary extends up to 30 meters west of the original boundary that was surveyed in 1905, which placing it prior to the historical landslide.

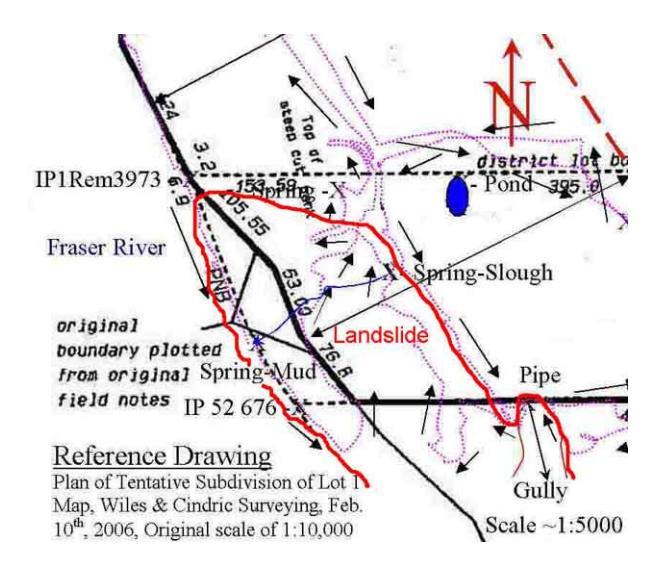
Figure 3. Field Traverse at the Historical Landslide Site

The field reconnaissance traverse was done in conjunction with a GPS survey, so the crest of the embankment and toe of the slope were traversed, and features of interest recorded using way points. Several legal pins were used to tie the field work to the surveyors plan. Figure 3 shows the field traverse as the dotted line, using the surveyor's subdivision plan as a base map. The arrows indicate the direction of travel taken during the field traverse.

Mature, back-tilted fir trees were found on the landslide debris, consistent with a deep seated rotation, along with juvenile vertical timber, roughly 80 years old, both fir and aspen. The mature timber curves sharply back to the azimuth, which indicates a large, single event rather than slow rotational creep. Logs are partially buried in the debris within the high water mark of the Fraser River, exposed as the toe of the debris is eroded.

There is at least one spring below the headscarp, and groundwater seepage is evident throughout much of the debris along the lower slopes. The landslide scarp exposes the upper glaciofluvial sand and gravel, and deeper deposits of glaciolacustrine silt in the area labelled as the gully in Figure 3. Although speculation, the deeper silt deposit on the adjacent property may have extended along the length of the landslide, blocking drainage from the glacial fluvial sand and gravel behind it, and ultimately leading to this large landslide. The island in the Fraser River appears to be related to the landslide as remnant debris. Figure 4 is from the 2006 air photo series and shows the 1963 air photo landslide extents. The island has eroded at the northern end, with little growth to the south end as might be expected in typical fluvial processes.

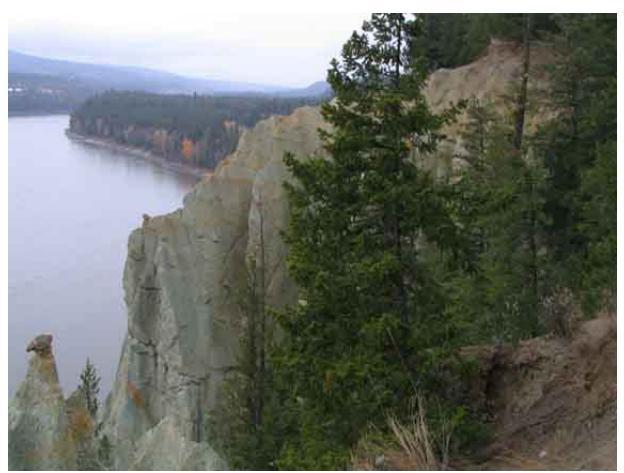
The embankment has steep slopes to the north of the historical landslide site. There are cliffs of dense till soils, with remnant columns extending out from the slopes capped with tough, partially cemented, coarse till.

Figure 5. Basal Till. Steep slopes, slow erosion and the formation of hoodoo topography. Note the upper lacustrine deposits.

These erosion features are called hoodoos. The hoodoos extend out from the crest of the embankment at two or three prominent locations. Small streams were found along the Fraser River banks between these dominant sets of hoodoos that originate well up the slope of the embankment, from buried gravel seams in the glaciolacustrine deposit. The crest of the embankment is recessed where the springs are located, with higher erosion rates. Figure 5 is a photo of the basal till, showing the steep cliff face with the Fraser River in the background to the north-west.

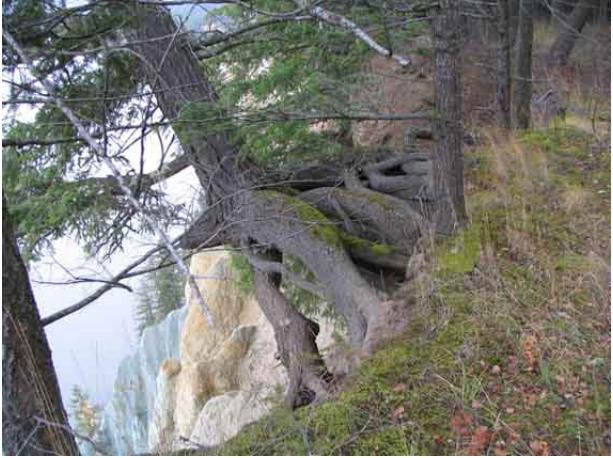
There is a peculiar feature found along the crest of the embankment, above one of these recessed areas. An old fir tree was found overhanging the embankment by almost 4 metres. The old fir has several large roots firmly tied back into the slope. The tree is estimated at least 200 years old and in all likelihood, much older based on its difficult growing site. The tree, as a seedling, started at the very edge of the embankment and established a strong root system into the solid portion of the bank, in order to grow to the size it has without toppling down the slope. Figure 6 below is a photo of the overhanging tree.

Figure 6. This tree has struggled to keep ahead of the eroding embankment. It provides a conservative erosion rate estimate over its 200 plus years.

The second significant mode of slope instability is slow but inevitable erosion by denudation, topples and falls of the thick glacial till embankment and resulting in the formation of the hoodoos. The overhanging fir tree has been used to provide a conservative estimate for the rate of erosion. 4 metres has eroded over a 200 year life span, which is 1 metre every 50 years, or 2 cm per year. Since the overhanging tree is in the recessed area, the rate is considered to be one of the highest rates at this site. Therefore, in 5,000 years, the crest of the embankment in the area of the hoodoos should be no more than 100 meters from its current location. A 150 meter set-back from the crest of the embankment is indicated on Figure 8. This provides low risk for building, allowing for potentially higher erosion rates over a 5,000 year time frame, during which the slope should be monitored and surface drainage controlled. Again, future remedial works can be done on the river to stabilize the landslide cycle at a time when it becomes necessary.

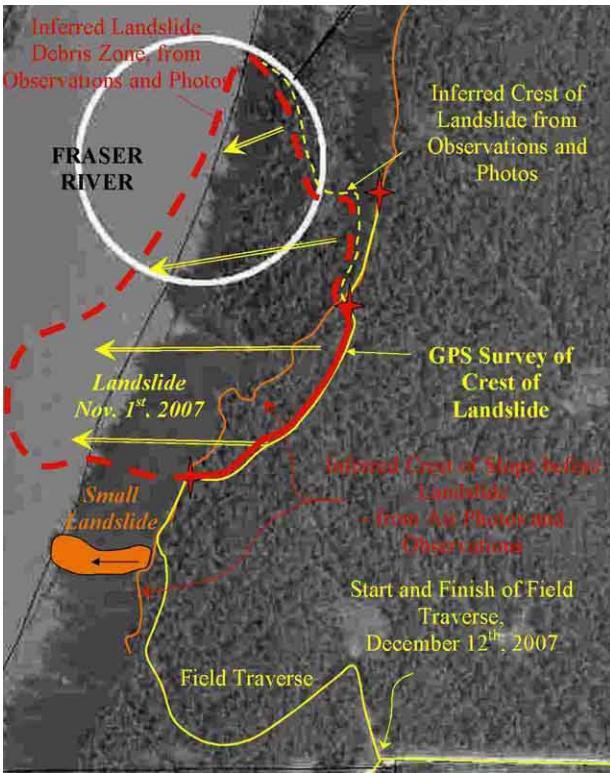
Figure 7. Kersley Landslide, November 1st, 2007

A field reconnaissance of the Kersley landslide was done on December 12th, 2007 to provide a perspective on the relative size and nature of the landslide. A hand held GPS survey was done along the original crest of the embankment and along the crest of the new head scarp. The crest of the embankment to the south and north of the recent landslide were located to orient the new landslide position. The results of the GPS traverse are given on Figure 7 using the orthophoto base map shown.

The air photos reviewed for the Kersley landslide show an older landslide to the immediate north, coalescing with the recent landslide in the timbered portion located west of the original embankment. The headscarp at the southern end of the 2007 landslide is near vertical for an estimated 40 metres in height, and the embankment crest placed at up to 50 metres from the original. There are topples and sloughs occurring.

The pre-landslide embankment slope at the southern end of the Kersley landslide was up to about 100m vertical to 150m horizontal, which is 67% or 34° . The slopes in the area of the smaller landslide are up to 100m vertical to 100m horizontal, which is 100% or 45° . The new crest of the slope from the original toe has been extended by up to 50 meters resulting in a 100 meter vertical to 200m horizontal offset, which is at 50% or 27° .

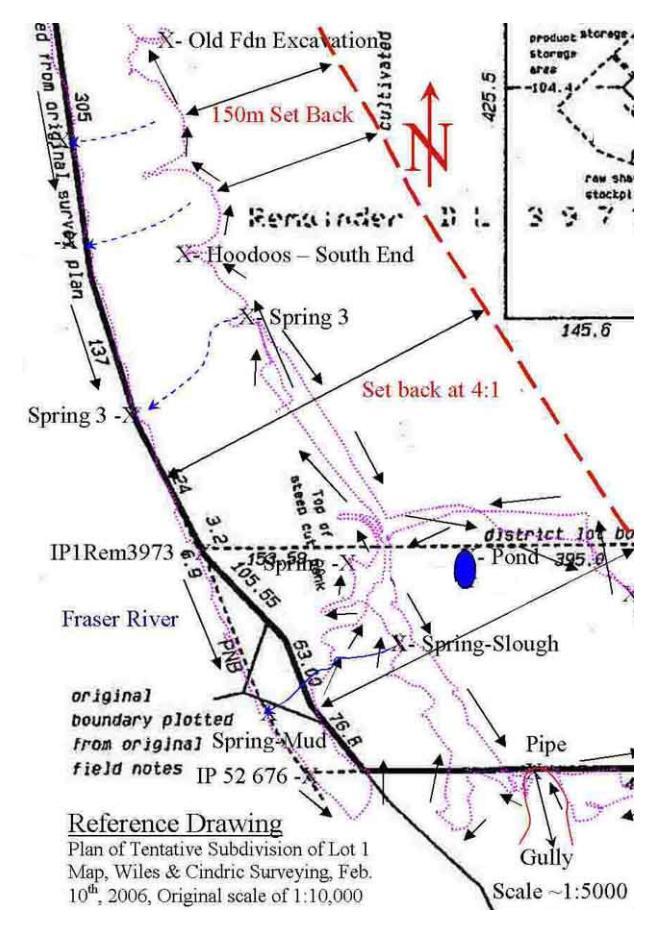
Figure 8. Setback for Building Development

The historical landslide failure at the site was a single, large event that cut into the embankment by 10 to 50 meters, and pushed the toe of the slope out into the river. The river has been eroding the debris at the toe for a period of well over 50 years based on the air photos. It has not yet eroded the bank to where the original toe was when the first event occurred. The slopes are estimated to have been in the order of 45°, or 100% before the landslide event. The landslide cut away from the crest by about 110 meters from the original toe, reducing the original slope angle to approximately 77%, or 38°.

The period for a landslide cycle has been considered in this assessment, since landslide activity has been occurring, and will continue for the foreseeable future. A landslide cycle involving a major event, with complete removal of the debris is assumed to be 500 to 1000 years before the area could be subjected to another major landslide. A set-back line from the toe of the prelandslide embankment of 4 horizontal to 1 vertical, (14°, or 25%), as indicated on Figure 8 was determined to give low risk for future development in conjunction with recommendations to limit surface erosion. This set-back will allow seven successions of landslide activity before the embankment works back to it. This is a conservative time frame in the order of 5,000 years, during which the slope should be monitored and surface drainage controlled. Remedial works can be done on the river.
