The Santana Port accident: Could it be a sensitive clay flowslide under the Equator?

S. Sandroni & E. Barreto

Pontifical Catholic University of Rio de Janeiro, Rio de Janeiro, Brazil S. Leroueil Université Laval, Québec, Canada GEOQuébec 2015 Challenges from North to South Des défis du Nord au Sud

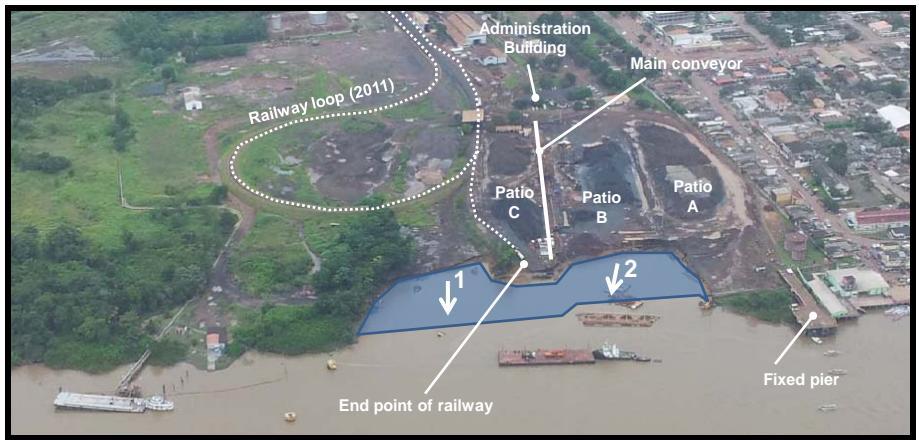
Figure 2. Aerial inclined photo taken after failure. Shading indicates failure area.

Overall the landslide affected an area of 20,000 m², had a width of 220 m, regressed by 50 to 100 m and involved an average thickness of 30 m of sediments (see Figures 4 and 5).

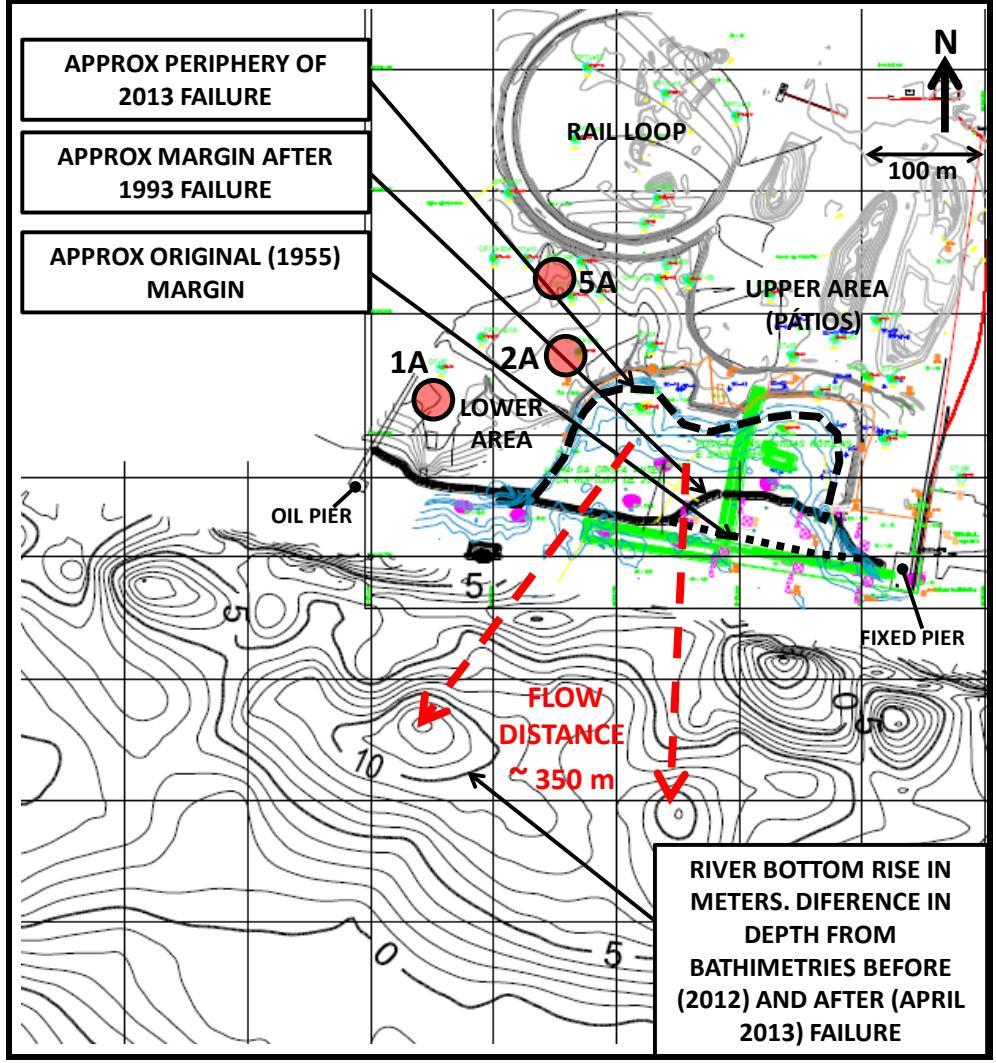
Figure 3. Plan of failure area comparing situations before and after.

The Port operated without geotechnical problems from 1957 to 10 October 1993 when a slide involving an area of about 2,000 m² and a volume around 30,000 m³ happened in the East side of the lower area, as schematically indicated in Figure 3. From the limited information available about this failure, one learns that no load had been applied on the failed area nor in its vicinities, that no previous signs of impending failure had been observed and that failure was sudden, caused damage to the ship loading system (but, fortunately, no casualties) and generated strong waves.

The comparison of bathymetries before and after failure indicates that a considerable part of the failed material flowed under water to the river channel, for an average distance of about 350 meters, causing the river bottom to rise up to about 13 meters, as shown in Figures 3 and 4.

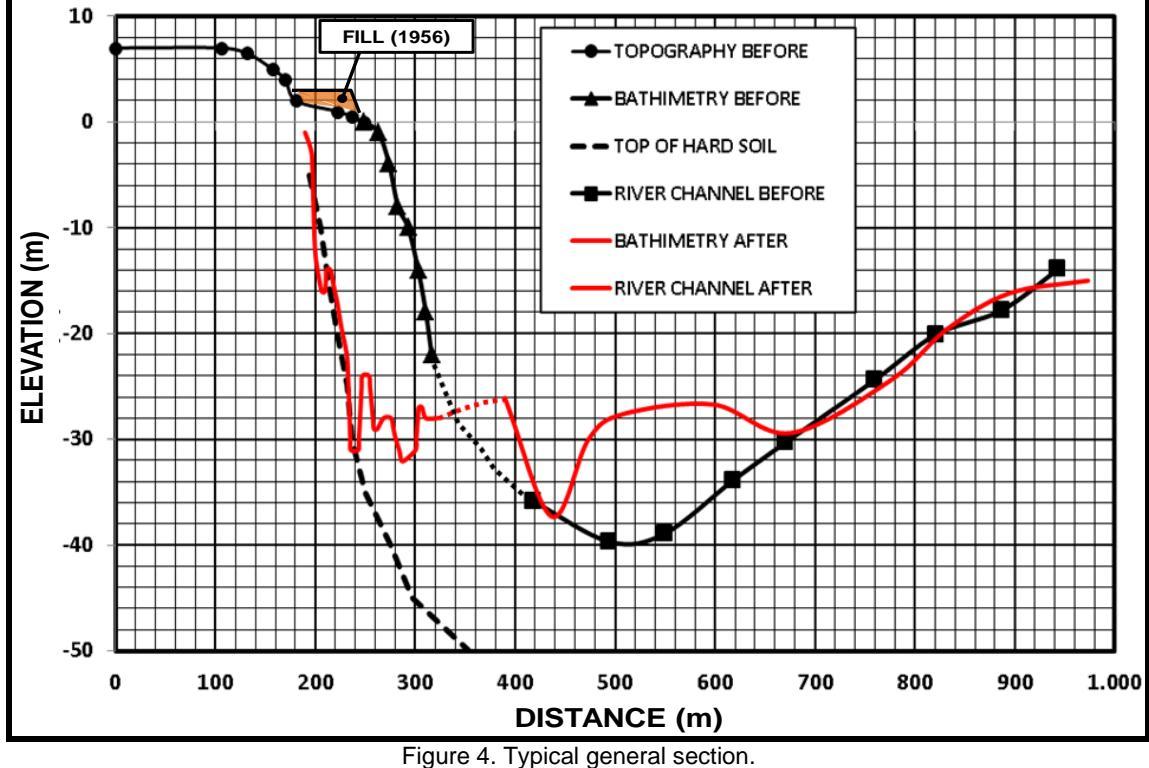
A large failure happened abruptly at 00h:10m:28s of 28 March 2013 as registered by a security camera which was obliterated a few seconds after failure started. In the moment of failure the river level was low. Some 30 min before it had reached its spring tide minimum, around elevation -1.70 m. At the moment of failure the river level was around -1.60 m. Weather had been rainy for a month or so with intensity inside the normal range for the period. A typical general section before and after the failure, can be seen in Figure 4.

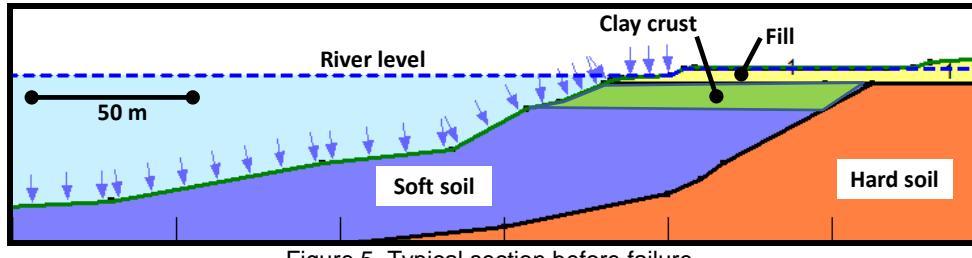
A typical geotechnical section before failure is shown in Figure 5. There are four main materials of interest from top to bottom: a clayey fill placed in 1955-1956, a clayey

(probably desiccated) crust, a soft soil and a hard soil which underlies the soft soil in the failure area and reaches the surface in the upper (patios) area. The soft soil is a grey clayey silt with SPT values around zero. The hard underlying soil is mottled clay with SPT N values in excess of 20.

Figure 5. Typical section before failure.

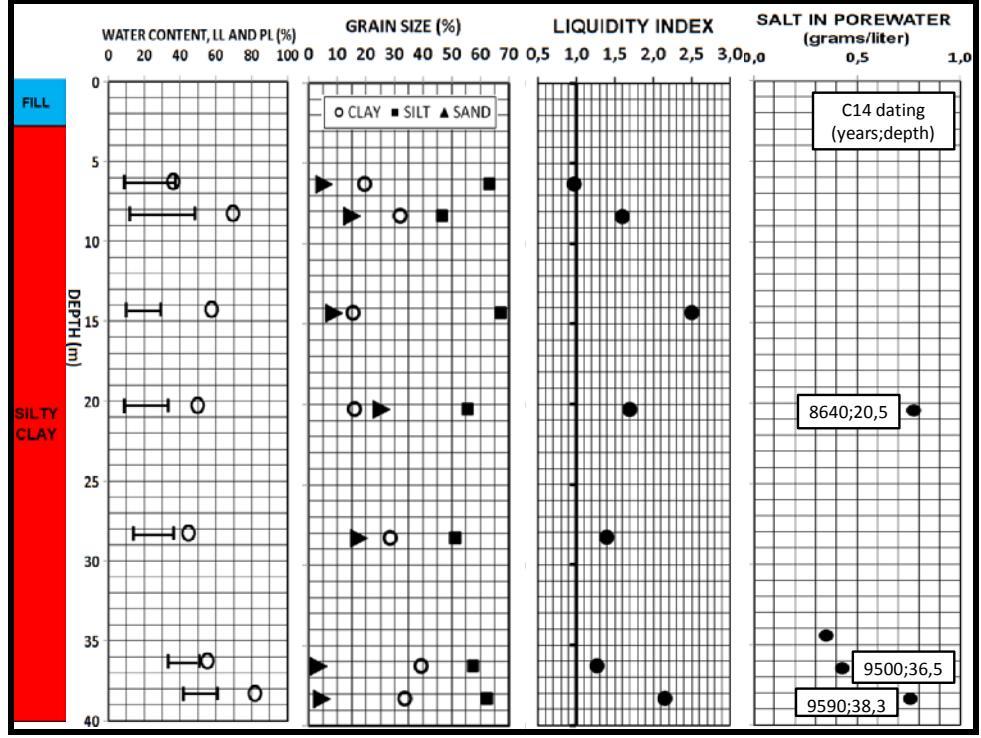
Figure 6 shows the water content, LL, PL, grain size and liquidity index values obtained in thin tube samples from point 1A. The plasticity index is around 25% (20% to 35%). The right hand diagram of Figure 6 shows pore water salt content and radiocarbon dating. Without any surprise the salt content is less than 1 g/l. The age of deposition varies between 8.5 kyears at depth of 20 m and 10 kyears at depth of 40 m.

Figure 6. Characterization tests, pore water salt content and radiocarbon dating at point 1A.

IL values quite above 1 have been determined in samples of the Santana soil from different depths. The usual Brazilian soft clays show IL values up to around 1 and usually less (0.8 is typical). High values of IL some

exceeding 2, as shown in Figure 6, are unheard of in the Country as far as the Author's knowledge goes. Values of IL in excess of about 1.2 have been considered to characterize sensitive clays that can make a landslide becoming a flowslide (Lebuis et al., 1983).

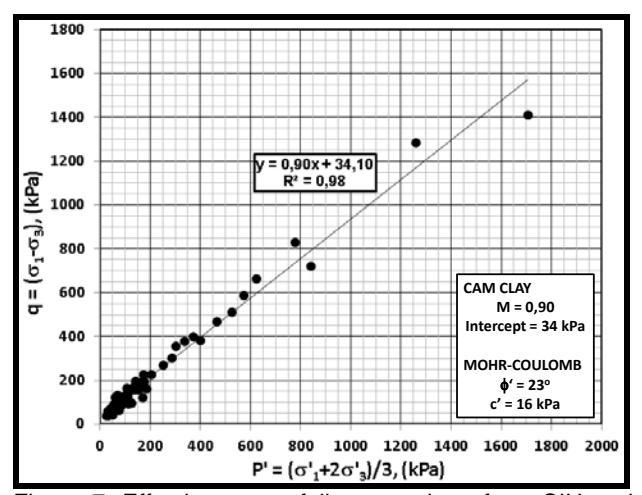
CIU and CKoU triaxial tests (with pore pressure measurement) yielded the failure points (maximum deviatoric stress) plotted in p' = $(\sigma'_1+2\sigma'_3)/2 \times q = (\sigma_1-\sigma_3)$ diagram in Figure 7. They indicate friction angle of 23° and effective cohesion of 16 kPa.

Figure 7. Effective stress failure envelope from CIU and CKoU triaxial tests. (Results of 39 CIU and CKoU tests in specimens carved from shelbies - Points 1A, 2A and 5A).

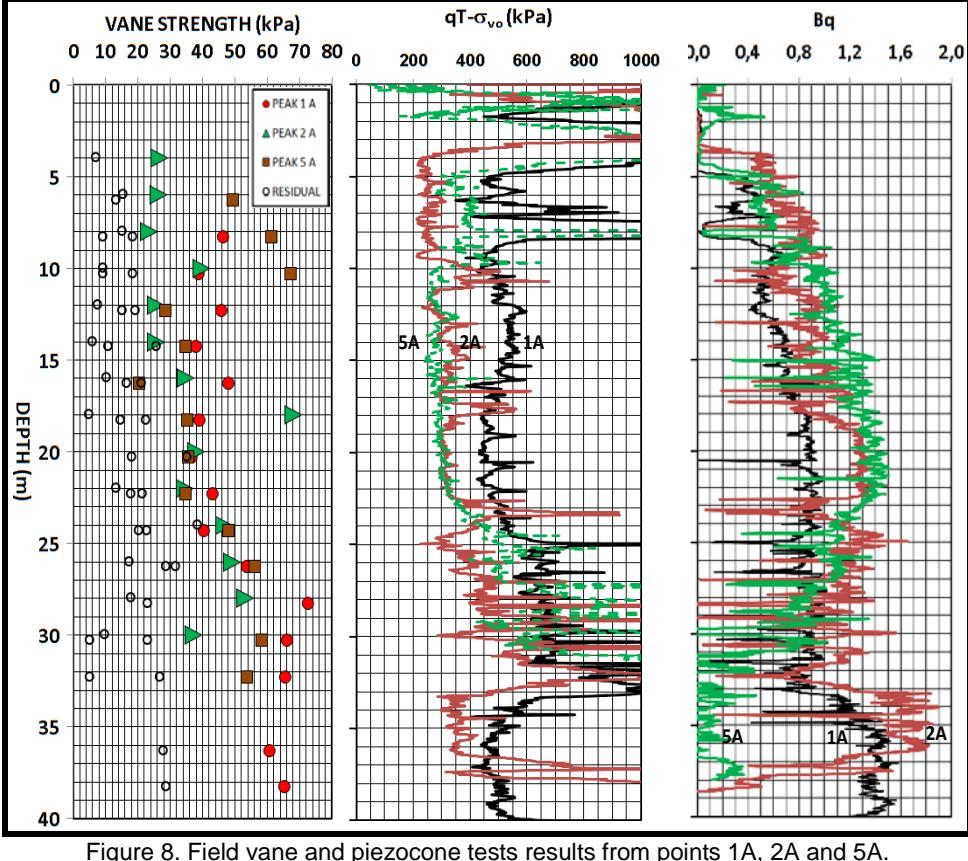
gure 8. Field vane and piezocone tests results from points 1A, 2A and 5/ (Residual vane values obtained after ten rapid full turns).

Results from field vane and piezocone tests carried out at positions 1A, 2A and 5A are presented in Figure 8 and show a more or less constant value of $S_{u \text{ vane}}$ and of $(q_T - \sigma_{vo})$ values for depths between 10 m and 20 m. Below 20 m these values present a linear increase with depth. B_q values for depths in excess of 10 m are frequently above 1.0 and reach 1.4 and 1.6 (which are unusually high values as will be discussed later). Values of the consolidation coefficient obtained from piezocone dissipation tests at depths between 5 m and 40 m, varied between 2 and 8 x10⁻³ cm²/s. N_{kt} values were found to be in the interval from 8 to 14, with a mean value around 12.

SPT N values are practically equal to zero and collide with peak vane strength values in the 35 kPa to 50 kPa or more range (Figure 8). The SPT values to be expected from these peak vane values would be, in any soft Brazilian coastal soils, in the range of 3 to 5. Similar relation applies to silty clays from several parts of the world as shown by Kulhawy and Mayne (1990). There are no shells or fibrous organic matter that might induce unusually high vane strengths and the N_{kt} values, as seen above, are normal (around 12).

B_q values well above unity reaching 1.6 or more have been regularly obtained (Figure 8). These are unusually high values in any soil and have never been systematically observed, to the Author's knowledge, in Brazilian clays. The usual Brazilian soft clays show B_a values up to around 1 and usually quite less (typically 0.6 to 0.8). It is noteworthy that B_{α} values in sensitive Eastern Canadian clays are generally between 0.6 and 0.9 (Demers & Leroueil, 2002) and, in sensitive Scandinavian clays are usually below or slightly above 1 (Karlsrud et al, 2005; Schnaid, 2009). The high Bg values obtained in the Santana soil cannot be credited to qT being unusually low since, as mentioned above, Nkt values are in the normal range. It has to be noted that the high B_{α} values have been obtained in two different site investigation campaigns, 2007 and 2013, carried out with quality equipment by well trained personnel.

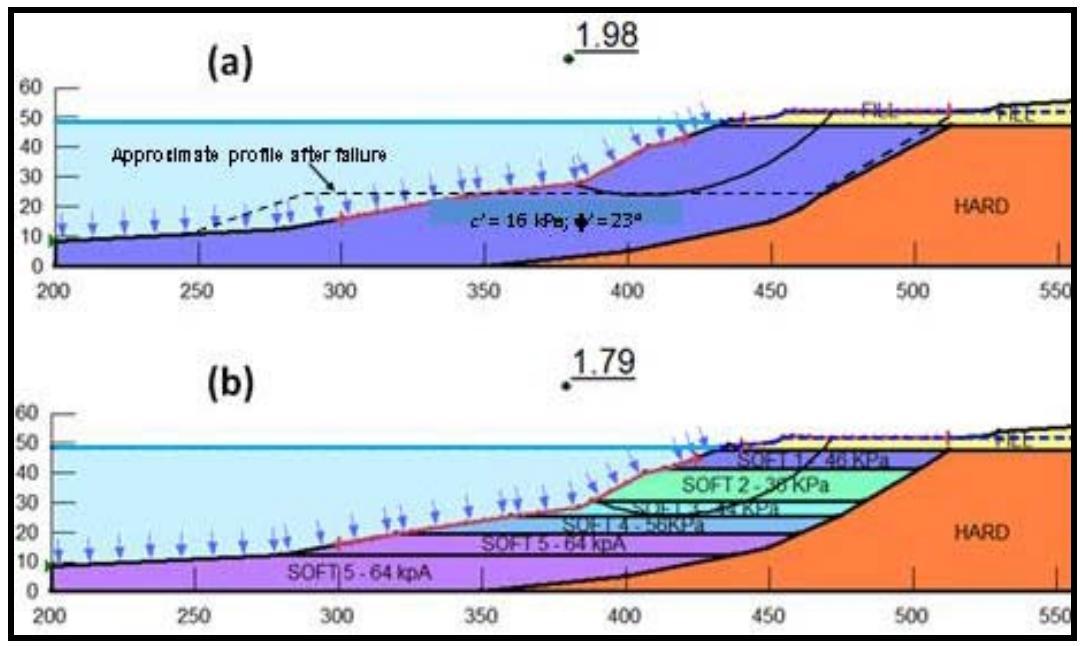
Effective stress analyses. Seven VW piezometers have been installed at points 1A, 2A and 5A at several depths and consistently indicated that excess pore pressures in the soft soil are less than 5 to 10 kPa above or below hydrostatic pressure. Considering the peak effective stress parameters obtained from the triaxial tests (c' = 16 kPa and φ' = 23°, Figure 7), a safety factor of 1.98 is obtained, as shown in Figure 9a.

• Total stress analyses. Interpretation of field vane results at points 1A, 2A and 5A led to dividing the clay in six layers as shown in Figure 9b. Total stress (φ =0) analyses, which have no meaning in this case of natural slope failure, yield a safety factor of 1.79.

Figure 9. Limit equilibrium analyses with peak parameters: (a) Effective stresses; (b) $\phi = 0$.

Also to be noted is the fact that the critical failure surface obtained in the effective stress analyses shown in Figure 9a is not conditioned by the hard soil as it is known to have happened upon actual failure (see Figure 4 and after failure profile in Figure 9a).

The high values of safety factor indicate that failure is not adequately represented by limit equilibrium analyses with peak strength parameters. Failure seems to have mobilized average strength parameters substantially lower than the peak ones or to have induced high positive excess pore pressures. To get safety factors around unity it is necessary to reduce the effective cohesion to zero and to consider some loss in the effective strength angle. The results of such reduced strength analyses indicated that the failure would happen along a surface close to the face of the slope. Such a shallow failure surface would be compatible with the occurrence of a smaller triggering slide, which in turn could be associated with the movements registered by the security camera a few seconds before general failure. Such initial failure could also have initiated other failures that would have retrogressed to the final scar. Another possibility that could be consistent with the high calculated safety factor and also the fact that the failure crater is much larger than the volume indicated by the critical circle (Figure 9a) is the

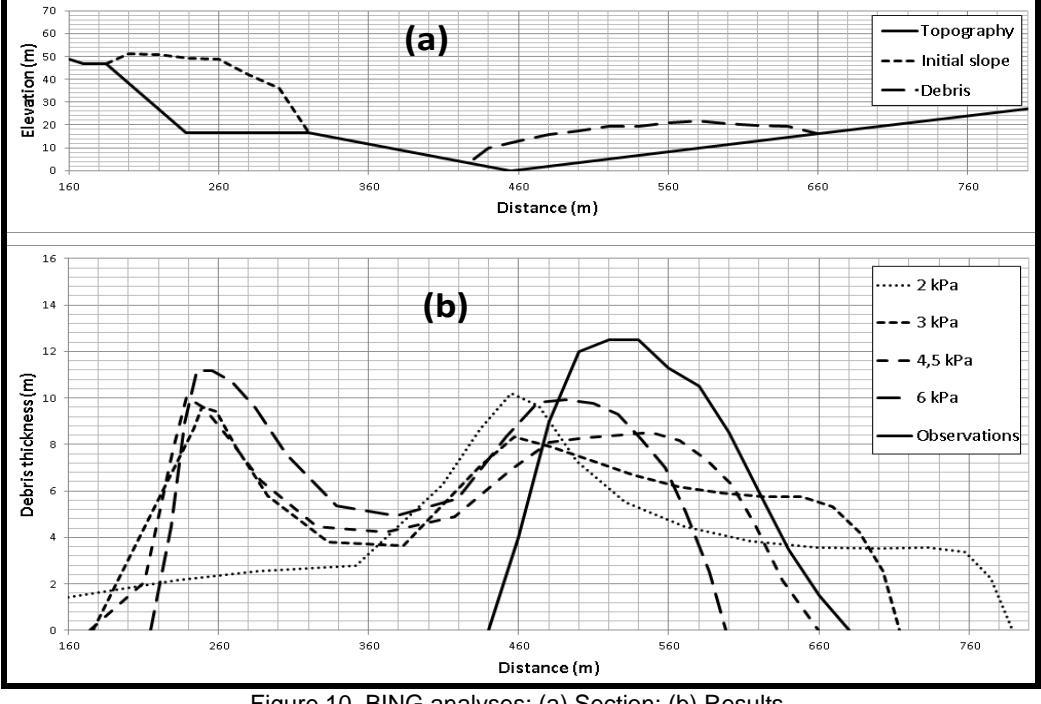
Figure 10a shows the considered section, based on Figure 4, with the landslide crater and the zone of debris. Figure 10b shows the observed debris and debris thickness obtained from the analyses. The following comments can be made:

Strengths of 3, 4.5 and 6 kPa show debris close to 10 m in the crater, which does not seem to

correspond to the observations. $\tau_y = 2 \text{ kPa gives a}$ more realistically empty crater, but the runout distance is too long compared to the observations.

- The observations in terms of runout distance would correspond to strength of about 4 kPa.
- It appears on the basis of this simple analysis that the average strength of the flowing soil is somewhere between 2 and 4 kPa.

Figure 10. BING analyses: (a) Section; (b) Results.
