# Slope Stabilization at km 229 and km 701-703 of the Alaska Highway: Site Challenges and Lessons Learned

Jason Pellett, P.Eng./P.Geo. & Andrew Horwood, AScT Tetra Tech EBA, Vancouver, British Columbia, Canada

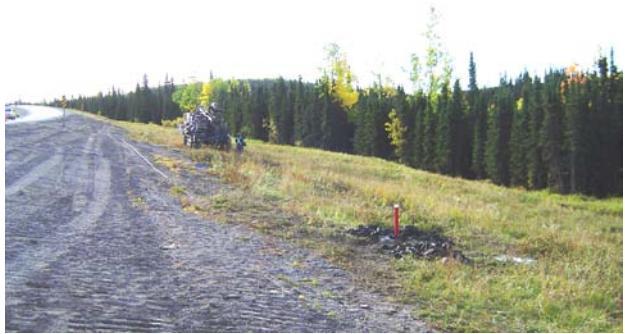
Figure 2. View of unstable slope at km 229, looking south towards Pink Mountain (Photo taken in September 2009).

- The slopes below the highway are approximately 6 m high with relatively gentle grades (8 to 12 degrees), although locally steeper 30 degree slopes are present near the treeline.
- The slopes were generally wet including pockets of standing water observed at the base of the slope.
- The forested slopes above and below the highway right-of-way were also locally wet and soft with observed seepages and "wet-site" vegetation.
- Tension cracks up to 50 mm wide and 3 m long were observed along the highway shoulder. The southbound lane was also cracked and rutted.

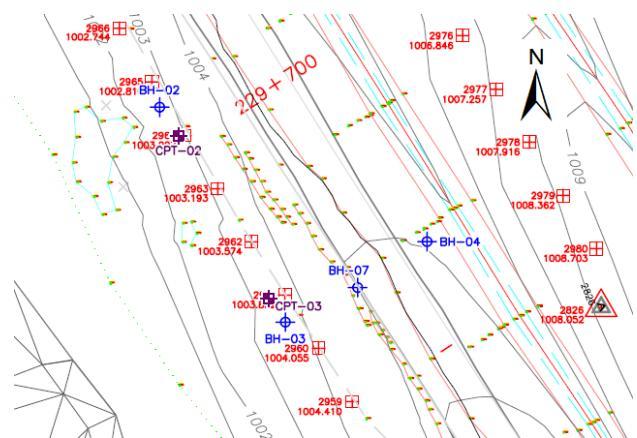
Figure 3. Survey plan of km 229 area showing testhole and rebar survey pin locations, topographic contours and location of tension cracks.

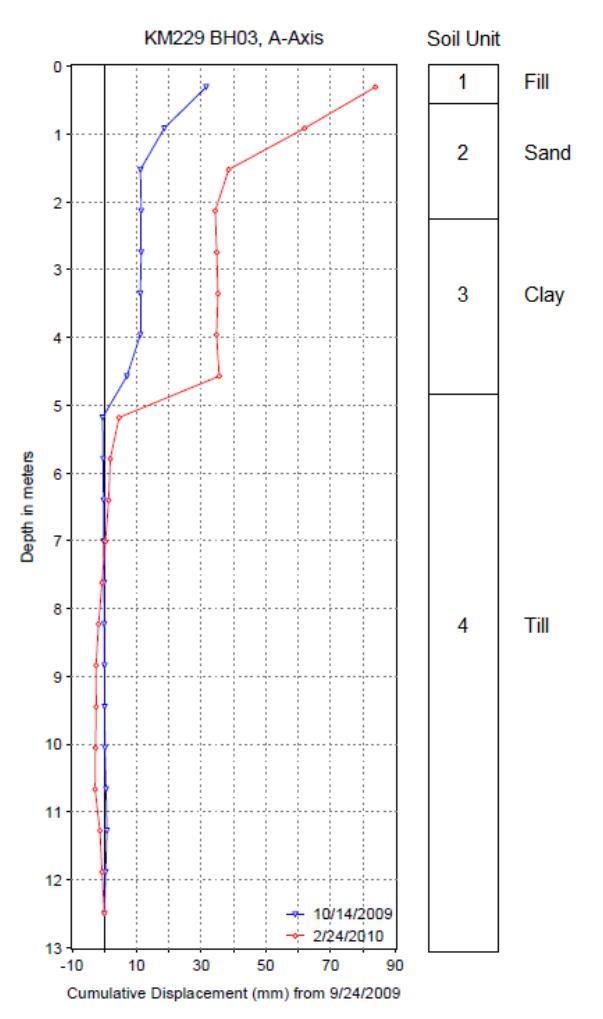
The results obtained from BH-03, located approximately 15 m downslope of the highway within the middle of the slide area are shown on Figure 4. From this figure it can be seen that the slope movements were occurring along a well-defined, discrete failure plane at a depth of about 5 m below ground surface, near the base of Unit 3.

Figure 4. Movement in Slope Inclinometer installed in BH-03 in September 2009.

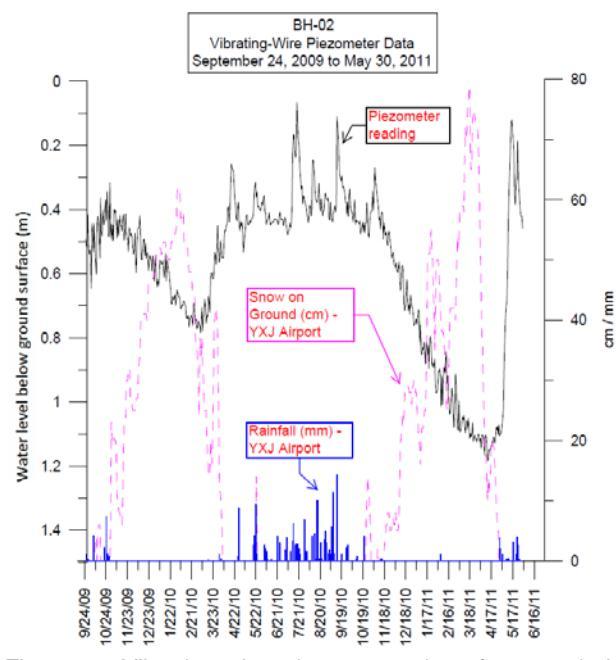
• The measured water levels were relatively shallow, which was consistent with the general site conditions and observations during drilling.

- Water levels fell by approximately 0.5 m between October 2009 and February 2010. This trend coincided with the onset of freezing temperatures and accumulation of snow.
- Water levels rose by about the same amount between March and April 2010, in response to rising temperatures and melting of the snowpack.
- Several sharp "spikes" in the data were recorded between April and October 2010, generally coinciding with rainfall events recorded at the Fort St. John airport which was the nearest source of daily weather records.
- Similar seasonal trends in the data were observed between October 2010 and May 2011.

Figure 5. Vibrating-wire piezometer data from testhole BH-02 recorded between September 2009 and May 2011.

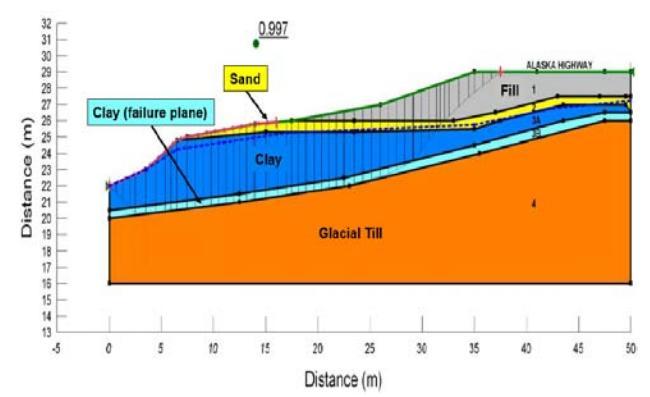
A typical back-analysis is shown in Figure 6, with various colours representing the inferred soil stratigraphy, dashed blue lines for groundwater, and vertical hatching of the critical failure surface.

Figure 6. Typical back-analysis of the km 229 slide area.

As part of the back-analyses, it was also determined that the FoS was decreased by approximately 5% for each 0.25 m rise in water levels. It was therefore evident from the piezometer data that seasonal fluctuations in water levels had a significant effect on slope stability.

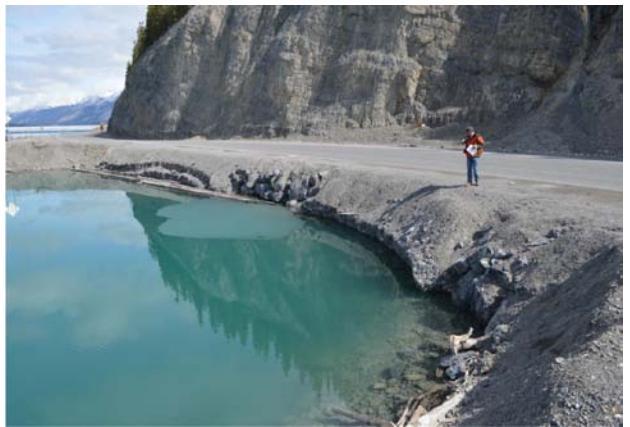
- The highway shoulder in these areas was fairly steep (up to 50 degrees) and supported by deteriorating gabion baskets as well as unstable and eroding riprap. According to PWGSC, the gabion baskets were thought to have been constructed sometime in the 1960s.
- The gabion baskets at Area 2 had toppled (slumped) outwards and had experienced significant differential settlement.
- Surface erosion from highway run-off and wave erosion from Muncho Lake both appeared to be contributing to the loss of the shoulder fill.
- The bottom row of the gabion baskets at each site was generally situated below lake level, and as such could not be observed in detail. At Area 2, log cribbing was also visible underneath the gabions at several meters below lake level.
- Tension cracks were observed along the highway shoulder and southbound lane at Areas 2 and 3.

Figure 8. View of Area 2 showing the existing riprap and gabion baskets. (Photo taken in May 2013).

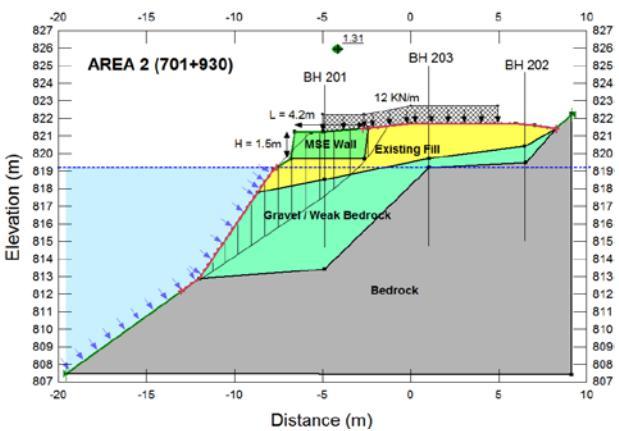
A typical global stability analysis is shown in Figure 9, with various colours representing the inferred soil stratigraphy, dashed blue lines for groundwater, and vertical hatching of the critical failure surface.

Figure 9. Typical global slope stability analysis of the proposed MSE wall at Area 2.

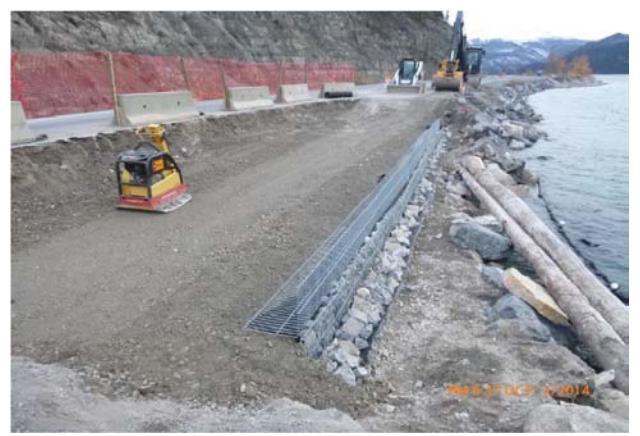
The conditions in the excavations were broadly consistent with the testhole data, except for some areas where shallow bedrock, buried rows of gabion baskets and old tie-back cables were encountered. The excavation of these materials was completed without incident.

Figure 10. MSE wall construction at Area 3. (Photo taken in October 2014).

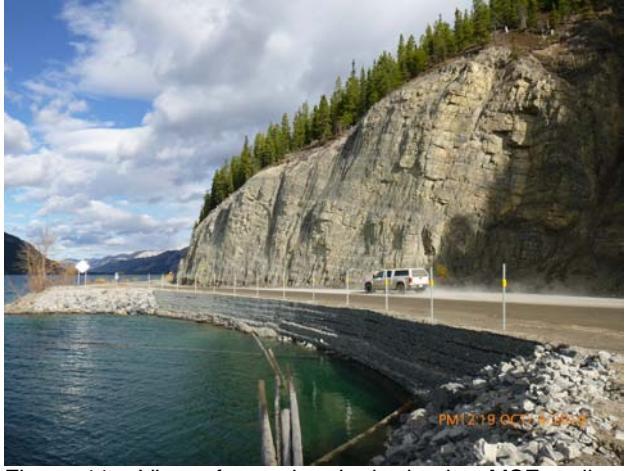
Figure 11. View of completed wire-basket MSE wall at Area 2. (Photo taken in October 2014).

Tetra Tech EBA visited the km 701-703 area in February 2015 while en route to another project site along the Alaska Highway. The MSE walls appear to have experienced minor settlements in some areas, but overall are performing as expected.
