Slope Observations and Field Mapping to Verify the Stability of Slopes near Kitimat, BC

Ali Khalili, Jason Pellett, Brian Hall & Jack Price Tetra Tech EBA, Vancouver, British Columbia, Canada

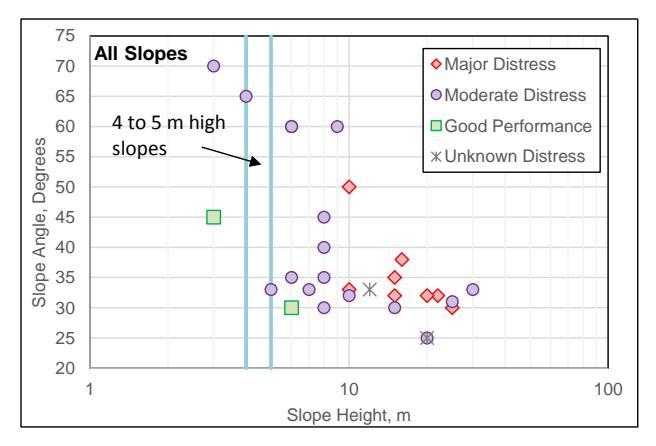
Figure 5. Mapped Data Corresponding to All Slopes

The results presented in Figure 5 indicate that majority of the mapped slopes were higher than 4 to 5 m. The available data points pertaining to the slopes less than 4 m in height, which are typical of engineering construction, however, are very limited in the database and the results should be interpreted with caution. Slopes between 5 m and 10 m in height generally showed moderate distress whereas slopes higher than 10 m showed a greater tendency to experience distress at higher inclinations.

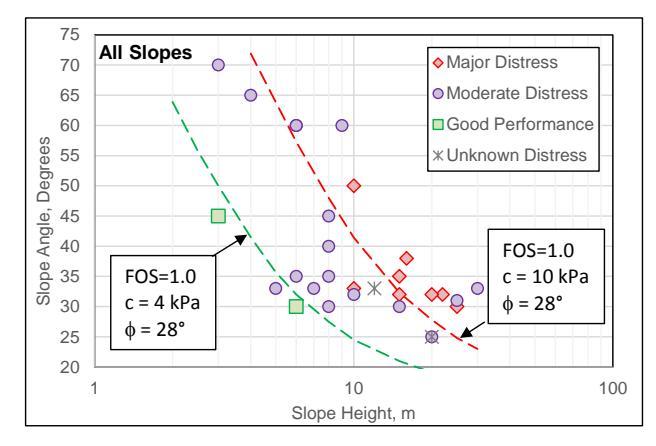
Figure 6. Boundaries Between Distress Categories Inferred from Hoek and Bray (1981).

The boundaries presented in Figure 6 imply that in general if the factor of safety is more than unity, and the friction angle is 28° , apparent cohesion is 4 kPa, unit weight is 19 kN/m³, and for average groundwater conditions, it is likely that the slope will show good performance over time. Similarly, if the factor of safety is less than unity or close to unity, the slope will likely show signs of major distress over time. Between these two scenarios, the slopes will likely experience moderate distress over time.

- Slopes with a factor of safety of more than unity obtained from Hoek and Bray (1981) stability charts, while assuming a friction angle of 28°, apparent cohesion of 4 kPa, unit weight of 19 kN/m³ and average groundwater conditions, are likely to perform well without showing moderate to major signs of distress (Figure 6).

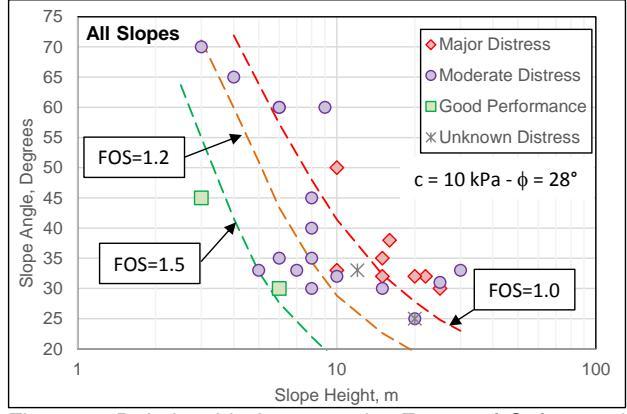
Figure 7. Relationship between the Factor of Safety and Slope Distress

Figure 7 shows the relationships obtained from Hoek and Bray (1981) stability charts, for apparent cohesion of 10 kPa and factors of safety of 1.0, 1.2 and 1.5. Other parameters were unchanged from previous assumptions. The results indicate that when the higher apparent cohesion of 10 kPa is adopted for the analyses, factors of safety of less than unity generally correspond to the major distress cases, while factors of safety of 1.5 and higher generally correspond to slopes exhibiting good performance.

The results also indicate that major distress should be anticipated for factors of safety of less than 1.2.

- The target factor of safety should be commensurate with the reliability of the shear strength parameters. The results show that if high apparent cohesion is adopted for the stability analysis at the general area, a higher target factor of safety should be adopted. A higher target factor of safety of 1.5 was found to represent the slopes with good performance if an aggressive apparent cohesion of 10 kPa is adopted while all other variables are kept unchanged (Figure 7).

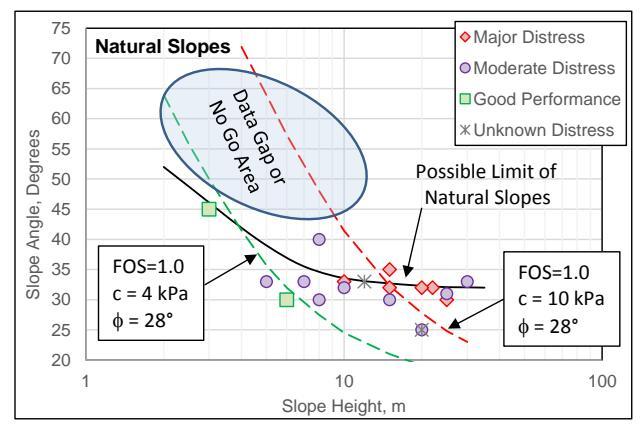
Figure 8. Mapped Data Corresponding to Natural Slopes

Figure 8 presents only the data points corresponding to the natural slopes along with distress boundaries inferred using the Hoek and Bray (1981) stability charts. It appears that the natural slopes with inclinations of more than about 32° and more than 10 m in height generally show major signs of distress. Similarly, natural slopes with inclinations of more than 30° and more than 5 m in height generally show moderate signs of distress.

The number of data points pertaining to steep slopes (i.e. more than 35° for higher than 10 m, and more than 40° for slopes between 5 m and 10 m) are very limited in the database. This is likely because over-steeped natural slopes do not occur; however, this could not be confirmed using the available data.

The possible boundary/limit of the natural slopes with respect to inclination and height is presented by a solid black line in Figure 8.

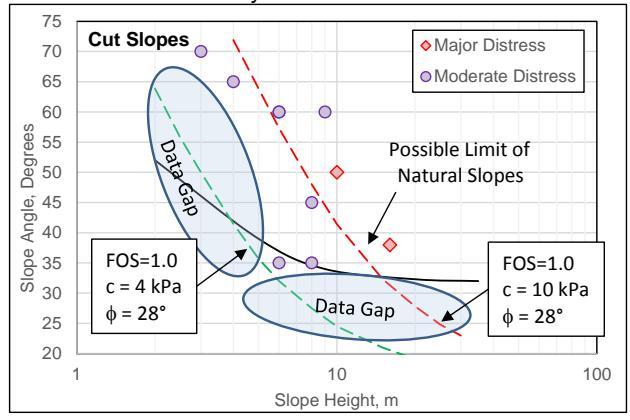
Figure 9. Mapped Data Corresponding to Cut Slopes

Figure 9 presents only the data points corresponding to the cut slopes, which generally show moderate or major signs of distress. A gap in the collected data is noted pertaining to the cuts slopes with good performance. Steeper slopes are noted among the cut slopes.

Previous studies show that cut slopes in silt/clay material are generally most stable immediately after the construction due to the generation of negative pore pressures and apparent cohesion but typically become less stable over time. Implementation and construction of stabilizing measures such as toe berms, drains, etc. would likely compensate for the deterioration of internal/intrinsic stability factors.

In the absence of stabilizing measures, however, it is expected that slopes plotting above the possible limit of natural slopes would deteriorate over time until they reach the limiting boundary. Therefore, when designing cut slopes, which plot above the possible limit of natural slopes, rigorous exploration, verification and design must be undertaken before construction.

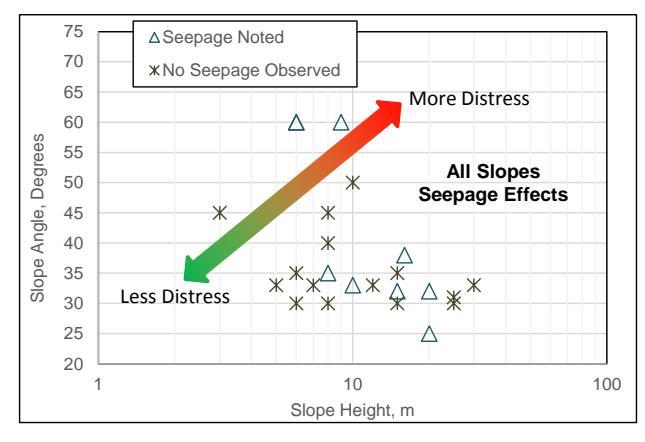
Figure 10. Effect of Drainage on Slope Conditions

The effect of seepage on the slope conditions are presented in Figure 10. The data is grouped into the slopes at which seepage was noted as well as the slopes at which no seepage was noted. At five locations no observations regarding surface drainage or seepage was recorded and the corresponding data points were not presented in Figure 10.

The results indicate that the slopes with seepage noted at the surface are more likely to show signs of distress than the slopes that showed no visible sign of seepage.

- An anticipated warmer and wetter climate in the future will likely provide conditions similar to 2000/3000 years ago, when slope instabilities were frequent in the area. This signifies the importance of proper drainage design in the future performance of the slopes and preventing the saturation of the soil to the extent possible.
