Case Study of a Landslide on Highway 20 North of Craven, SK

Harpreet Panesar¹, Hung Vu², Laurie Stang², Jody Schafer¹, Hamid Soleymani¹

¹*Ministry of Highways and Infrastructure, Regina, Saskatchewan* ²*Golder Associates Ltd., Saskatoon, Saskatchewan, Canada*

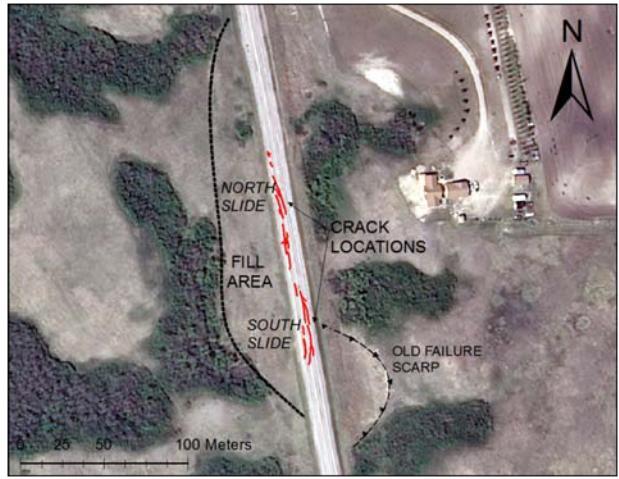
Figure 2. Site location plan showing high fill extent and cracks on pavement

The old failure scarp on the east ditch back slope shown in Figure 2 is also noted on aerial photographs dating back to 1969. Aerial photographs also reveal that the residential property at the crest of the back slope, approximately 75 m east of the north slide, was constructed sometime after 2001.

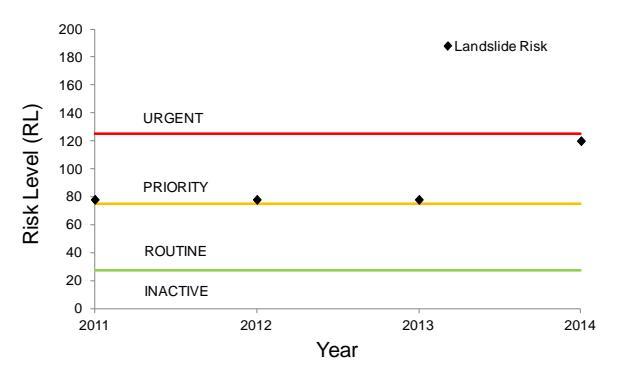
Figure 8 provides the record of historic geohazard risk rating for the site. The site was first included in the GRMP in 2011. A CF equal to 8 was assigned due to the fact that closure of the road would be a direct and unavoidable result of a slide occurrence and additional hazards such as fill height more than 20 m and third party concerns were present (such as house upslope). Cracking was observed throughout the fill section of approximately 150 m, primarily in the southbound lane and extending into the northbound lane in some locations. The landslide risk rating for the east abutment was equal to 78 in year 2011. In fall of 2014, horizontal and vertical displacements of the road surface were more severe (especially in the north slide) than those observed in previous years, results in an elevated risk level of 120.

Figure 8. Geohazard Risk Rating for the site

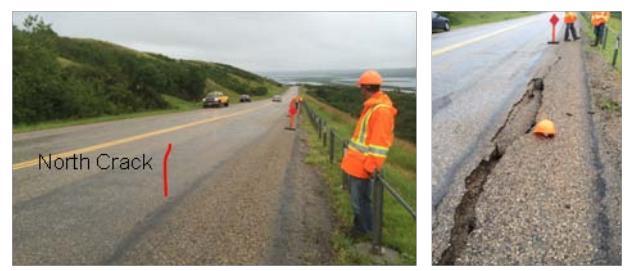
Two such failures were observed on Highway 20 north of Craven, SK. Highway 20 has a number of high fills across ravines that feed into the valley of Last Mountain Lake just a few kilometers north of Craven where the highway starts to climb out of the valley. The fill at the location of the failure is more than 20 m high. Severe cracking along the shoulder was observed in August 2014.

Figure 9. 2014 site inspection photos of the north slide (looking in the south direction)

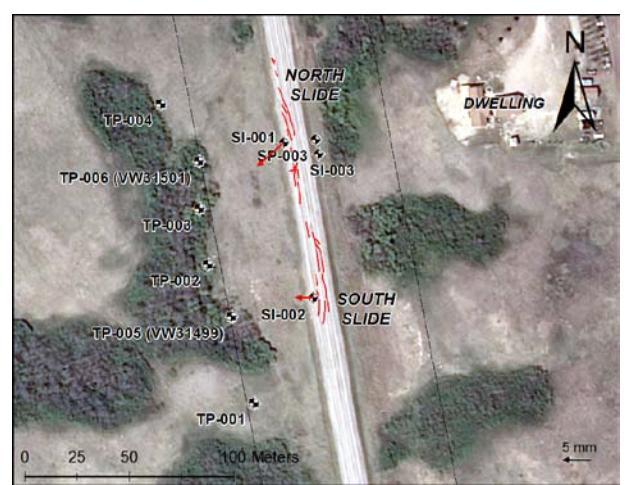
Shear displacement vectors at SI001 (approximately 5.5 mbgs/ 520 masl) and SI002 (approximately 6 mbgs/ 526 masl) are shown in Figure 13. SI003 showed a slight movement at approximately 19 mbgs/513 masl, indicating a potential multiple zone of movement at the site..

Figure 13. Instrumentation Location Plan

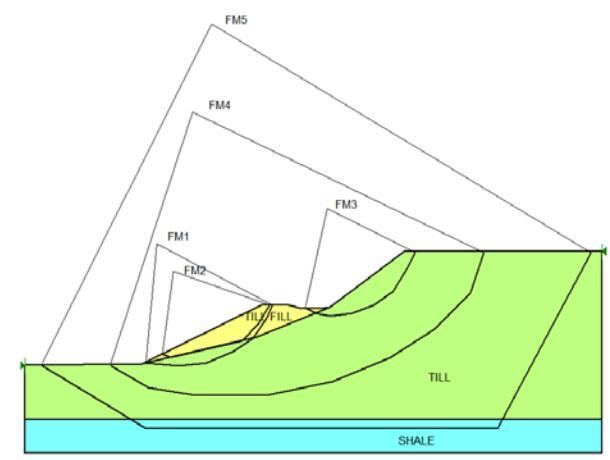
Figure 14. Illustration of potential slope failure mechanisms

The observed failures at the north slide area and south slide areas are associated with failure mechanisms FM1 or FM2. The old scarp from a shallow failure on the east ditch back slope south of the two slides (see Figure 2) was associated with failure mode FM3. This study addresses the failure through the till fill (failure mechanisms FM1 and/or FM2). Because shale was not countered to the depth of investigation, failure mode FM5 was not considered in this study. The soil investigation and instrumentation program were conducted to provide geotechnical information for the remediation of the embankment slope. Any proposed remediation option should not have negative impact on failure mechanisms FM3 (stability condition of upper slope) and FM4 (stability condition of overall slope). Seepage analysis was not conducted to evaluate ground water conditions of the site because of inadequate site specific geotechnical information. One piezometric line was assumed based on available piezometer data to represent the shallow groundwater conditions in the embankment till fill and till under the embankment. There is significant uncertainty associated with assumed groundwater levels for failure mechanisms FM3 and FM4.

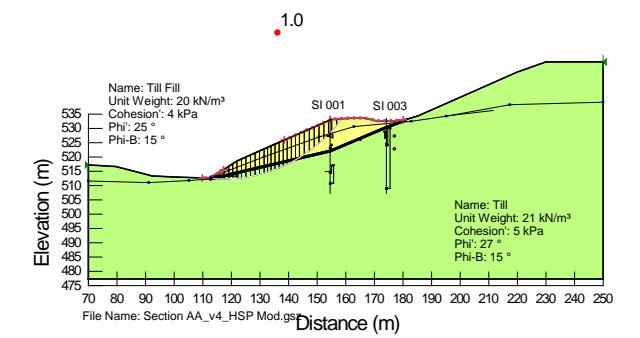
A parametric analysis was completed to assess the sensitivities of the calculated factor of safety to variability in material properties. The results of the parametric study indicated that the effective friction angle and effective cohesion of till are the factors that have the greatest effect on the calculated slope F_s . However, the effective cohesion and angle ϕ^b of till fill appear to control the shape of the slip surface.

Figure 15. Factor of safety map with F_S increment of 0.01 for the back analysis of cross-section A-A'

Several remediation options were evaluated, namely finger drains at the toe of the embankment, drainage trench (10 m deep) installed along the east ditch, combination of finger drains and drainage trench (5 m and 10 m deep), steel H piles installed along the embankment crest and a toe berm constructed at the toe of the slope. Table 4 provides the results of deterministic and probabilistic analyses. Table 5 provides a summary of F_S increase, along with advantages and disadvantages of various remediation options. Based on the results, the toe berm was selected as the preferred remediation option for this site. Because there is uncertainty in soil conditions at the toe location, field monitoring during the construction (e.g., visual observation and instrumentation monitoring) is recommended.
