# Steepbank River Valley Geomorphological and Geological Categorization

H. Joanna Chen, Rob Charron, Dan Hepp, Jeffrey MacLean Klohn Crippen Berger Ltd, Calgary, Alberta, Canada Jason Chen Suncor Energy Inc., Calgary, Alberta, Canada

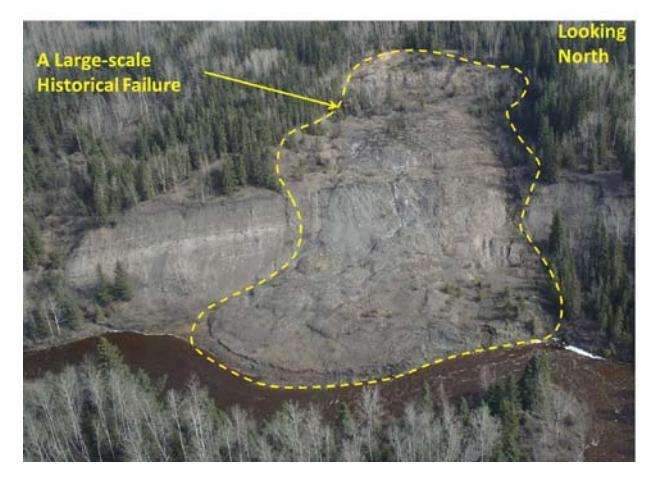
Figure 4. An example of a large-scale historical failure observed along the escarpment slopes.

Key features visually identified on these photos include large-scale slope movement features such as erosional gullies and large-scale historical failures (Figures 4 and 5). Small-scale or detailed features such as crest retrogression, sloughing, fallen/inclined trees, fractured bedrock, signs of seepage, bitumen seeping and salt precipitate, etc. were identified in areas where photos are available (Figures 6 and 7). In a few areas the slope toe undermined by the river likely during storm/high flow events causing lateral erosion was also observed.

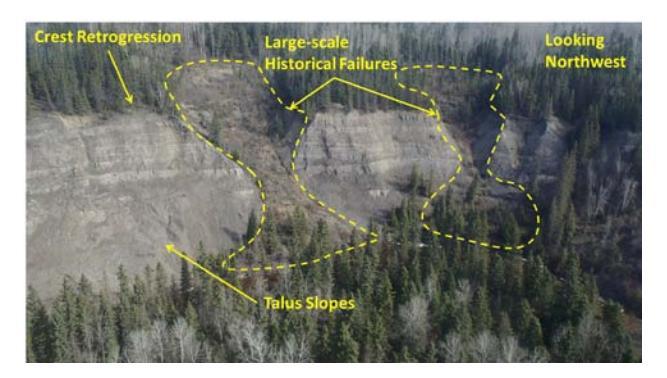
Figure 5. An example of large and small-scale failures along the escarpment slopes.

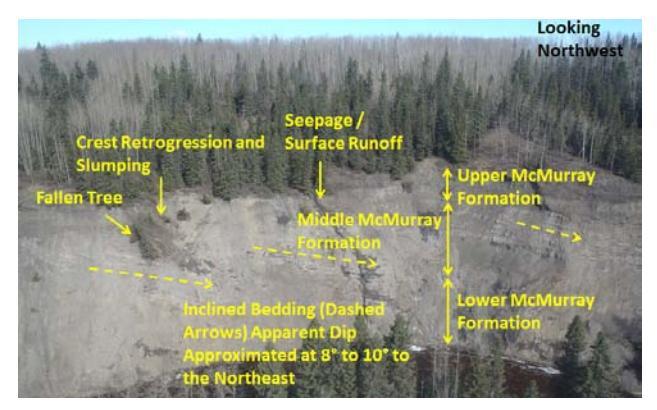
Figure 6. An example of several key features observed along the escarpment slopes.

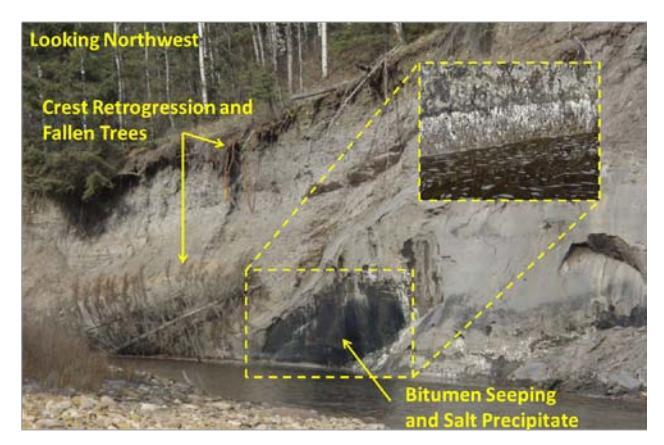
Figure 7. An example of small-scale failures and bitumen seeps along the escarpment slopes.

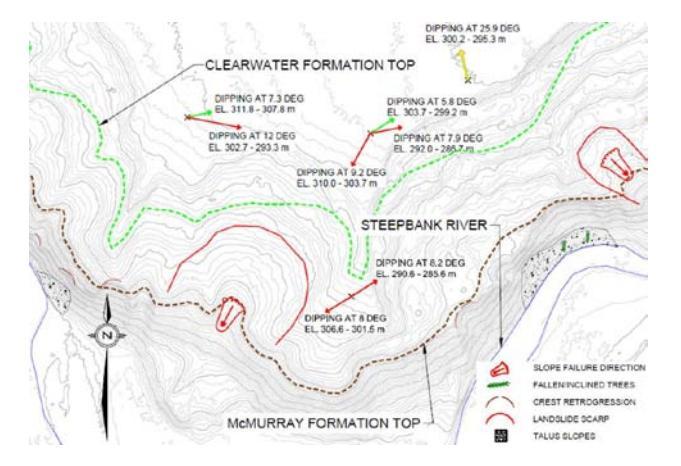
Figure 8. A portion of the inventory map along the escarpment slopes with slope movement features mapped.

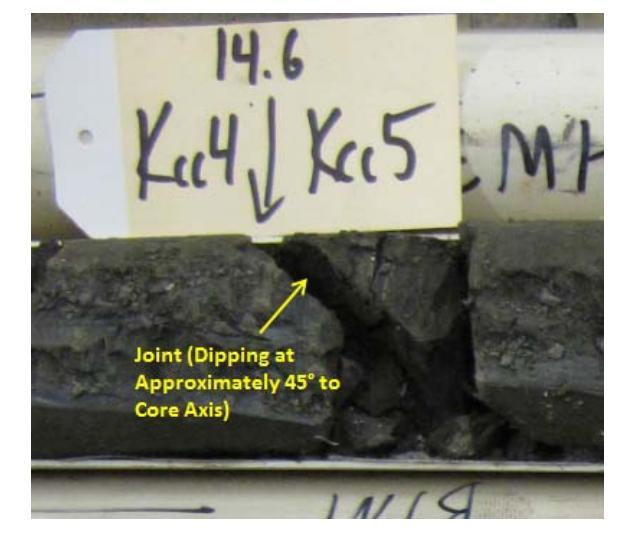
High-angle joints (dips greater than 40°) and smallscale faults were frequently observed in the Clearwater Formation. The orientations of the discontinuities cannot be determined from the core descriptions or core photos alone. High-angle joints and small-scale faults with random orientations may be observed from existing dipmeter data; however, the dipmeter data does not differentiate between dipping beds and other geologic structures (e.g. joints and small-scale faults). The randomly oriented discontinuities are likely widespread throughout the Clearwater Formation and may be caused by glaciations.

Figure 13. A typical joint observed in the core from the Clearwater Formation

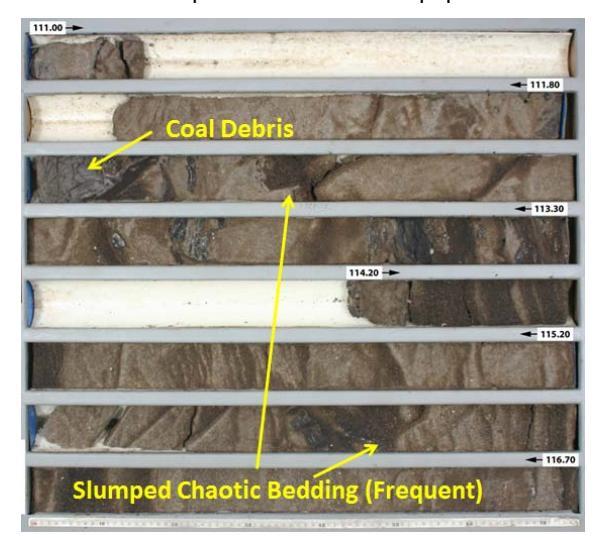
Figure 14. Typical chaotic and slumped bedding observed within the lower McMurray Formation overlying deeper Devonian limestone collapse breccias and paleosol infills (not shown).

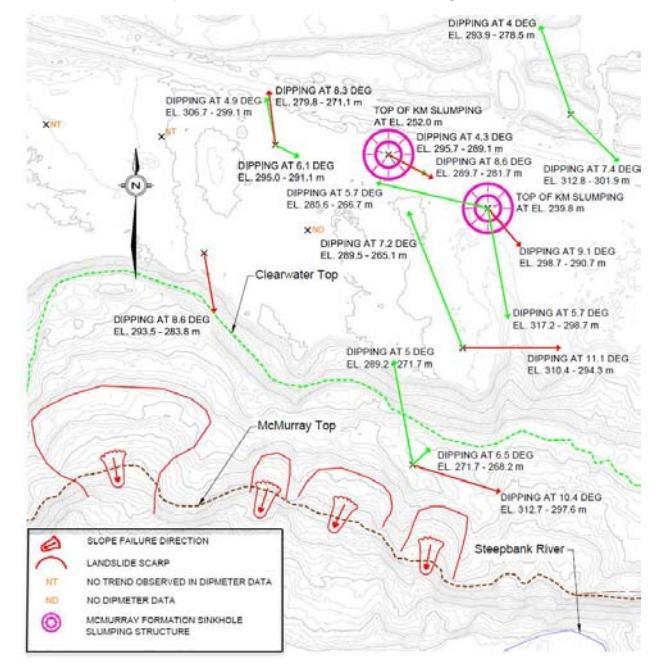
The collapse structures occurring during the deposition of the McMurray Formation often result in slump structures in the existing sediments. Slumped sediments can yield normal faults along with steeply dipping beds. These structures are marked by slumped McMurray sediments (erratic and steeply dipping beds), by limestone and McMurray Formation breccias and by clay (Paleosol) and McMurray Formation infills. Collapse structures within the McMurray Formation were observed in six boreholes, which are likely isolated occurrences (Figure 15).

Figure 15. A portion of the inventory map along the escarpment slopes with collapse structures, dipping trends and slope movement features mapped.
