# BACK ANALYSES OF AN ANCIENT LANDSLIDE: A CASE STUDY IN ZAGROS

Department of Civil Engineering–University of Rahman Ramsar, Ramsar, Mazandaran/Iran

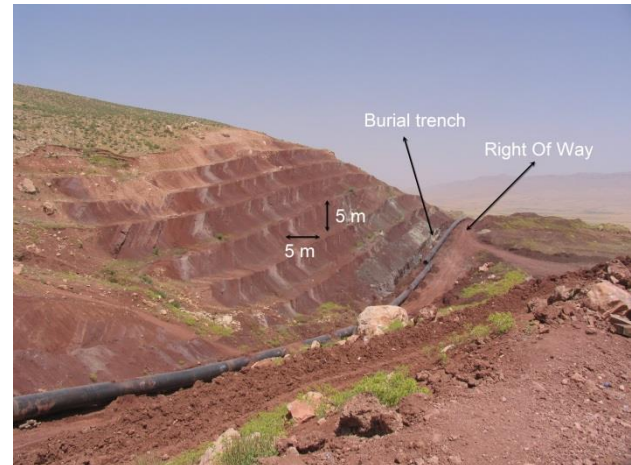
Figure 2. Steps used for stabilizing slopes in Zagros

Experience in this region of Iran has shown that slopes of 1:1 are acceptable and suite the requirements for constructing the R.O.W for gas pipe lines. Engineers and contractors usually remove the soil on top of the slopes with an angle of 45° by constructing steps. The steps have a width and height of 5 m as illustrated in Figure 2. The diameter of the pipe line for this route is 140

cm and the width of the R.O.W is around 28 m. After constructing the R.O.W, the pipe line must be buried under the ground at a depth of at least 1.5 m. The width of the R.O.W is large so that if there are any emergencies, machineries can easily get access to the required location.

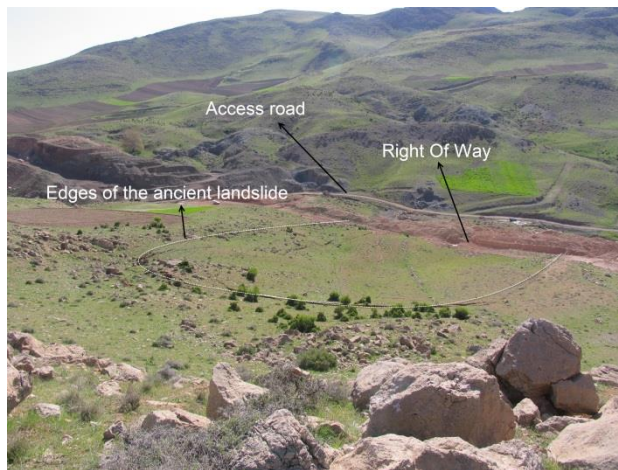
Figure 3. The edges of the ancient landslide

The width of the sliding mass at the level of the R.O.W is 350 m. The sliding mass did not contain a particular geometry along its length; this means that the slope changed at a point along the length of the sliding mass. From the upper step constructed by the contractors the slope moved with an angle of  $10^\circ$  for 105 m and then increased to  $20^\circ$  and continued for another 70 m up to the graben. The head scarp was generated after the rain fall at the intersection between the two described slopes (where the slope angle changed from  $10^\circ$  to  $20^\circ$ ). Furthermore, the geometry does not change along the width of the sliding mass, that means that a two dimensional analysis provides acceptable results. Figure 7 illustrates the landslide with the two slope geometries and the head scarp. The soil removed from constructing the steps was deposited along the sides of the R.O.W, as illustrated in Figure 7. Before depositing the removed soil, the slope was flattened so that a higher volume of material could be deposited along the sides of the R.O.W. It can also be noticed that the instability is a translational sliding mass, which the slip surface is shallow compared to its length (Figure 3).

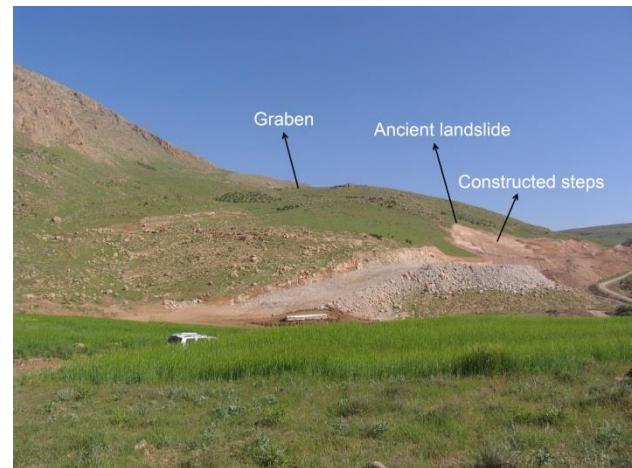
Figure 4. The ancient landslide with its graben

Figure 4 illustrates the ancient landslide with its graben (the location were the initial soil mass was positioned) and the constructed steps.

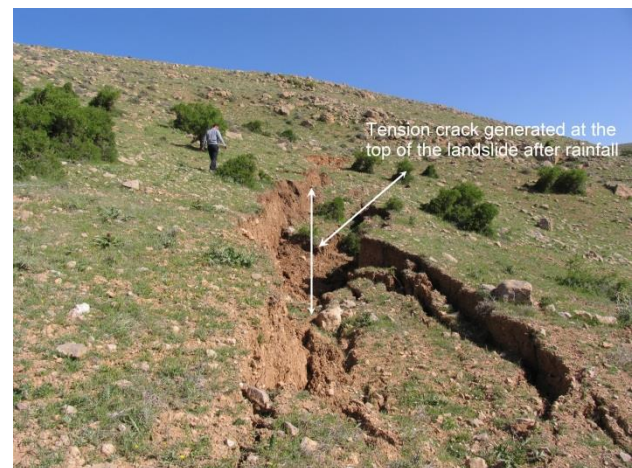
Figure 5. Tension crack generated at the head scarp

Figure 5 illustrates the head scarp of the sliding mass after the heavy rainfall in the region. The depth of tension crack was 3 m. It must also be noted that no bulging was detected on the R.O.W during the inspection; this means that the slip surface is not exiting at the level of the R.O.W. After the rainfall, most constructed steps collapsed and cracks appeared at their base.

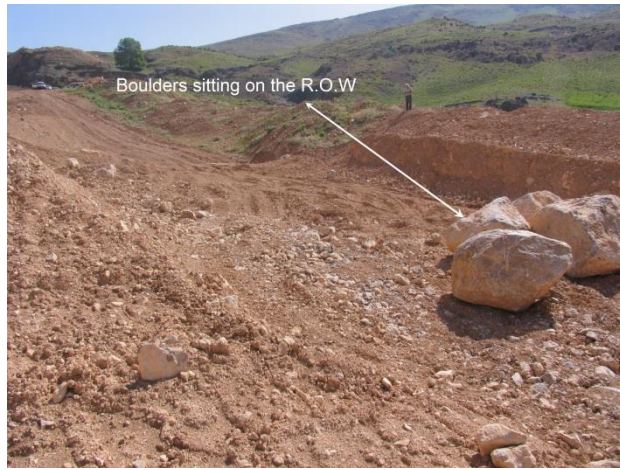
Figure 6. Large boulders closing the R.O.W due to the soil movement

Figure 6 illustrates the R.O.W after the movement of the landslide, it is clear that the landslide contained all types of material from large boulders to fine grained soils (comparing Figures 6 and 8).

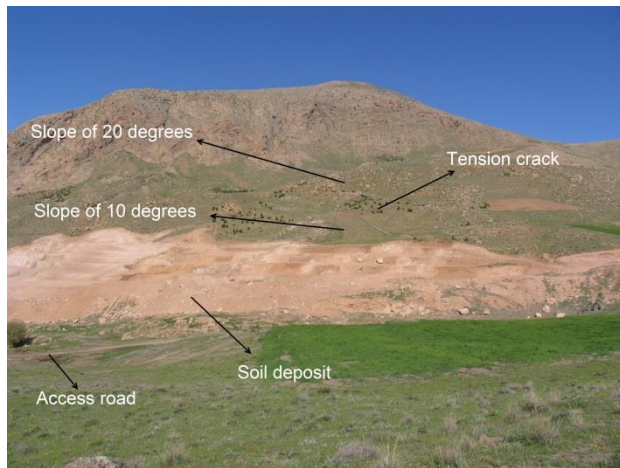
Figure 7. The two slopes involved in the ancient landslide

The initial soil mass before cutting the slope for the R.O.W had a slope of  $10^\circ$  for its initial section and it that was followed by a slope of  $20^\circ$  (similar to Figure 7). The discrete shear zone was also parallel to the ground level for both slopes involved in the landslide. The water depth (piezometric line) is at a depth of 30 m from the level of the R.O.W in the analysis. It is also assumed that at the time of failure no suction is present and the factor of safety is equal to 1. Furthermore, the slip surface in the analysis must pass through the discrete shear zone.

It was recommended that for the width of the ancient landslide the route must be changed to the right of the access road (Figure 7) as it does not contain any steep

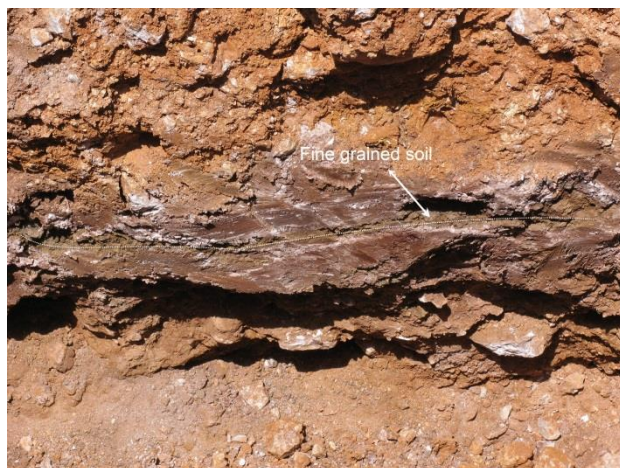
Figure 8. The discrete shear zone of the ancient land slide in the trench opened on the R.O.W

Figure 8 illustrates the excavated trench on the R.O.W and the discrete shear zone which contained fine grained material. The discrete shear zone was at a depth of around 3.0 m below the level of the R.O.W and at a depth of 10 m above the tension crack. This indicates that the discrete shear zone is almost parallel to the ground surface for both slope angles involved in the sliding mass.

During the excavations it became clear that the soil was a mixture of all types of materials, i.e. a mixture of fine grained soils up to large boulders. The average properties of the fine grained soil in the discrete shear zone are: LL 65, PL 34,  $w$  37% and PI 31.

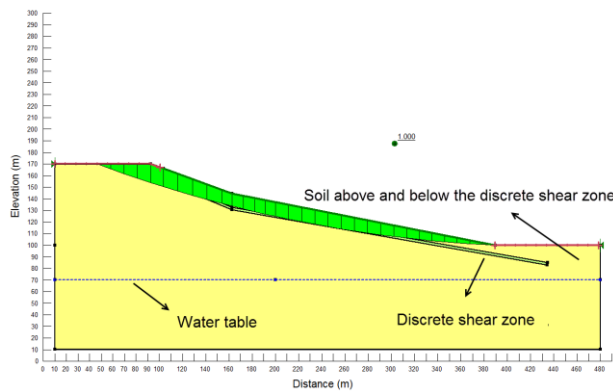
Figure 9. The safety factor calculated by the circular method (phase one)

The results of this analysis are illustrated in Figures 9 and 10 for the circular and optimized methods respectively. Usually the calculated values for the factor of safety from the optimized method (noncircular) and the results of the ordinary method (circular) are close to each other. With the same shear strength values used to obtain a factor of safety of 1.0 for the ordinary method, a factor of safety of 0.529 is calculated for the optimized method (Figures 9 and 10).

The shear strength parameters obtained from the circular method for the soil on top and below of the discrete shear zone are as follows: unit weight  $20 \text{ kN/m}^3$ ,  $\phi' = 17^\circ$  and  $c = 4 \text{ kPa}$ . The shear strength parameters from the circular method for the discrete shear zone are also as follows: unit weight  $17 \text{ kN/m}^3$ ,  $c = 0 \text{ kPa}$  and  $\phi' = 6^\circ$ .

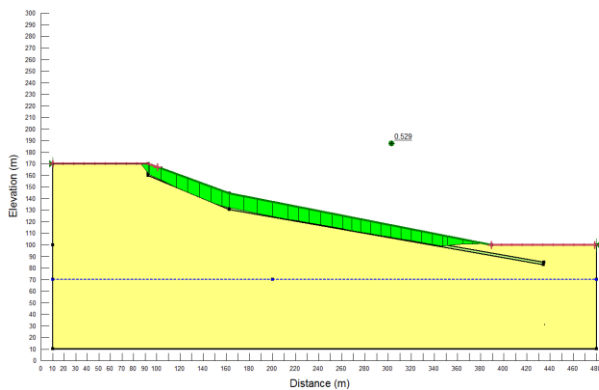
Figure 10. The safety factor calculated by the optimized method (phase one)

The soil shear strength parameters are changed for the optimized method to achieve a safety factor of 1.0 (as it provided a value of 0.529 through using the circular method). For the soil above and below the discrete shear zone the shear strength parameters are as follows: unit weight  $20 \text{ kN/m}^3$ ,  $c = 4 \text{ kPa}$  and  $\phi' = 34^\circ$ . For the discrete shear zone, the values are as follows: unit weight  $17 \text{ kN/m}^3$ ,  $c = 0 \text{ kPa}$  and  $\phi' = 11^\circ$ .

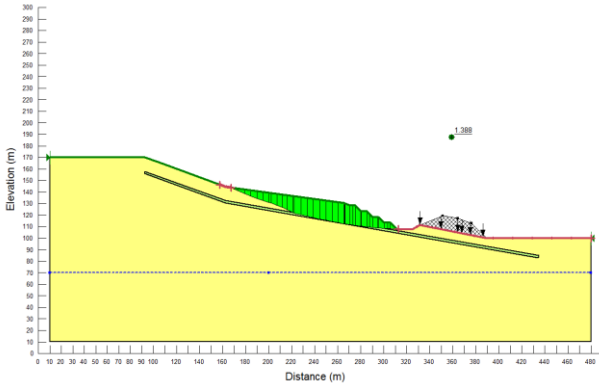
Figure 11. The results of the optimized method (phase two)

For phase two of the analysis the factor of safety calculated by the optimized method and its corresponding shear strength parameters is equal to 1.388. For the ordinary method with its corresponding shear strength values, the factor of safety is equal to 0.973. Figures 11 and 12 illustrate the factors of safety calculated for the optimized and the circular method respectively. After the heavy rainfall the soil mass moved and tension cracks were generated on the top and its sides which indicates that the factor of safety dropped below one. This clearly illustrates that if the gap between the factors of safety calculated by the two methods (circular and noncircular) are large, the ordinary method must be used for back calculating the shear strength parameters involved in a translational sliding mass.

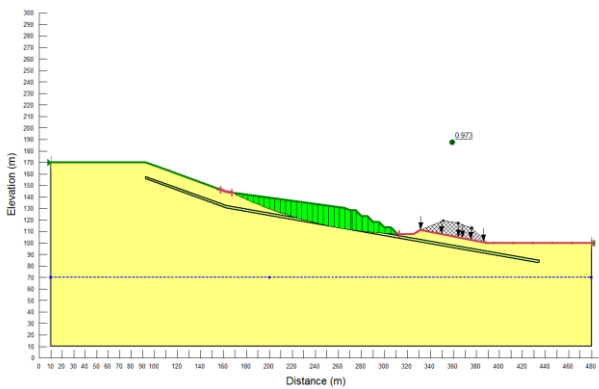
Figure 12. The results of the analysis for the circular method (phase two)

Through further investigating the numerical results of phase two it became clear that the circular method (ordinary) illustrates that the upper slices are in tension (i.e. tension cracks are anticipated). Through checking the slice information, the depth of the tension crack is about 3.5 m which is in a very close agreement with the depth of the tension crack generated in the field (Figure 5). The optimized method also predicts that the upper slices are in tension but it anticipated that the tension crack depth is over 20 m, which is much deeper than the depth sighted in the field.

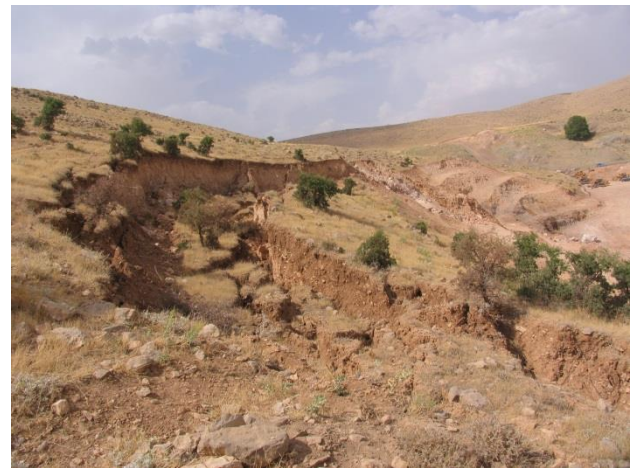
Figure 13. The head scarp after removing the landslide's toe

As advised, the contractors removed 30 m of soil from the location of the destructed steps into the slope and constructed the required steps but they were not able to decrease the level of the R.O.W as the landslide experienced large displacements. Figure 13 illustrates the tension crack on top of the landslide after removing the toe of the landslide (compare Figure 5 and Figure 13).

In this phase a consultant (not the author) provided advice for stabilizing the moving mass. It was advised that from the constructed steps, 30 m of soil must be removed into the landslide and steps must be constructed with a slope of 1:1 (this is essentially removing the slope's toe and increasing the width of the R.O.W). The constructed steps for stabilizing the slope must also have lengths and breadths of 5 m. It was also mentioned that the R.O.W's level must be decreased by 2.5 m. In a case history described by Cornforth (2005) (case history number 6, Pelton Upper Slide) it is mentioned that a consultant made such an advice in the US in 1990 which generated movements in a sliding mass. The reason that the consultant made such a decision for the gas pipe line route was to open enough space for materials that might fall down from the slide. He was also looking forward to bury the gas pipe line beneath the discrete shear zone of the ancient landslide. By using such a technique, he could

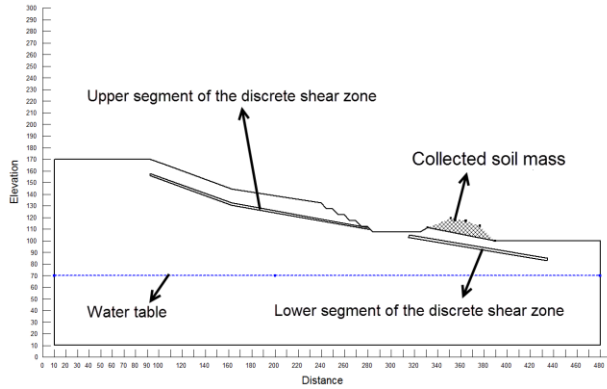
Figure 14. The discrete shear zone segmented due to soil removal (phase three)

As the soil is removed (30 m into the sliding mass) it is clear that the lower part of the slope (that is where the steps are located in phase two) will intersect the discrete shear zone of the ancient landslide and it will cause a rupture in the shear zone (that is because a huge amount of soil is displaced towards the shear zone of the ancient landslide). Essentially one segment of the discrete shear zone sits along the original slope and the other starts beneath the R.O.W as illustrated in Figure 14.

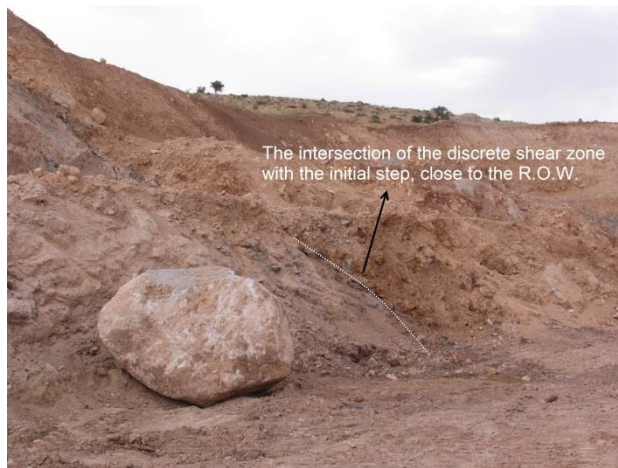
Figure 15. The intersection of the discrete shear zone with the initial step above the R.O.W

Figure 15 illustrates the intersection between the discrete shear zone of the ancient landslide with the initial step above the R.O.W after removing the landslide's toe. This also confirms that the discrete shear zone moved parallel to the ground level. It must be pointed out that the discrete shear zone was shaved during the process of generating the initial step and only a small segment of it was present when the author investigating the site after the landslide's toe was removed (Figure 15).

As anticipated, the slip surface with the minimum factor of safety passes through the defect and will come out at the intersection of the discrete shear zone and the constructed step above the R.O.W, which is also illustrated in Figure 15.

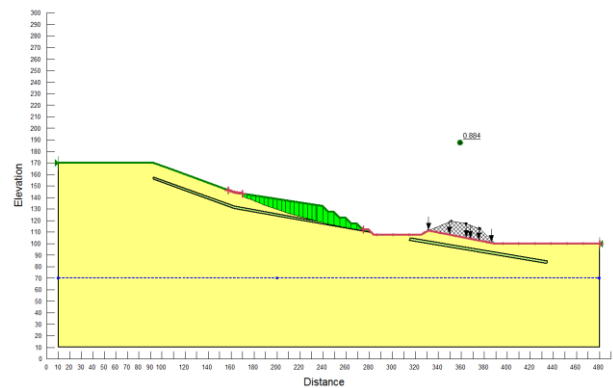
Figure 16. Results of the circular method for phase three

zone are as follows: unit weight  $17 \text{ kN/m}^3$ ,  $c = 0 \text{ kPa}$  and  $\phi' = 6^\circ$ . The values are adopted in the third constructed phase and a factor of safety equal to 0.884 which is less than the second phase (0.973) is calculated. The result of this analysis is illustrated in Figure 16. It is interesting that as the discrete shear zone is segmented during the construction process, the minimum calculated factor of safety is only related to the upper part of the ancient land slide and consequently the existence of the semi buttress constructed by heaping up the removed soil does not influence the minimum factor of safety. Figure 17 illustrates the same analysis without the existence of the heaped soil along the R.O.W. As anticipated, changes made to the geometry significantly influenced the behavior of the ancient landslide.

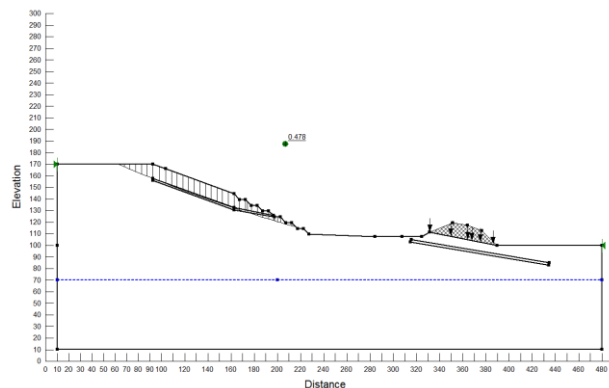
Figure 18. The minimum factor safety calculated with the circular method for phase four

In this phase it was recommended that the soil must be removed from the head scarp downward (i.e. towards the R.O.W) with an angle of 45° and then to bury the gas pipe line 3.5 m below the ground level (at this stage the discrete shear zone is broken up into two segments). This is removing the soil from the upper segment of the slope which has an angle of 10° (Figure 7) up to the R.O.W; this requires removing a large amount of soil and further enlarging the R.O.W. As the geometry of the landslide changes and the defect is present in both sections of the slopes above the R.O.W (i.e. along the slopes of 10° and 20°), this recommendation did not sound acceptable as the minimum slip surface passes through the defects. This recommendation is considered as phase four and it is modelled in this section. Figure 18 illustrates the results of this analysis with the circular method with the back calculated shear strength parameters derived from phase one. It is clear that by removing the soil, the upper segment of the ancient landslide is activated and it can cause failure (the calculated factor of safety is 0.478). To increase the factor of safety in this case, soil must also be removed from the segment of the slope which has an angle of 20° (Figure 7) in the ancient landslide.

As in other phases, the effect of suction is investigated through adopting a value of  $\phi_b$  equal to 12. In this analysis the minimum factor of safety is equal to 1.543. This essentially means that this phase can also be completed but a heavy rainfall can waive the effect of suction and trigger a land slide.
