# THE USE OF DISTRIBUTED FIBER OPTIC STRAIN SENSING IN ORDER TO CONDUCT QUALITY ASSURANCE AND QUALITY CONTROL FOR GROUND SUPPORT

This paper focuses on the development of fiber optic strain sensing and its use in order to ensure that support elements have been installed according to specifications (Quality Control) and that they are performing correctly (Quality Assurance); both in a controlled laboratory environment and in-situ. Results of the testing program demonstrated that a developed fiber optic technique could determine material flaws within grouted rock support installation as well as determine the strain and capacity of support elements in the lab and in-situ. i.e. during pull-out tests. As well, results demonstrated the capability of the optical technique to capture expected loading mechanisms of the support elements throughout their serviceability life, agreeing well with numerical and theoretical predictions. The optical technique has been successfully employed on-site at mines and tunnels around the globe.

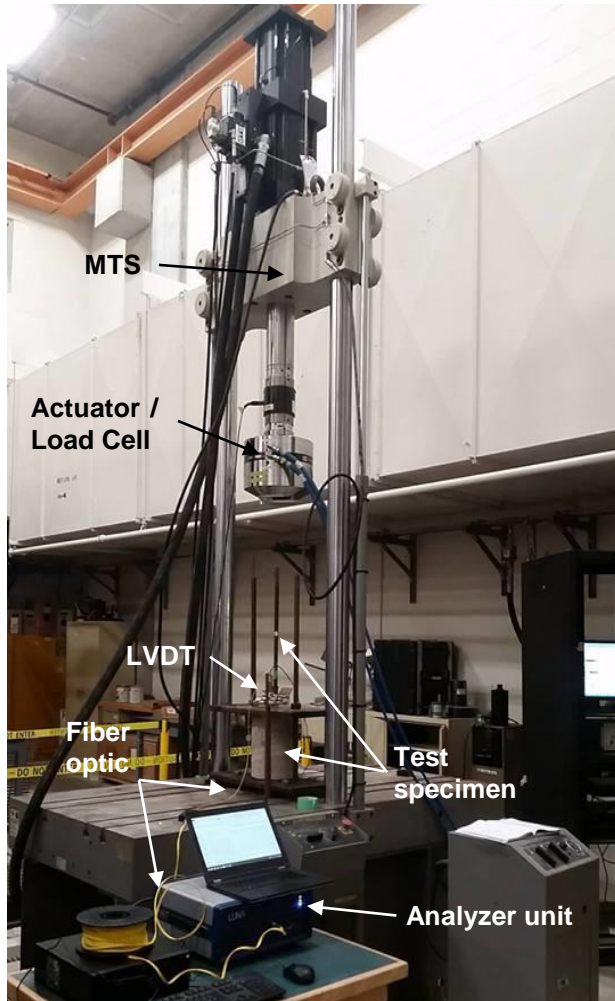
Figure 1. Laboratory Testing - Pullout test apparatus

A series of pullout tests were carried out in the structures laboratory at the Royal Military College of Canada. Tests were carried out using a 322.41 Material Testing System (MTS) that has a capacity of 500 kN in tension (Figure 1).

The MTS was modified by utilizing an arrangement of two 1 inch (25.4 mm) steel plates along with two ¾ inch (19 mm) threaded bars in order to fix concrete specimens containing cement grouted rebar. This allowed for the axial load to be applied to the rebar in a controlled manner.

through the far end of the concrete cylinder in order to measure any slip at the grout interface (Figure 11). The rebar was loaded using a 322.41 material testing system (MTS) as previously presented in Figure 1. The coaxial stress distribution and shear traction distribution for the laboratory pull-test are presented in the two right plots of Figure 13.

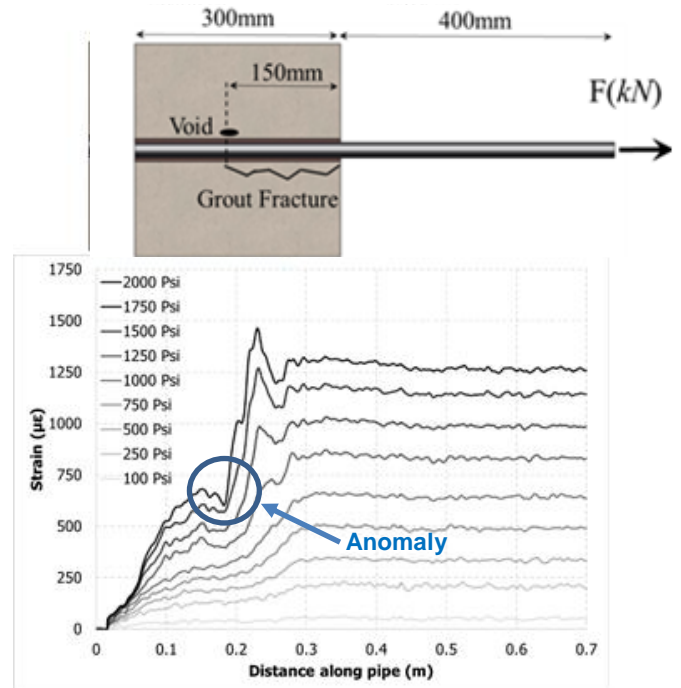
Figure 3. Axial pull-out test. Strain profile along the length (Side 1) of the steel pipe at various applied axial loads.

Results from an axial pullout test using grout are shown in Figure 3. During the testing it was evident using the optical technique that an anomaly existed within the grout or concrete block as unloading and reloading of the sample produce similar results (i.e. the instrumentation was functioning properly). Post-testing, the grouted length was cut from the concrete specimen. Aligned with the optical instrumentation, fracturing of the grout extending approximately 150 mm from the load to toe end was discovered (Figure 4 top). A circular void in the grout was also identified at approximately 150 mm from the load end of the grout, Figure 4 bottom. Comparing these post-test discoveries of the grout with the axial strain profiles verifies the accuracy and scale at which the optical instrumentation operates and allows for the detection of such 'defects' in the installation of such specimens. Such observations using this technique were noted by Vlachopoulos and Forbes (2015).

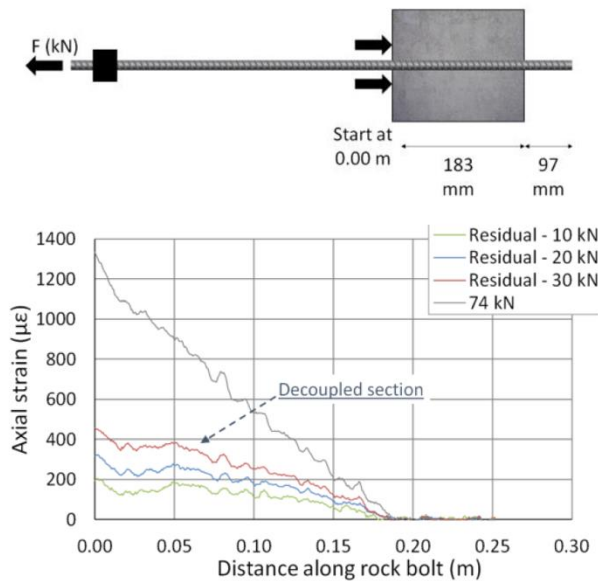
Figure 5. Distributed Fiber Optic strain profile results for pullout test of rebar; post failure response.

Insight of mechanisms associated with the bolt-grout interface as well as the bolt-rock interface can also be gained using this fiber optic technique. The results seen in Figure 5 correspond to the strain profile of the embedded section of the rebar as observed during incremental load testing. The strain profiles are shown at selected applied

loads. For lower loads, the strain is seen to generally decay away from the collar of the borehole to the end of the embedded section of the rebar. Furthermore, the jaggedness (*i.e.* the periodic disturbances) of the strain profiles correspond with the spacing of the bolt ribs – as the ribs cause the cross sectional area of the bolt to change. This is akin to the results described by Hyett et al. (2013). The section of the rebar which extends outside of the concrete cylinder is clearly distinct as there is no strain that develops along this segment of the rebar. This is due to the fact that this end of the rebar is free (*i.e.* limit equilibrium). The fiber optic technique was also able to capture the response of the rebar post non-critical failure of the system (*i.e.* the fiber optic is still able to withstand further loading). For this particular test, a brittle failure mechanism caused the concrete to radially split along two visible regions of the concrete cylinder. The radial splitting of the concrete cylinder decreased the radial confinement provided to the rebar and grout by the surrounding concrete. Accordingly, the amount of contact that existed between the rebar-grout and grout-concrete, post failure, was not enough to adequately mobilize the entire shear strength available at one of the interfaces. The flat region seen in the strain profile of the rebar near the borehole collar (*i.e.*, from 0.00-0.05m, Figure 5) is indicative of the region along the embedment length of the rebar where decoupling at an interface has occurred. The efficiency of load transfer along this region therefore decreased. Therefore, the grouted rebar system could not carry any additional load. This residual load bearing capacity of the specimen was mainly provided by the region of the rebar 0.1 m into the embedment length and further on where the grout and borehole and rebar and grout maintained a stronger bond. Indicatively, conventional instrumentation (LVDT) also captured the slip that occurred through incremental loading during the pull-out test (Figure 6).

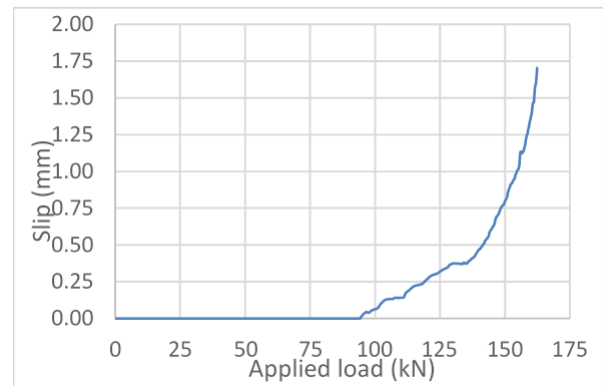
Figure 6. Pullout test slip result

As can be seen, slip began to take place along the bolt-grout interface at a load of ~100 kN (Figure 6). This proceeded until a peak load of 162 kN was reached. A total amount of 1.7 mm of slip was recorded. Analysis of a cutaway of the specimen shows that the bond between the rebar and grout remained relatively intact throughout the loading of the bolt (Figure 7). Forensics conducted post testing demonstrates that past the region where slip began to take place, the slip occurred along the grout-borehole

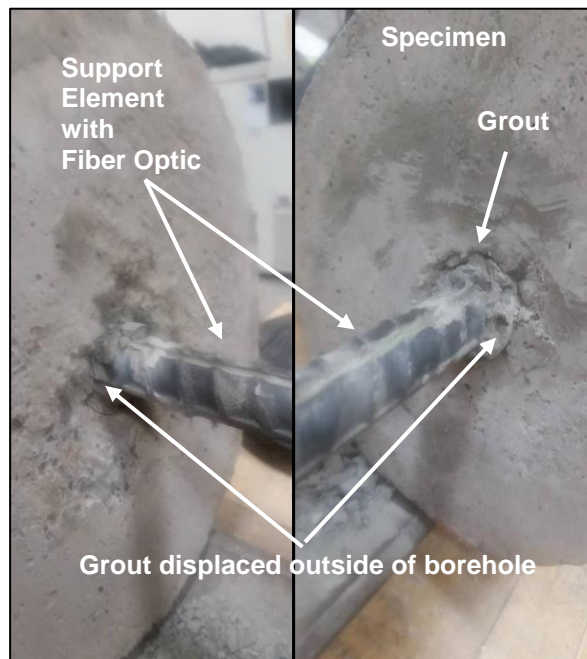
Figure 8. Movement of grout outside of borehole.

interface. The shear strength past the onset of slip is therefore provided mainly by the friction created as the grout moves along the grout-borehole interface. This observation provides mechanistic evidence of the slip recorded with conventional instrumentation and that which was visually observed (Figure 8, Figure 9).

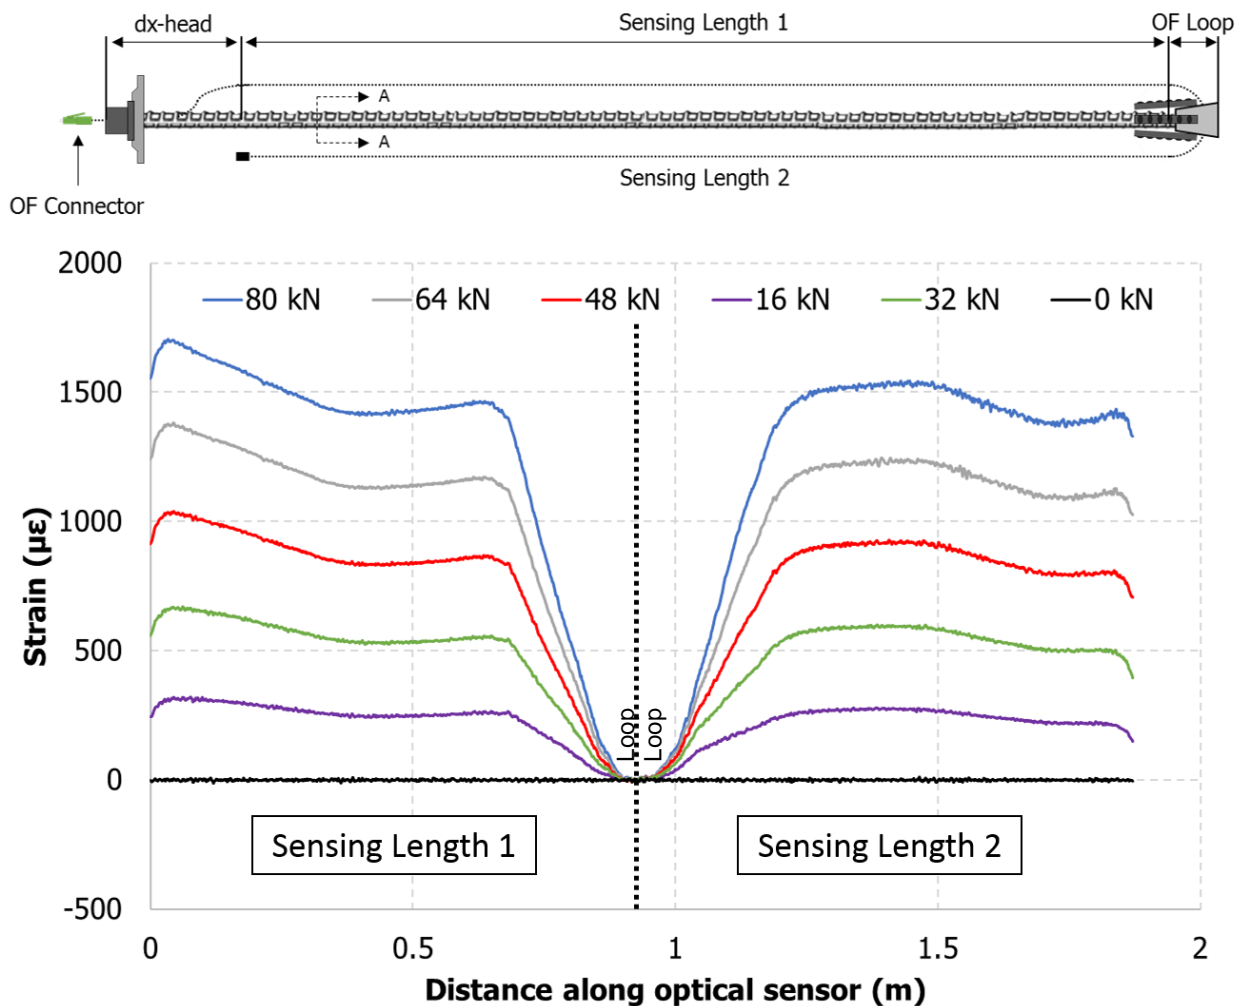
Strain measured along the entirety of an optical fiber sensor for a selected field pull-out test is presented in Figure 10. This test corresponds to a sandstone outcrop

Figure 10: Field coaxial pull-test. Top: Schematic depiction of the optical fiber sensor along the rock bolt member. The optical sensor loops at position of the mechanical expansion anchor at the toe of the bolt. Bottom: Strain measured along the entirety of the optical fiber sensors (or both sensing lengths of the rock bolt) at various level of applied load. Note: Positive strain is extensile and negative strain is contractive. The sensing length is approximately 1 m.

the toe; refer to Figure 11. Load was applied during this test using a 30-tonne hydraulic cylinder. A similar pull-test configuration from an underground trial is presented in Figure 12. Applying Eq. 1, and multiplying by the Young's Modulus of the steel rebar (E), the strain profiles presented in Figure 10 are used to plot the coaxial stress distribution along the length of the rock bolt member, Figure 13. In addition, the shear traction distribution between the rock bolt and the grout interface can be derived according to Eq. 2 (Farmer, 1975), where  $r_b$  is the radius of the steel rebar and  $n$  is the given strain measurement position.

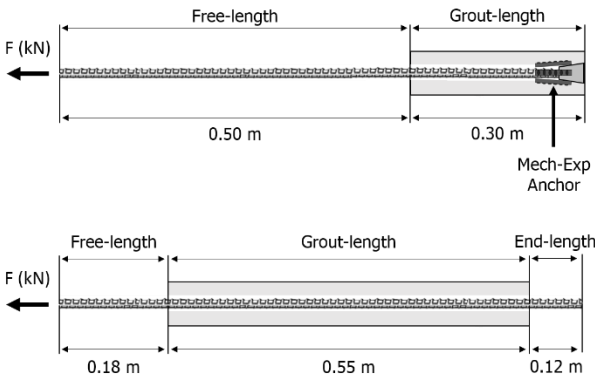
Figure 11: Upper: Field pull-out test arrangement. Lower: Laboratory pull-out test arrangement.

installation of 19.05 mm diameter rock bolt specimen. The rock bolt was installed into a 0.80 m long and 32 mm diameter drilled and washed borehole using a mechanical expansion anchor and 0.30 m of cement grout (0.4 W:C) at
