# Real-time Monitoring of Soil Water Content and Suction within a Slow Moving Landslide

## ABSTRACT

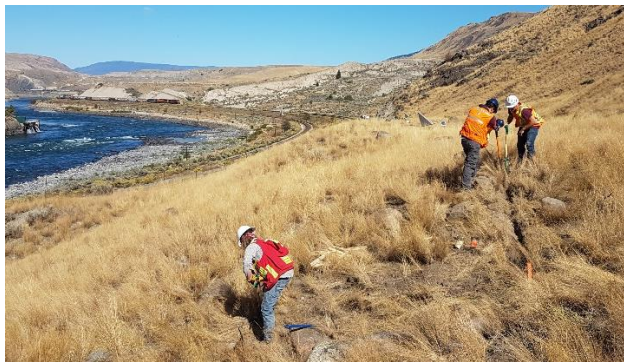
Figure 3. Installation of ERT system

(Figure 2). As shown in Figure 3, the grid layout was hand excavated and covered following installation of the probes and the associated cabling. The lines were later armoured with small boulders to limit animal disturbance.

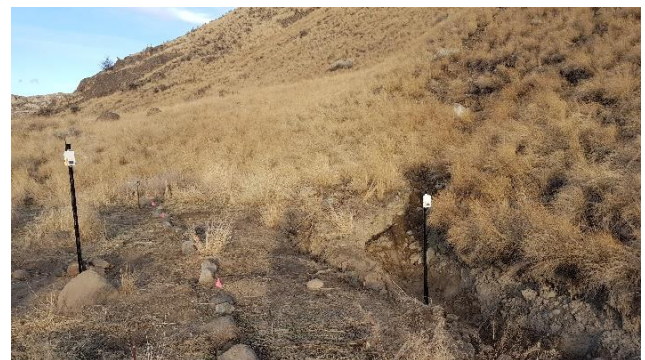
Figure 4. Matric suction instrumentation relative locations on the landslide an in the head-scarp

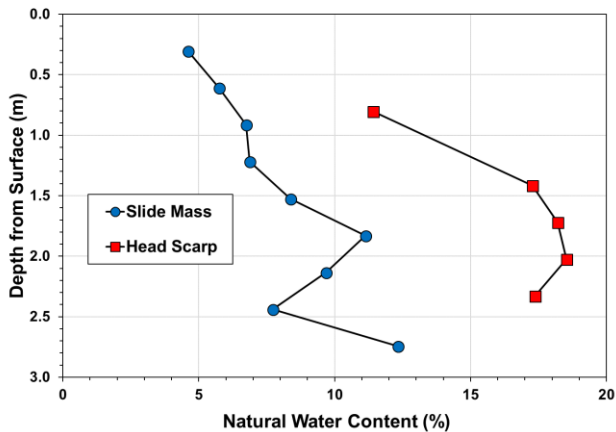
Figure 5. Natural water content variation with depth

Natural water content was measured from sealed bag samples collected during the site investigation. The results are plotted in Figure 5. It is evident that the natural water content within the head scarp was approximately 5 to 10% higher when compared to the samples taken from the slide mass. This was attributed to an increased capture and storage of surface runoff within the head scarp due to the presence of the tension crack, and an interception of some of the surface runoff upslope of the head-scarp, as compared to the direct infiltration and minimal surface runoff from the slide mass site.

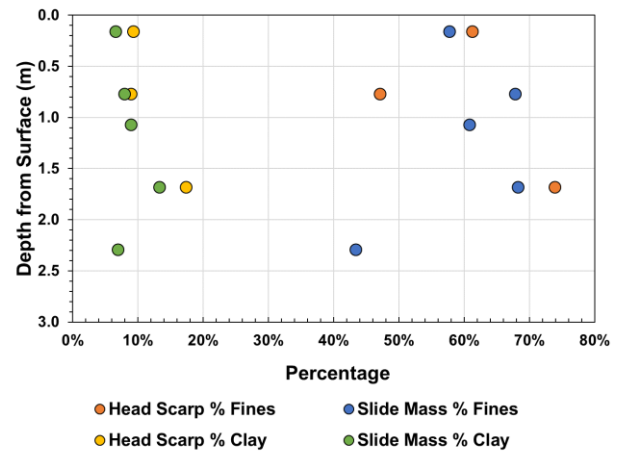
Figure 6. Fines and clay composition from head scarp and slide mass

The grain size distribution testing was conducted at regular intervals for both boreholes. The results from the mechanical sieving and hydrometer indicate a well-graded soil predominantly composed of a mixture of sand, silt, and clay with trace gravel and cobbles. Typically, around 60% of the samples tested passed the No. 200 sieve. Hydrometer testing indicated that most of the fines were silt sized particles. While there was no apparent trend in the percentage of fines by mass when plotted with depth, the percentage of clay in both boreholes was consistently less than 10%, excluding those samples taken at a depth of 1.7 m (Figure 6).

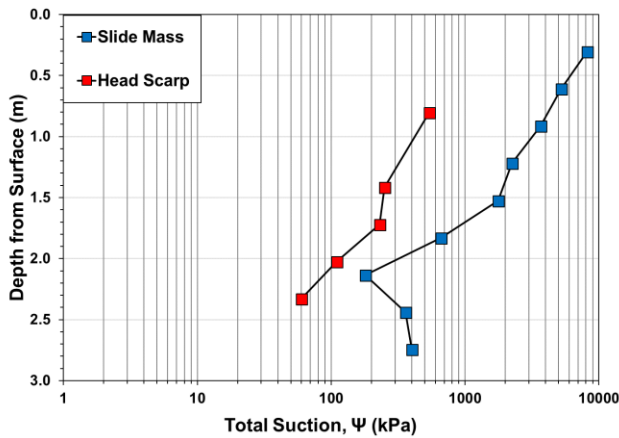
Figure 7. Total suction with depth

Atterberg limit tests were carried out for one sample in each of the boreholes and the results were found to be similar between the two locations. The plastic limit varied between 19 and 22%, whereas the liquid limit ranged between 30 and 33%. These results indicate a reasonably low plasticity clay (CL). A laboratory hygrometer was used to determine the total suction for the samples recovered from the slide mass and within the head scarp and the results are shown in Figure 7.

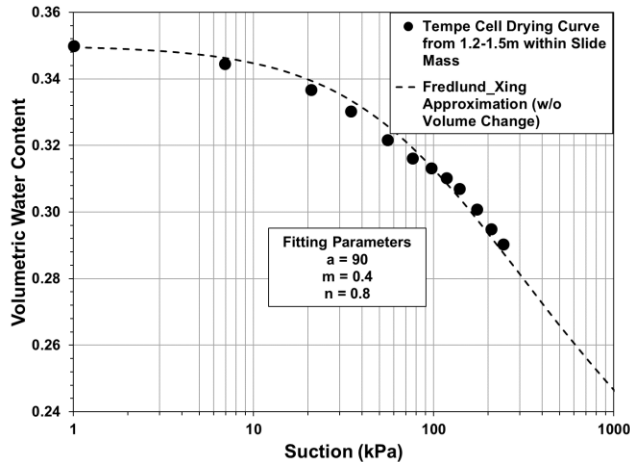
Figure 9. Preliminary SWCC for slide mass soil

The soil water characteristic curve (SWCC) implies that increases in water content cause a loss of matric suction which aids in the temporary stabilization of the landslide. A preliminary SWCC is shown for the soil recovered from the unsaturated slide mass of the Ripley Slide. The figure indicates substantial losses in suction would occur due to changes in water content (Figure 9).

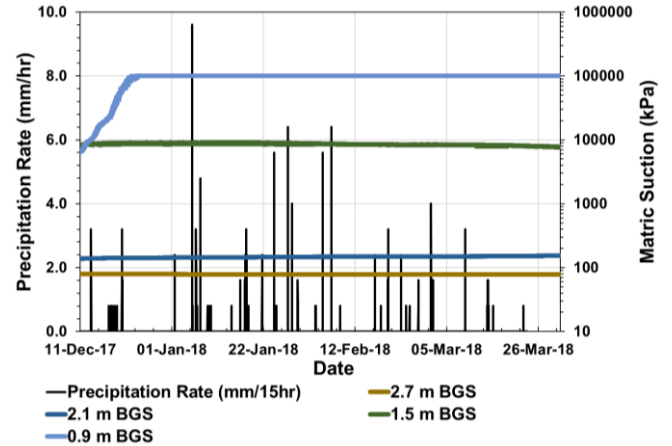
Figure 11. Constant measured matric suction in the slide mass with precipitation rate

The infiltration and rate of recharge into these tension cracks can cause a gradual loss in shear strength and results in changing rates of landslide movement. Infiltration can lead to rising water contents at depth further reducing the effective stress along the slide plane which can increase movement rates resulting in deeper tension cracks. The matric suction monitoring data suggest that the matric suction near the surface can change quickly with minor changes in the precipitation rate (Figure 10). During the same period, the matric suction in the slide mass is relatively unaffected (Figure 11). When compared with the recorded air temperature, the data confirm a loss of head scarp matric suction a few days after the temperature starts to reach daytime highs above 5°C (Figure 12).

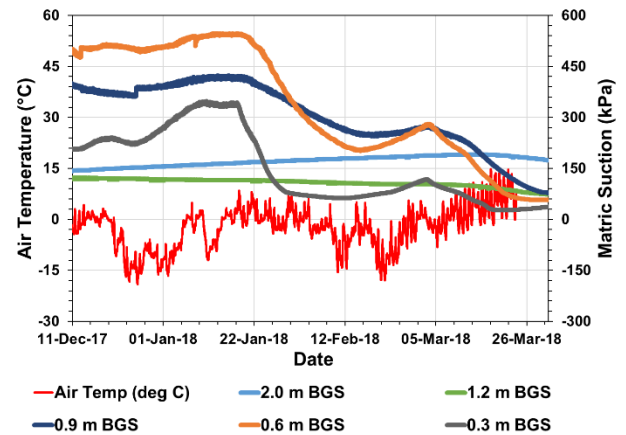
Figure 12. Head scarp measured matric suction and air temperature fluctuations

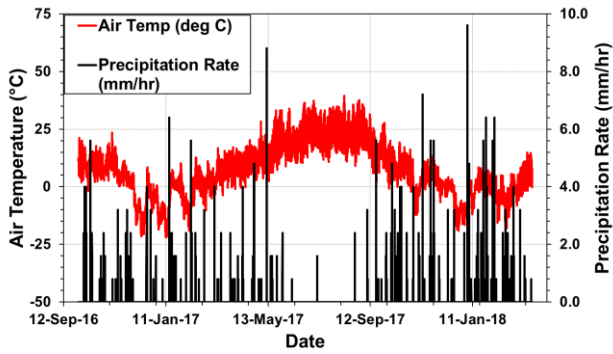
Figure 13. Change in air temperature and precipitation rate

A weather station installed on site has been continuously tracking total precipitation, precipitation rate, and air temperature since late September 2016. The data collected during this period suggest that June to September are characterized by very low precipitation as expected for the Thompson River valley (Figure 13). During the summer, the rate of landslide movement tends to stagnate (Figure 14). Noteworthy is the contribution of changing river stage. When the precipitation levels are low (June and July), the Thompson River is subjected to spring freshet water levels shown to partially buttress the slope as well as reduce any artesian pressures acting on the slide plane. These additional factors likely contribute to the reduced movements. During the fall and winter months, the Thompson River level drops and the movements increase (Eshraghian et al., 2007; Hendry et al., 2015).

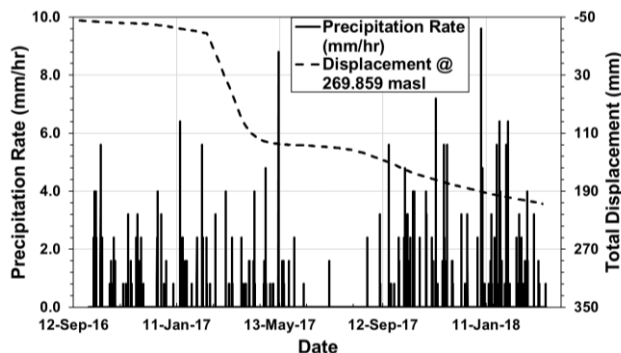
Figure 14. Change in precipitation rate and displacement

A period of rapid landslide movement started in mid-February 2017 based on data from an SAA inclinometer located adjacent and upslope of the tracks near the centreline of the Ripley Slide (Figure 1). Displacement data at approximately 270 masl was associated with the highest rate of lateral movement (Figure 14). During the first few months of the year, the river level was at its lowest prior to spring runoff (Figure 15). At that point in time, the Ripley Slide is susceptible to any stability-altering changes that could trigger movement. The gradual lowering of the river level could provide an explanation for the accompanied gradual increase in movement starting in August 2017.
